Technical product information

| Topic | New Continental GT - Power boot close switch - Correct diagnosis |
| Transaction No. | 2038253/1 |

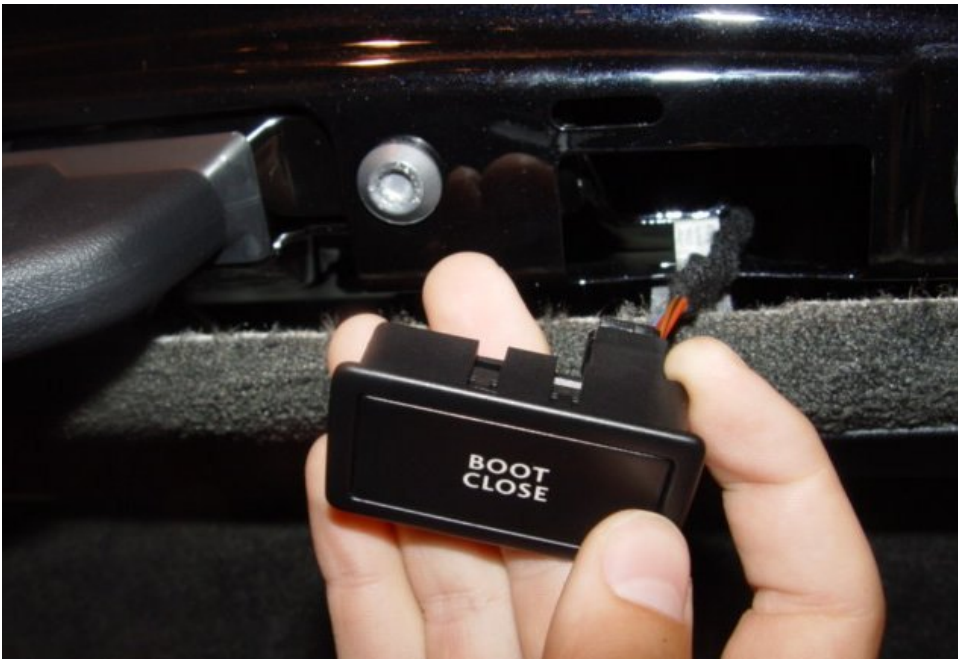
Figure 2

-With the boot close switch hanging in free air press the switch to check if the boot lid starts to close, should this be the case and the boot lid starts to close the switch is serviceable, you should now proceed with procedure 6 **NOTE:** should the boot not start to close proceed to procedure 5

- 4.Reconnect the switch to the electrical connection (Figure 2) allowing the switch to hang in free air

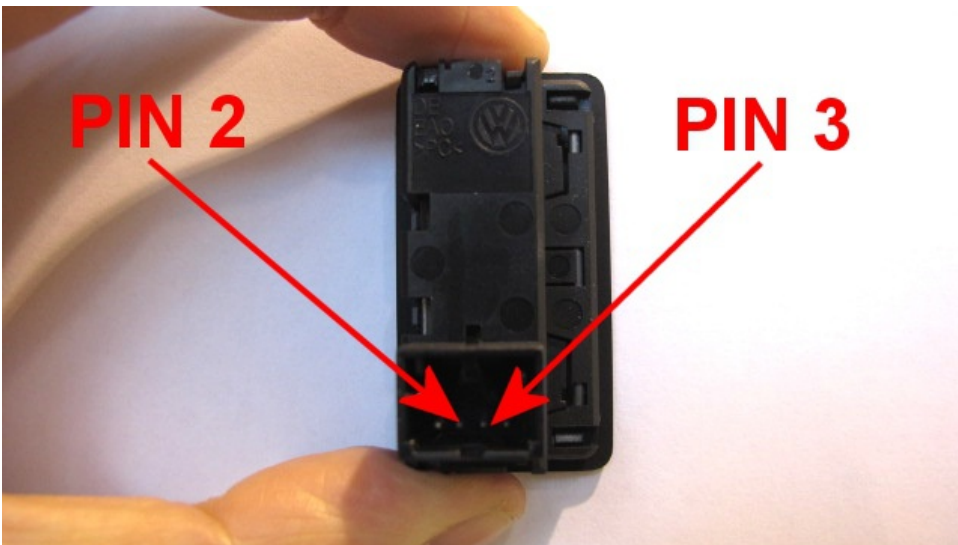
Figure 3

The resistance for a fully serviceable switch when operated (pressed) is 0.2 Ohms

- Measure the resistance between pins 2 and 3 (Figure 3) The button on the boot close switch must be pressed and held in otherwise a correct reading will not be obtained
