Technical product information

Topic	New Continental GTC - Power boot close switch - Correct diagnosis
Market area	Worldwide Bentley (1WBE)
Brand	Bentley
Transaction No.	2038255/1
Level	EH
Status	Approval
Release date

New Continental GTC

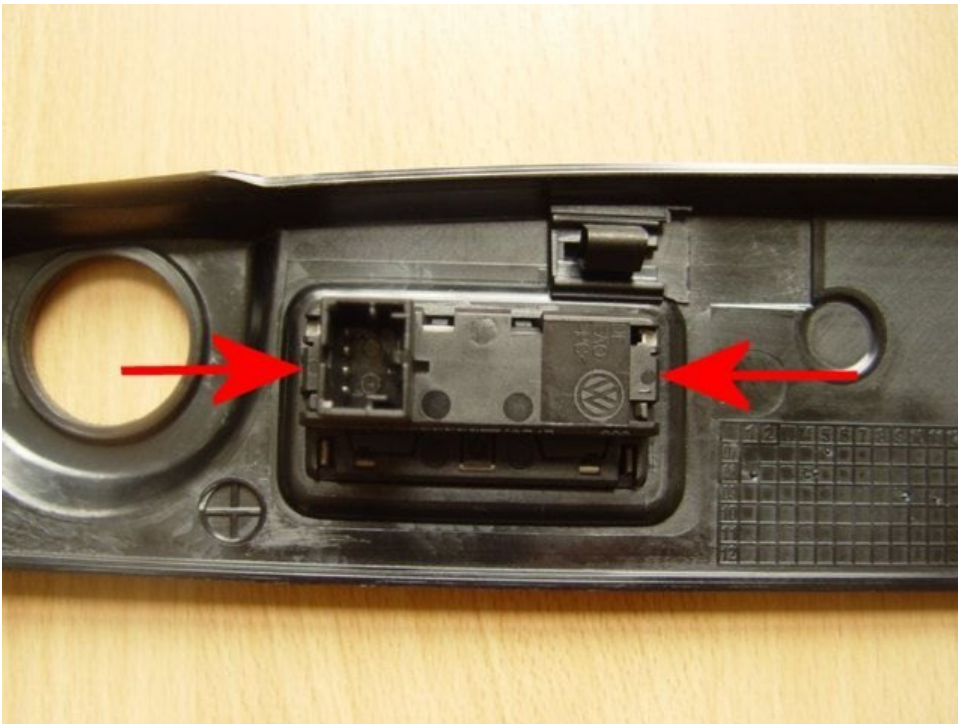
Figure 1

- 1.Press the boot close switch to confirm the switch does not attempt to close the boot. **NOTE:** Should the boot lid start and attempt to close please still commence with this TPI to test the full serviceability of the switch as the fault within the switch may be intermittent.
- 2.Remove the boot lid latch cover Refer to Workshop Manual Rep.Gr 70 - Boot lid latch cover panel - To remove and fit
- 3.Remove the switch from the cover panel by pressing the two retaining clips inboard and remove the switch from the cover panel (Figure 1)

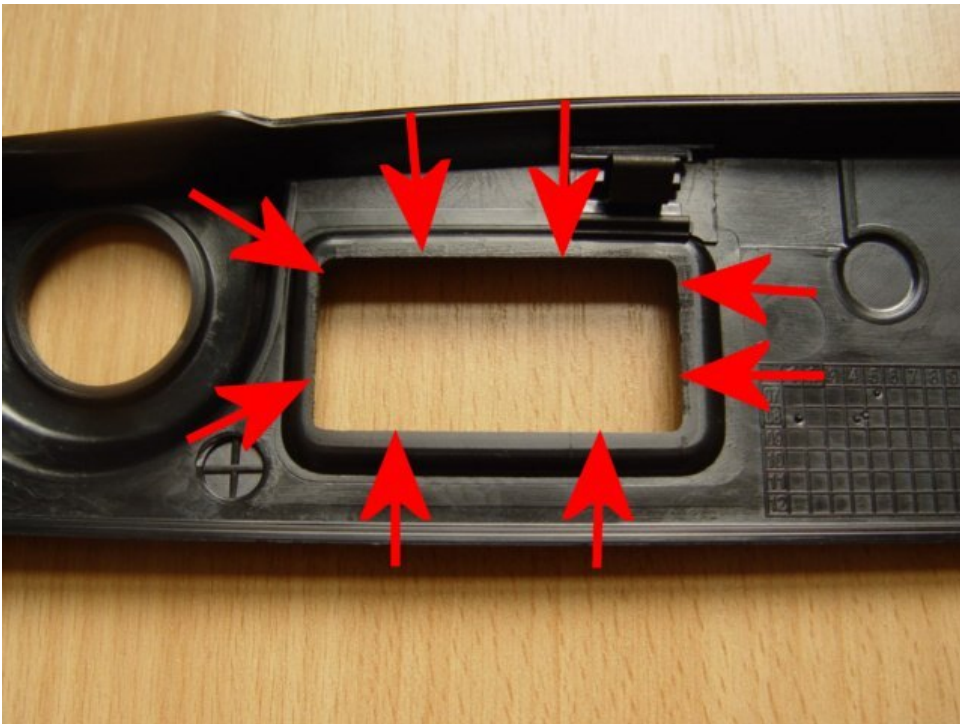
Figure 4

6.Before refitting the existing or new switch it is essential that the switch fits into the cover without any excessive resistance, should there be any burrs or jagged edges around the aperture (Figure 4) you should carefully smooth away any burrs or jagged edges using fine sandpaper taking care not to enlarge the aperture

- Remove the boot lid latch cover Refer to Workshop Manual Rep.Gr 70 - Boot lid latch cover panel - To remove and fit

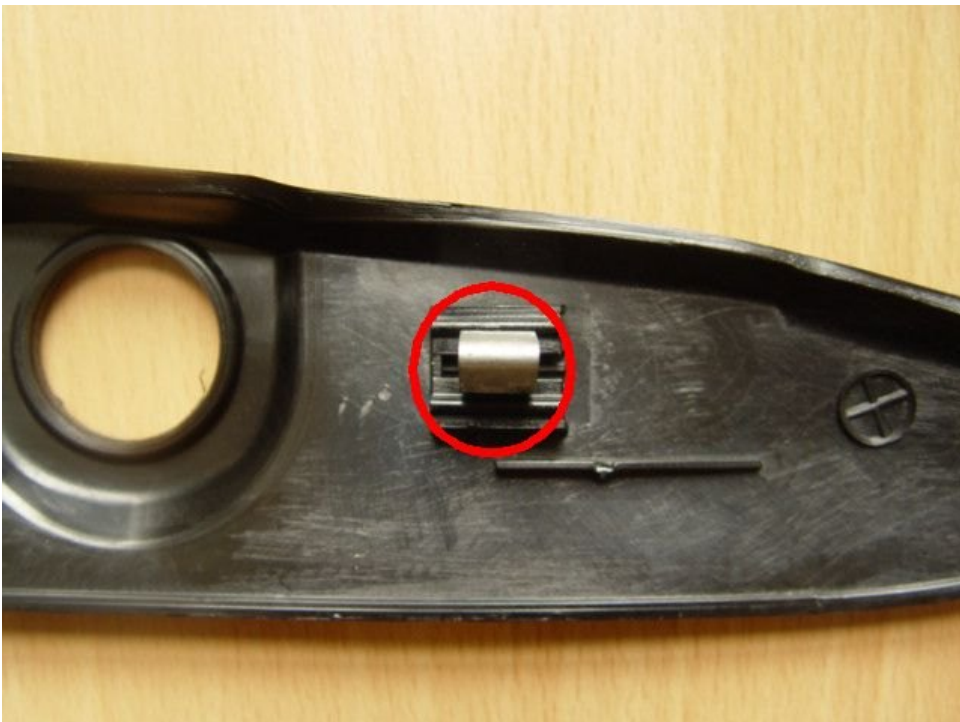
Figure 5

7. Refit the switch into the aperture ensuring correct orientation and the two clips are fully locked into position
-Check that the latch cover clips are centrally positioned before refitting the latch cover (Figure 5)

8. Refit the boot lid latch cover Refer to Workshop Manual Rep.Gr 70 - Boot lid latch cover panel - To remove and fit
9. Press the boot close switch to confirm full operation
