Technical product information

Topic	New Continental GT - GTC and Flying Spur - Steering wheel noise
Market area	Worldwide Bentley (1WBE)
Brand	Bentley
Transaction No.	2027022/5
Level	EH
Status	Approval
Release date

New Continental GT,GTC and Flying Spur

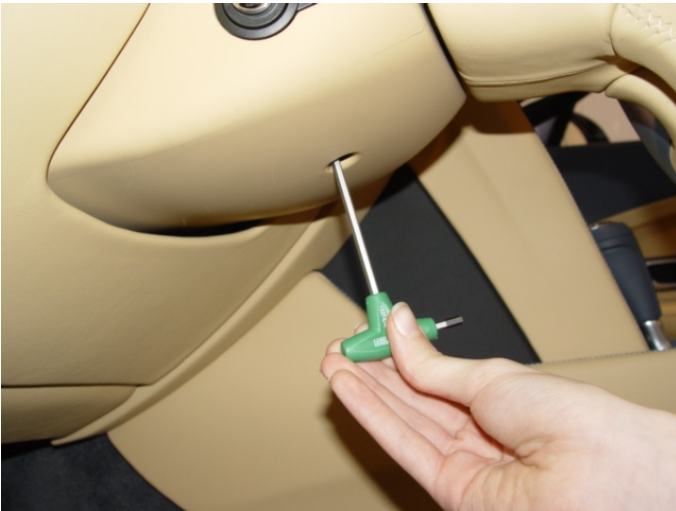
Figure 1

The chafing/grinding noise occurs when turning the steering wheel from lock to lock. The noise is not always evident throughout the full cycle. The noise is due to the multi-function switch coupling contacting the inner face of the steering cowl.

1. Slacken off the multi-function steering column (J453) switch 4mm allen bolt fixing which can be accessed through the steering column lower cowl (Figure 1).
