Topic	Flying Spur - Potential mismatch - Keys to entry and start authorisation control unit control J518 (SC14/12)
Market area	Worldwide Bentley (1WBE)
Brand	Bentley
Transaction No.	2037366/1
Campaign number	EA12
Note	
Type	
US code

EA12

Transaction No.: 2037366/1

Flying Spur - Potential mismatch - Keys to entry and start authorisation control unit control J518 (SC14/12)

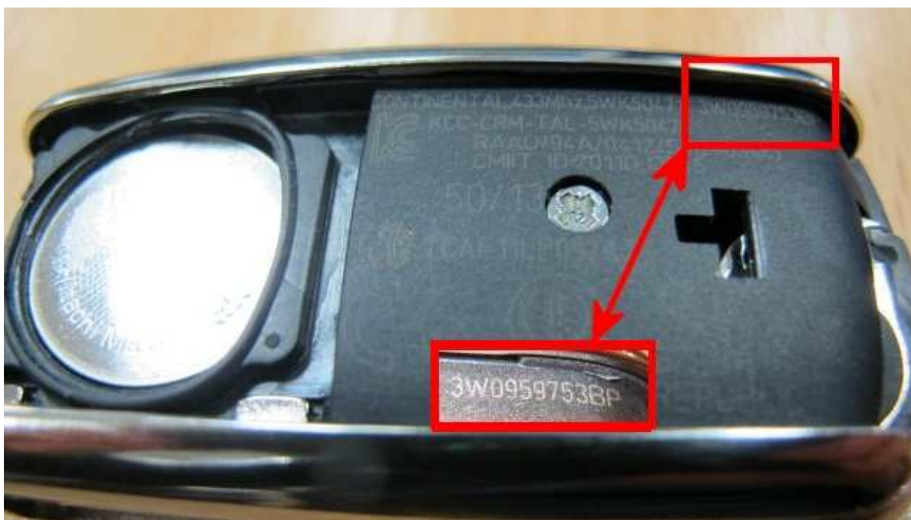
2. With the key fob back removed check the part number of the key, the part number is located as shown in Figure 1

The part number is formatted as 3W0 959 753XX

The suffix (XX) identifies the generation of the key as follows:

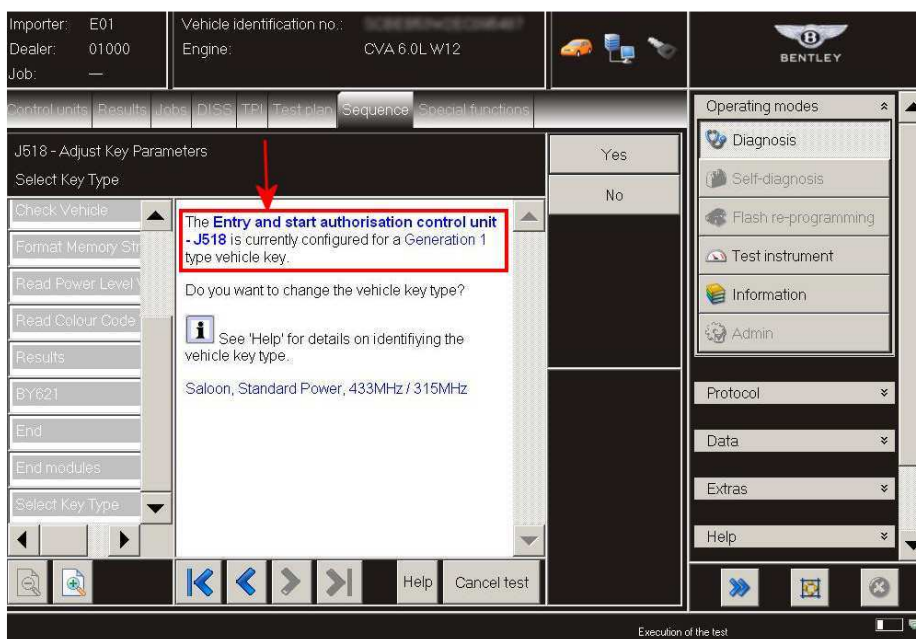
- Figure 6 confirms the Generation of the **Entry and start authorisation control unit -J518-**

IMPORTANT: Should the Generation of the key match the entry and start authorisation control unit -J518- no further action is required, should a mismatch be evident please go to Section 2 to change the Generation configuration within control unit -J518-

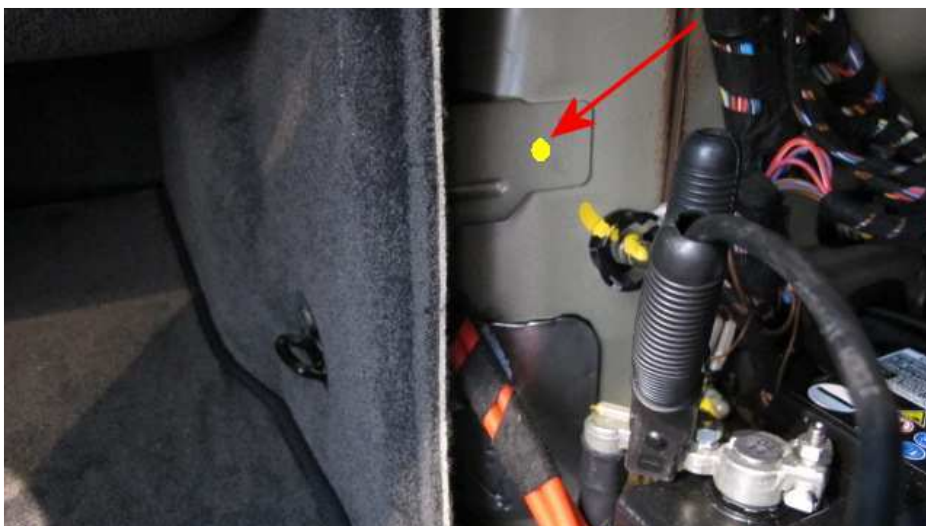
Figure 7

If the vehicle is not already listed as repaired in the "Repair history" (in Elsa Pro), check for the campaign identification mark which is a yellow paint spot on the right hand boot trim panel bracket located in front of the starter battery (Figure 7) if the paint marks are not visible please carry out the required work in accordance with

7. If **no** mismatch is evident, place a yellow paint completion mark on the right hand boot trim panel bracket located in front of the starter battery (Figure 7)

2. Place a yellow paint completion mark on the right hand boot trim panel bracket located in front of the starter battery (as shown in Figure 7)
