Topic	New GT - wind noise - water leak at cantrail seal
Market area	Worldwide Bentley (1WBE)
Brand	Bentley
Transaction No.	2037172/1
Level	EH
Status	Approval
Release date

Transaction No.: 2037172/1

New GT - wind noise - water leak at cantrail seal

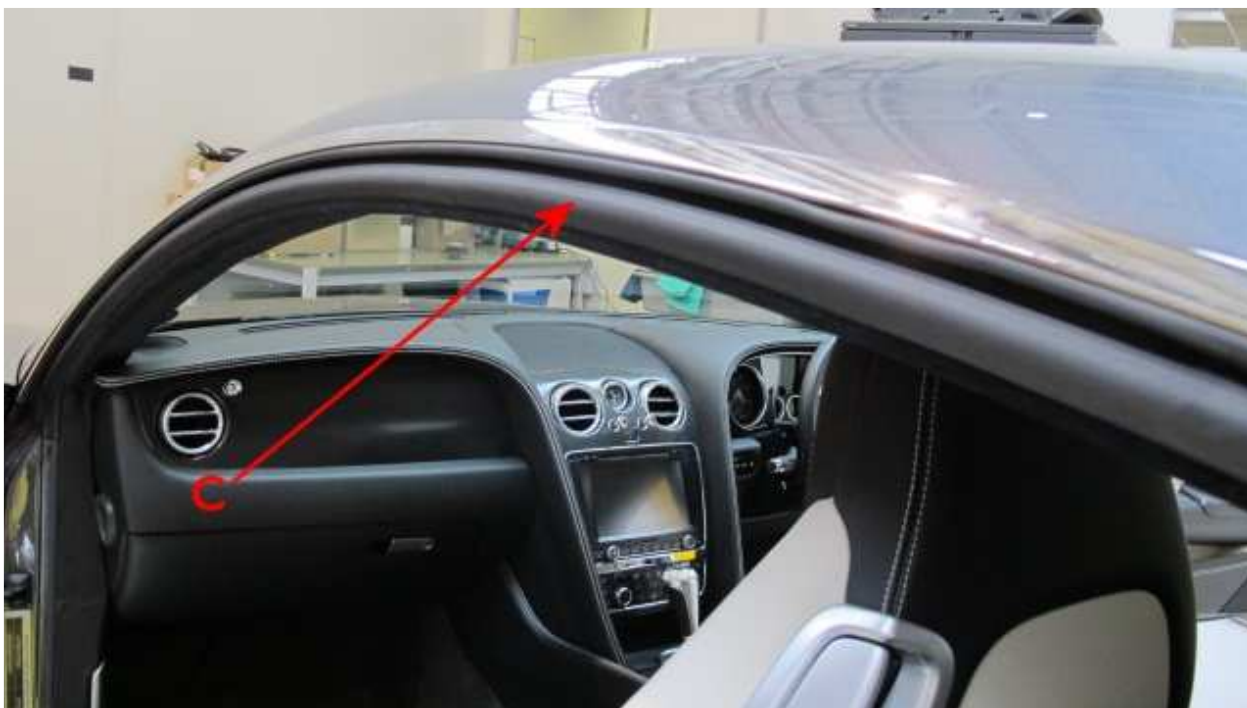
Figure 1

The cantrail seal (C) forms the landing face for the vehicles side drop glass (see Figure 1). If this seal is not fitted correctly a gap can be produced where the glass interfaces with the seal resulting in wind noise and possible water ingress.

In the event of a concern relating to wind noise or water leak in the vicinity of the cantrail seal on New Continental GT then incorporate the following checks into your investigation ensuring the cantrail seal (C) is fitted correctly

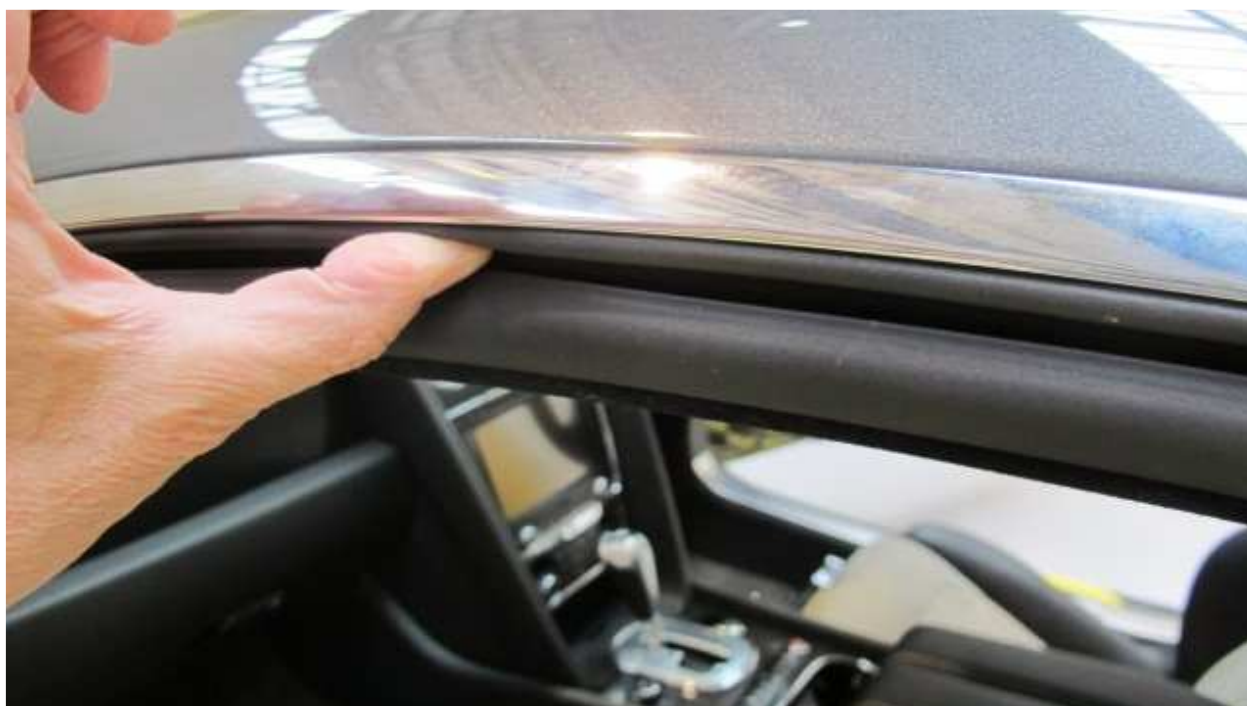
Note: The head of the fasteners can be felt through the seal when the seal is correctly fitted but when correctly fitted the seal profile is not changed at the location of each fastener
