Topic	New Continental GT and GTC - V8T Engine control module update (SC13/06)
Market area	Russische Föderation (5RU),China 796 VW Import Comp. Ltd (Vico), Beijing (6796),Russian Federation 935 Volkswagen Group RUS (6935),United Kingdom E01 Bentley UK (6E01),Germany E02 Bentley rest Europe (6E02),Australia E04 Bentley rest Asia and Australia (6E04),United States E05 Bentley USA and rest America (6E05),United Arab Emirates E06 Bentley Middle East and Africa (6E06)
Brand	Bentley
Transaction No.	2033405/3
Campaign number	E782
Note	
Type	
US code

E782

New Continental GT and GTC - V8T Engine control module update
(SC13/06)

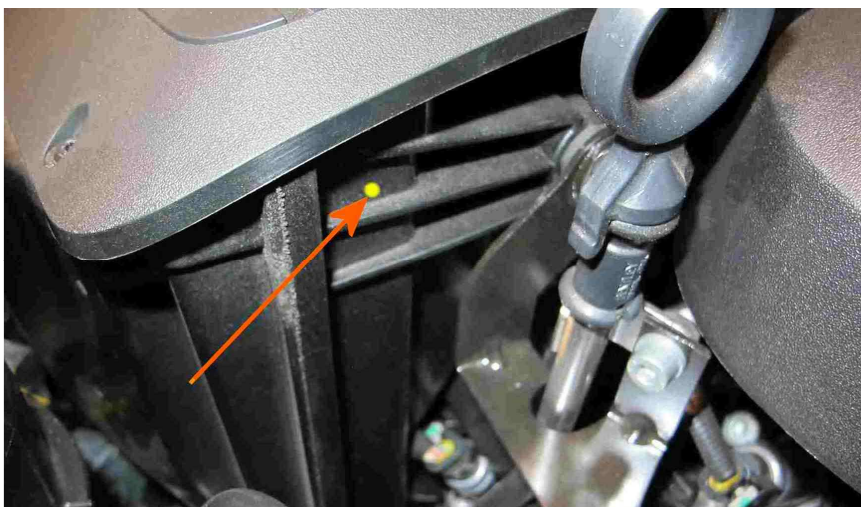
Figure 1

**ATTENTION:** Before commencing with this procedure please check the left hand air filter housing for a yellow paint mark (Figure 1) the paint mark signifies that the vehicle has already received a similar software update for a separate issue.

If the yellow mark is evident or TPI 2035573/3 has been conducted do not carry out this procedure please refer to the Warranty accounting instruction section of this procedure for labour claim instructions to allow the campaign applicability to be removed for the applicable VIN

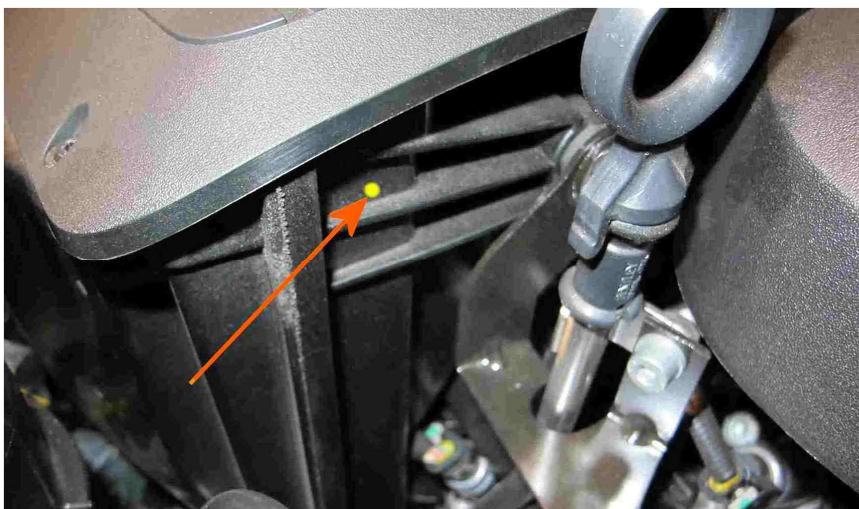
Figure 1

**ATTENTION:** Before commencing with this procedure please check the left hand air filter housing for a yellow paint mark (Figure 1) the paint mark signifies that the vehicle has already received a similar software update for a separate issue.

If the yellow mark is evident or TPI 2035573/3 has been conducted **do not** carry out this procedure please refer to the Warranty accounting instruction section of this procedure for labour claim instructions to allow the campaign applicability to be removed for the applicable VIN

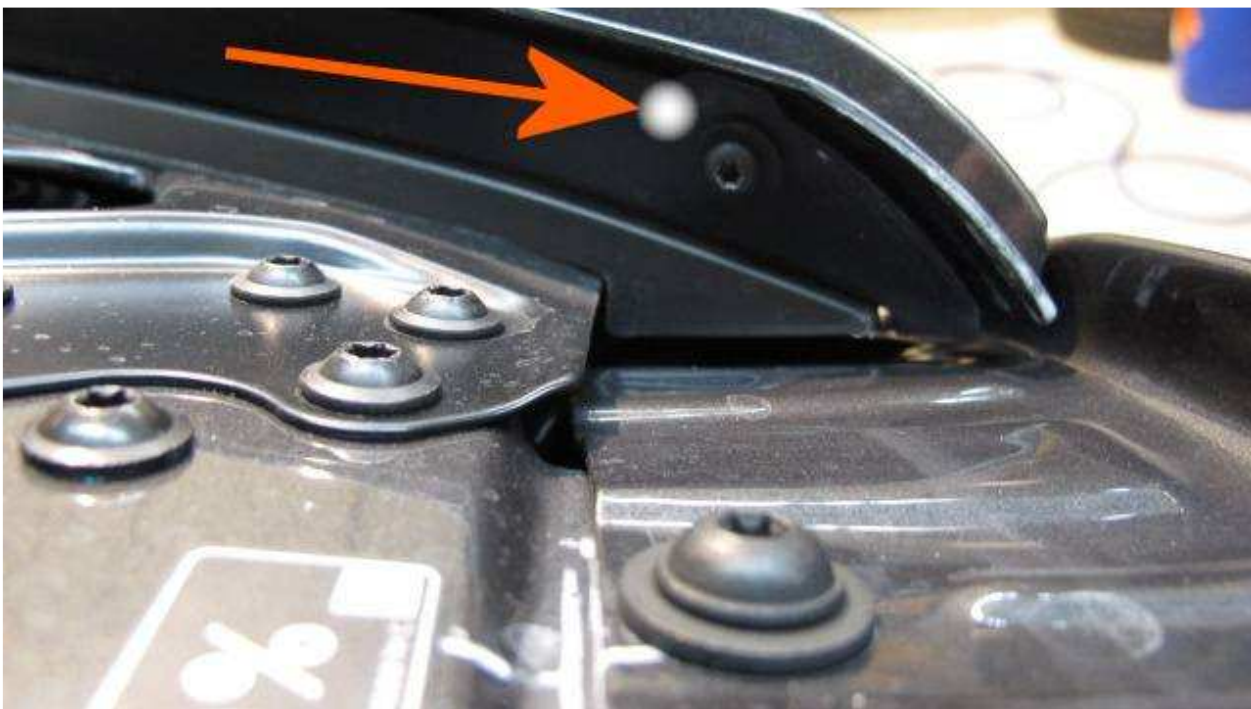
White paint completion mark on the right hand radiator shell fixing (see Figure 17)

7. Place a White paint confirmation mark on the right hand radiator shell fixing as shown in Figure 17
