<b>Topic</b>	Flying Spur HVAC Refrigeration Pipe Clip Replacement - Corrosion (SC14/02)
<b>Market area</b>	Russische Föderation (5RU), Russian Federation 935 Volkswagen Group RUS (6935), United Kingdom E01 Bentley UK (6E01), Germany E02 Bentley rest Europe (6E02), Japan E03 Bentley Japan (6E03), Australia E04 Bentley rest Asia and Australia (6E04), United States E05 Bentley USA and rest America (6E05), United Arab Emirates E06 Bentley Middle East and Africa (6E06)
<b>Brand</b>	Bentley
<b>Transaction No.</b>	2035328/2
<b>Campaign number</b>	EA02
<b>Note</b>	EA02
<b>Type</b>	Workshop Campaign
<b>US code</b>

### Flying Spur

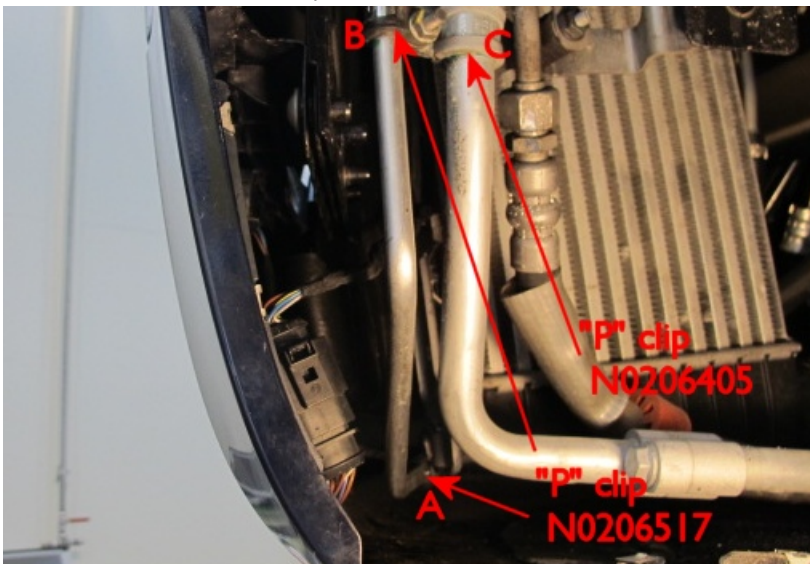
Figure 1

5. Referencing figure 1 identify the three P clips (A,B and C) located in the front left wheelarch that require replacement

- Remove and discard clips B and C (see Figure 1)

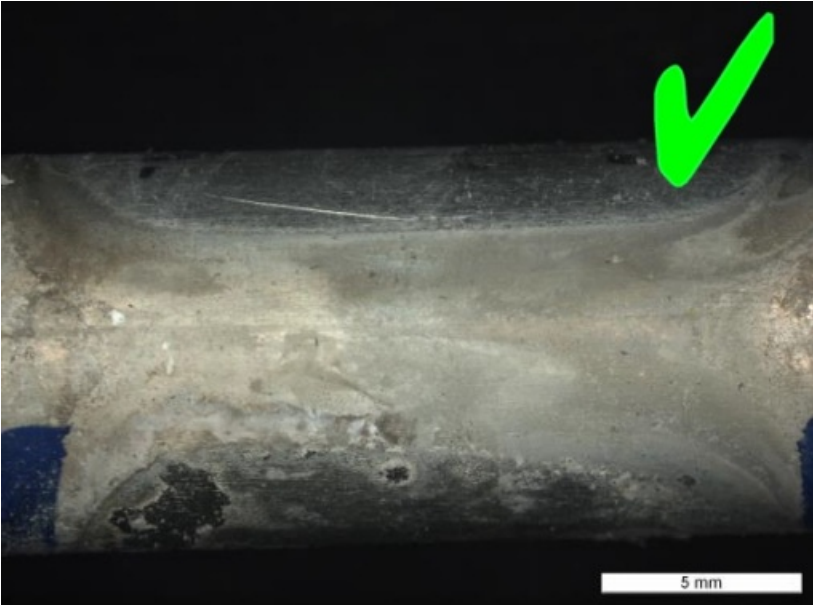
Figure 3

- The three locations from which the clips have been removed should now be inspected for surface corrosion, use of a mirror will aid inspection. Discolouration and light oxidation on the surface of the pipe is not detrimental and does not necessitate pipe replacement (see Figure 3). If the pipe surface shows signs of extensive corrosion and pitting (see Figure 4) then that pipe should be replaced

- On cars where the pipe is serviceable, figure 3, fit three replacement clips. For position A and B fit new clip part number RSGUV1.10-15W1 in position C fit new clip part number RSGUV1.18-15W1. If either pipe is found to have extensive corrosion then both pipes should be replaced before replacing the clips, in this case follow the *Air conditioning pipe replacement* procedure detailed below.

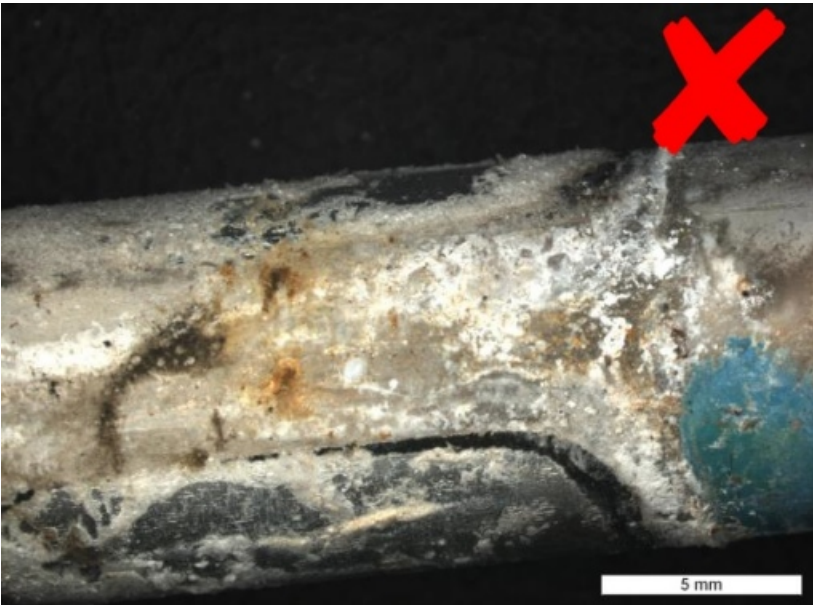
Figure 4

Extended durability trials have identified corrosion on the outside of the air conditioning pipe where it passed through the left hand front wheel arch area. This corrosion is only evident at the clipping point and is associated with the use of stainless steel clips. In extreme cases the corrosion would compromise the pipe integrity and result in refrigerant loss.

- This procedure is only to be performed if either pipe has extensive surface corrosion at the clipping points (see Figure 4)
  - Note:** If the refrigeration system is left open for more than 30 minutes the accumulator will have to be replaced
- Discharge the refrigerant from the system Rep. Gr.87 Refrigeration system – To discharge and charge
