In This Issue

Vehicle Technical Info

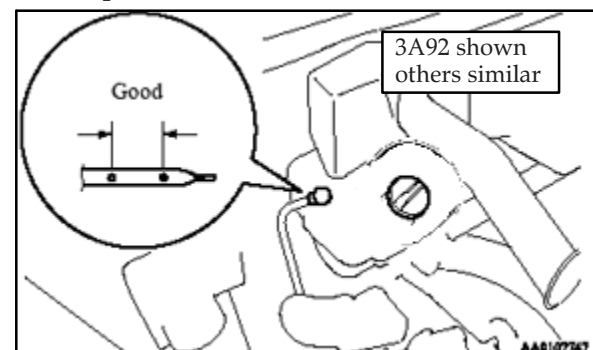
MAINTAINING PROPER OIL LEVEL — All models. Dealers have reported the appearance of “foam” on the engine oil gauge (dipstick) when checking oil in some vehicles, especially the 2014 Mirage. This could be tiny air bubbles in the oil caused by overfilling the engine oil, possibly due to checking the level too soon after stopping the engine. Overfilling can create oil cavitation and cause the bubbles, leading to reduced oil pressure. The 3A92 engine in the Mirage is particularly susceptible to overfilling, mostly due to how long oil takes to drain back to the oil pan. When adding oil to the engine, make sure you do not add oil above the “maximum” mark on the dipstick.

- Owners manuals advise that engine oil level should be checked before starting the engine (cold) and the level should be maintained in the “good” range, between the minimum and maximum marks on the dipstick as shown.

- Adding oil to a warm engine immediately after stopping could result in an overfill

condition. The drain back of oil into the oil pan varies by engine, and can take 3-5 minutes in some cases. Wait at least this long before checking oil in a warm engine.

Refer to the owner's manual and/or service manual for additional information on checking and adding engine oil.

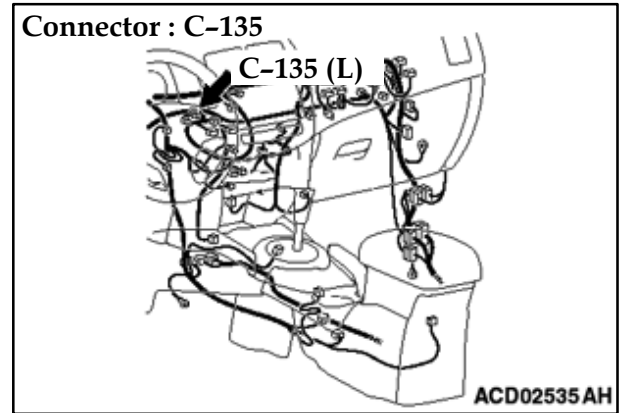
HANDS FREE SYSTEM DOES NOT RESPOND TO VOICE COMMANDS — 2014 models *without MMCS Navigation*. If you find during PDI that there is no response when checking the hands free speech commands in affected vehicles, it may be due to a jumper connector (loop connector) not installed at connector C-135. The jumper connector is blue in color and completes the hands free microphone circuit on vehicles built with an HFM. Vehicles with MMCS navigation are not affected as they have a

different wiring harness.

If you find the jumper connector missing, search ASA CAPS for PNC 83943 and order the correct part number for the model.

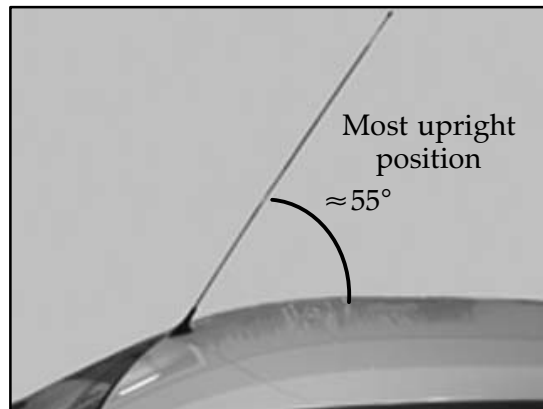
HOWLING NOISE FROM AUDIO ANTENNA — 2014 *Mirage*. If a customer reports a howling noise between 30 and 50 mph, it may be due to the angle of the roof mounted audio antenna. Currently, the noise has only been reported on vehicles where the antenna is positioned in the most upright position.

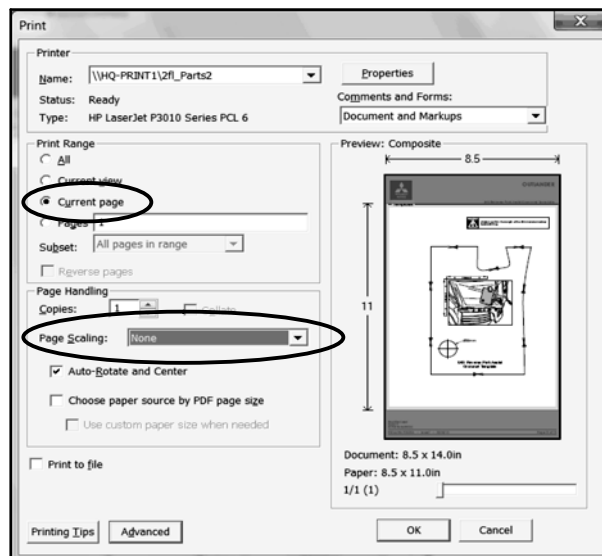
USING REAR PARK ASSIST SENSOR TEMPLATES — 2014 Outlander, Outlander Sport, Lancer-based vehicles. Some technicians have reported the templates used for locating and drilling holes for the rear park assist sensors are inaccurate. It is possible that printer variances have changed the dimensions of the drawing. Please note, the template cautions you to “Always confirm the length of the 50mm scale markers before drilling.” After printing the template, use a ruler to measure the distance between the positioning arrows in the upper left corner of the drawing. The space between the arrows **MUST** be 50mm for the template to be accurate.

To print the templates, select ‘Print.’ Under ‘Page Scaling’ select ‘None,’ then choose ‘Print Current Page’ and click OK.
