# TECH TALK

Volume 208 – June, 2014

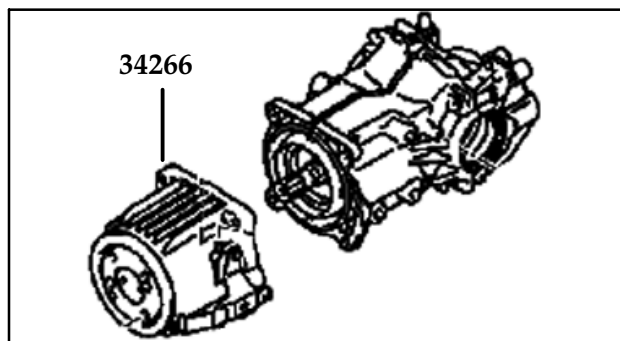
**4WD COUPLER DIAGNOSIS** 2007 & later Outlander, 2011 & later Outlander Sport/RVR. When diagnosing affected 4WD units for noise or a binding condition, be aware the 4WD coupling (PNC 34266) and rear carrier assembly are available as individual parts. In some cases, replacing the 4WD coupling unit has resolved concerns without replacing the rear carrier assembly.

With the scan tool, the 4WD ECU data list can be monitored for "Coupling current" which can range from 0 to 3 Amps. Lower amperage (0

Amps) indicates the coupler is unlocked (i.e. 2WD mode) while higher amperage indicates the coupler is locked (i.e. in 4WD and/or accelerating). If the data is not to spec, diagnose the coupler using the service manual and replace it if diagnosis directs you to.

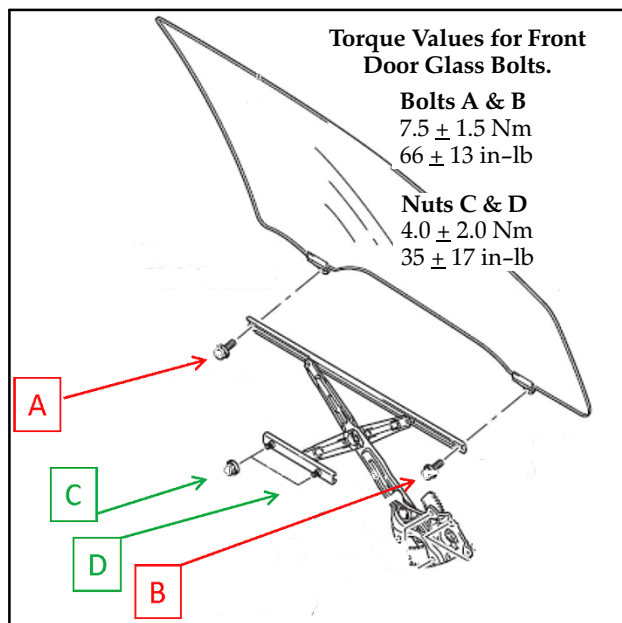
**FRONT WINDOW LOOSE, CROOKED, NOISEY (INC. RATTLES)** 2013-14 Outlander Sport/RVR. If a customer reports that either front window is not traveling up/down correctly or there are squeaks or rattles from the area, it may be caused by loose or under-torqued window mounting bolts.

To repair this condition, use the service manual to remove the inner door panel:

1. Remove the bolts labelled A and B in the following illustration.
2. Apply a non-permanent thread locking compound (e.g. Loctite) following instructions on the container. The locking compound should be appropriate for the application.
3. Repeat steps 1 and 2 for nuts C and D.
4. Torque fasteners to the upper end of the torque specification shown in the illustration.

5. Test window travel then reinstall the inner door panel.
6. Test drive the vehicle on a road suitable to create any rattle or other noise and recheck window travel.

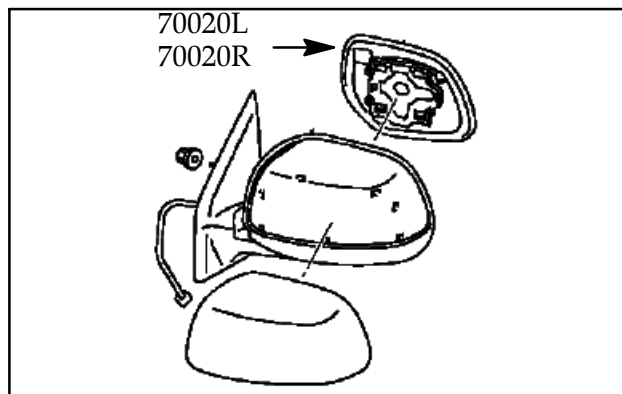
**EXTERIOR MIRROR IMAGE DISTORTION** — 2013-14 Outlander Sport/RVR. If replacing a door mirror for a distorted image, it is not necessary to replace the mirror assembly. Refer to ASA CAPS using PNC 70020L or 70020R to obtain the correct part number.

Mirror glass replacement instructions are found in the service manual under Group 51 - Exterior —> Outside Mirror —> Removal and Installation.

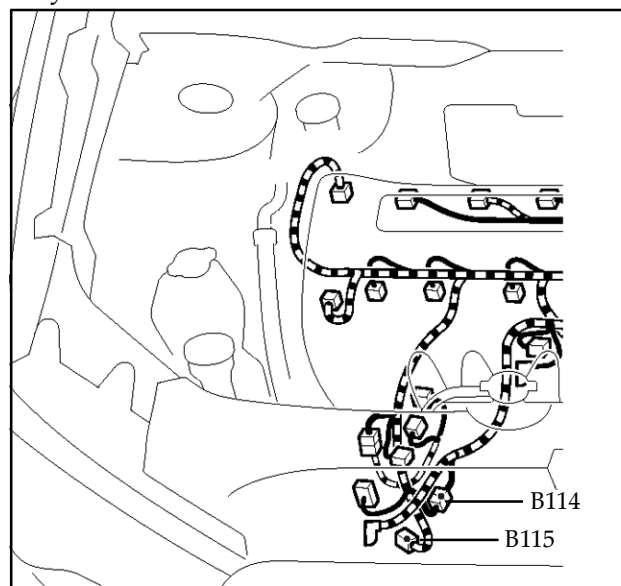
**DIAGNOSING A NO START AFTER REPAIRS IN THE ENGINE COMPARTMENT** — 2011-2014 Outlander Sport/RVR. If you've just made repairs in the engine compartment of the subject vehicle and now have a "no start" condition, be advised that connectors B114 and B115 are identical and both are in close proximity to each other on the intake side of the 4B11 engine. They can easily be cross-connected. Connector B114 contains the starter signal wire and B115 is for the compressor clutch. If these connectors are swapped, the vehicle will not start, and wire color is the only way to determine the correct connection.

If you find it necessary to disconnect B114 and B115 at the same time, use a marker or colored tape on one connector to make identification easier. Be particularly aware of this if a vehicle is towed in from an outside shop or body shop with a no start condition.

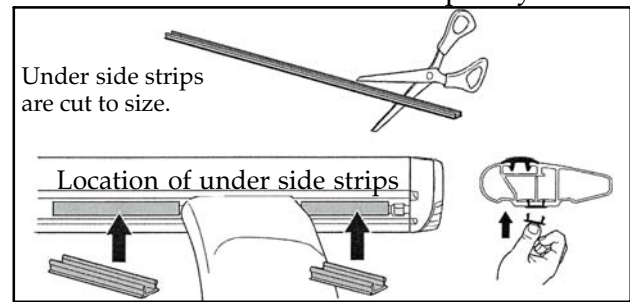
**WHISTLING NOISE HEARD WHEN DRIVING** — 2014 Outlander. Some drivers may report a shrill, flute-like noise heard when driving vehicles with the accessory roof rack (MZ314636) starting at 35 mph (56 kph). The noise may be from an incorrectly installed, sized (cut) and/or missing rubber filler strip, located on the upper or lower surface of the crossbar.

The kit includes two filler strips. Use one full length filler strip for the top surface and cut the other strip as described on page 8 of the

installation instructions (see illustration below). Make sure the strips are properly inserted and fill the channels in the cross bar completely.
