# TECH TALK

Volume 212 - October, 2014

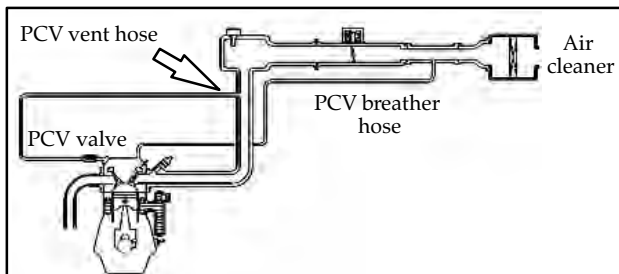
✓ **ROUGH IDLE, CHECK ENGINE LIGHT ON - LOOSE PCV HOSE** — 2014-15 Mirage. If a customer reports a rough idle and/or a check engine light on and the DTCs in memory relate to a lean mixture or misfire (e.g. P0171, P0300-P0303), check if the PCV vent hose is secured to the intake manifold. If you confirm it is not, please take photos showing the area and contact TechLine **before making repairs**. MMC is conducting an investigation into the cause of the hose coming loose and needs your help.

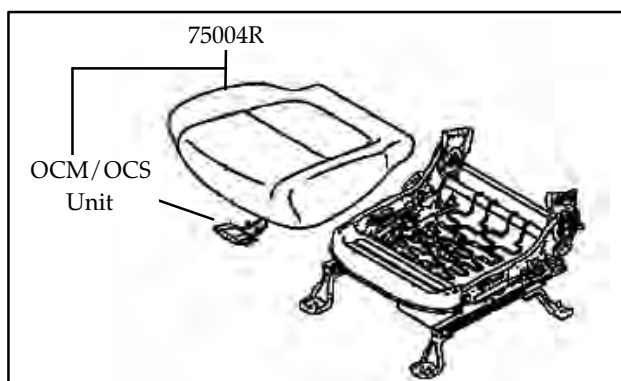
**OCCUPANT CLASSIFICATION SYSTEM REPLACEMENT** — 2014-15 Outlander. The occupant classification unit (combined occupant classification module with integrated occupant classification sensor) is attached to the underside of the right front seat cushion, not the seat frame. There is a detachable connector between the two parts that suggests they are separate, but they are one part and not available separately. To replace the occupant classification unit, you must replace the seat cushion (PNC 75004R). The seat frame is not fitted with any occupant classification parts.

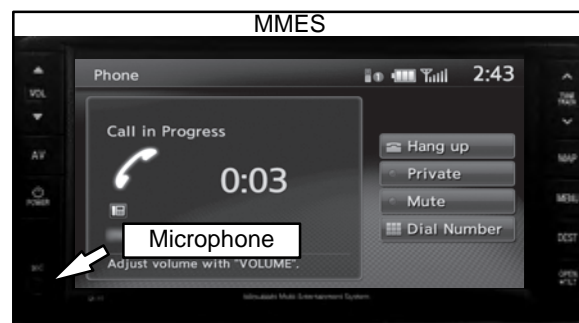
2. **Factory Installation - MMES Navigation:** System is built into the MMES unit. Microphone is built into the lower left of the display frame. Buttons and controls are on the touch screen. Voice commands are not available with this system.

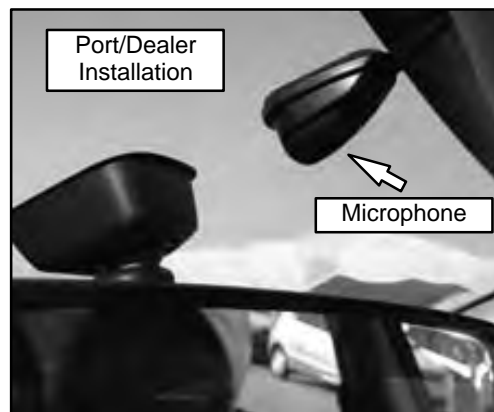
3. **Port/Dealer Installation:** Microphone is mounted on the windshield above the rear view mirror.

Controls are located on the lower dash to the left of the steering wheel, next to the ASC OFF button. Voice commands are not available with this system.

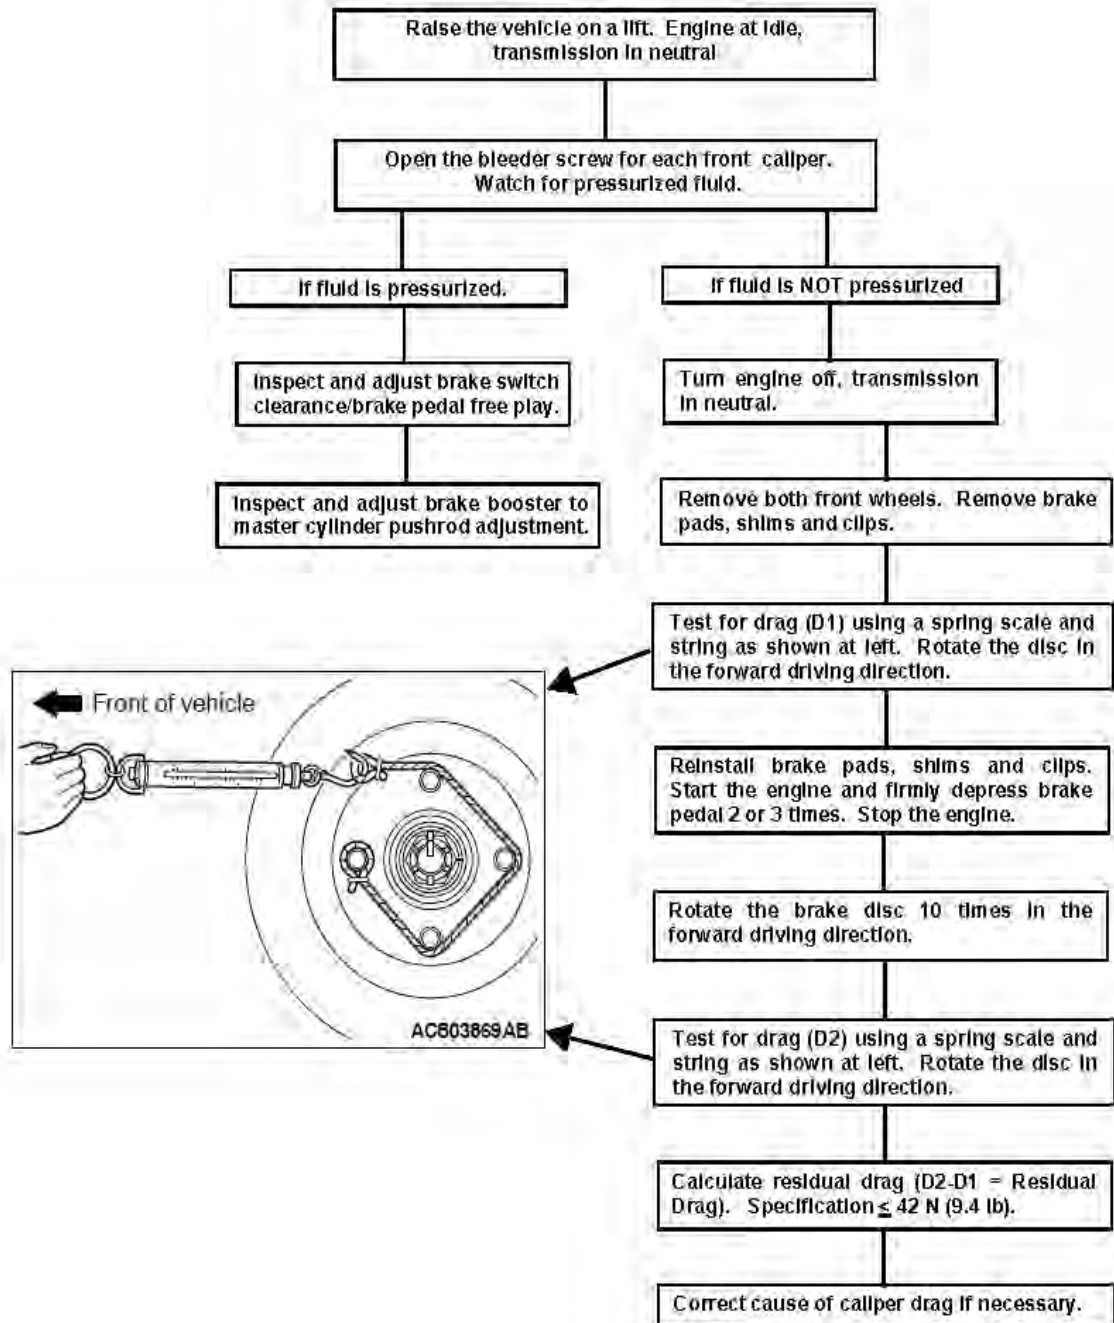
# RESIDUAL BRAKE DRAG TESTING

**LOW MILEAGE FRONT BRAKE WEAR AND/OR NOISE** — 2014-15 Mirage. MMNA has received reports of Mirage brakes requiring replacement due to wear at less than 15,000 miles, or reports of a grinding noise when the brakes are applied. In response, MMNA has launched an investigation to determine the root cause and study a production countermeasure and field fix.

A survey, including a brake drag check sheet, appears later in this Tech Talk. It is also available on the MDL (service —> service tech resources —> Service Related Items —> Technical Worksheets). If you see a vehicle with low mileage brake wear, or a customer reports a grinding noise when stopping, **before making any repairs**, please complete the survey with the customer and have the checksheet completed by a technician. FAX both to Techline at (714) 934-4279, then contact TechLine. If the customer reported noise, take photos of the rotors before contacting Techline.
