# TECH TALK

Volume 213 - November, 2014

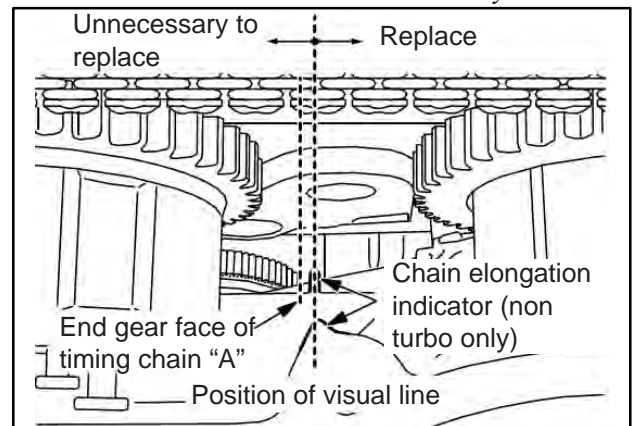
#### INSPECTING TIMING CHAIN STRETCH ON 4B11 TURBOCHARGED ENGINE — 2008 & later Lancer Evolution, 2009 & later Lancer/Lancer Sportback Ralliart.

The condition of the timing chain is monitored by the ECM. Over time, the timing chain will stretch and this will eventually affect the phasing of the camshafts. If the ECM determines the chain has stretched too much, the “Service Engine Soon” light will be turned on and DTC P0012 will be set in memory.

The first step in diagnosing P0012 should be to visually check timing chain elongation (stretch) using the procedure in the service manual. In order better understand this procedure, view the Tech Training video available on the MDL (service → Training Information → Technical Training Videos and scroll to Lancer Evolution – Timing Chain Stretch. When used together with

Note that elongation inspection is not included in the scheduled maintenance tables. Under normal circumstances it is only necessary to complete this inspection if DTC P0012 is set in ECM memory.

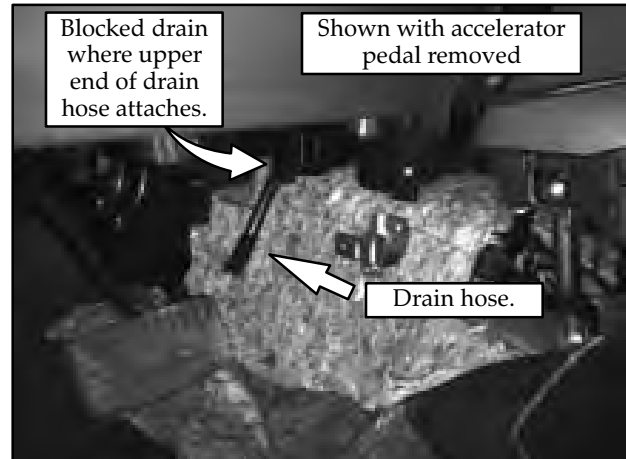
**WATER SLOSHING SOUND, UNUSUAL SMELL OR WET CARPET/FLOOR MAT** — 2013–15 Outlander Sport/RVR. Subject vehicles may have a restricted HVAC drain outlet. Flashing from manufacturing may be partially

(or completely) covering the drain inside the HVAC case. If a customer reports he has experienced these symptoms consistent with a blocked drain outlet, please remove the drain hose from the outlet (near the accelerator pedal) and use a mirror and light to examine the drain hole to determine if there is an obstruction. If you see an obstruction, clear the hole (a bent coat hanger works well) and insure proper flow from the drain with the A/C on.

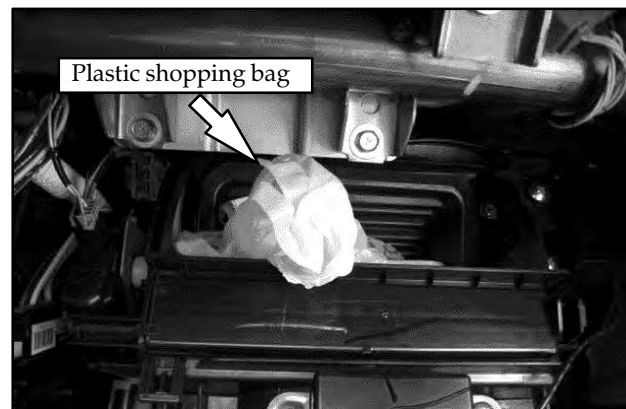
**LACK OF AIR VOLUME FROM VENTS OR MODE NOT CHANGING** — 2014–15 Mirage. If you get a report of poor air flow from the vents or the air outlet mode will not change, it's possible there may be a restriction in the recirculation air intake. You may also find DTCs in the system. The restriction shown in the following photo created DTC B1042.

When checking the customer's report, work the fan controls to confirm low air volume. If the fan speed is heard to change normally, remove the glovebox and make sure something isn't restricting the intake. Items made from light materials, like paper napkins or plastic shopping bags, are easily drawn into the intake, restricting air flow.
