TECH TALK

Volume 214 - December, 2014

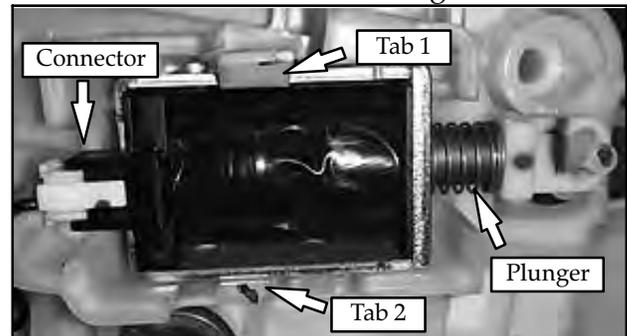
CVT WILL NOT SHIFT OUT OF P (PARK) POSITION — 2013-2015 Outlander Sport/RVR. If the customer cannot shift the vehicle out of the park position, even intermittently, refer to Group 52A - Floor Console Assembly and perform the following procedure before replacing the shifter.

Remove the RH console side panel. While watching the movement of the shift lock solenoid, have someone apply the brake pedal to

determine if the solenoid retracts. If the solenoid does not retract, it may be due to foreign material, identified as a sugary drink (e.g. Cola) residue built up in the solenoid plunger bore and on the solenoid plunger. This prevents the solenoid from retracting and the shifter cannot be moved from park.

Remove the solenoid for cleaning as follows:

- Remove the solenoid from the shifter assembly by GENTLY releasing TAB 1.
- Carefully wedge a small screw driver into the channel of TAB 2 to release the lower locking tab.
- Remove the solenoid by pulling it straight out.
- Unplug the electrical connector
- Remove the spring and plunger and clean them with soap and water.
- Dampen a wet paper towel or lint free rag with water and insert it into the bore of the solenoid to clean it.
- Reattach the electrical connector and re-install the solenoid to the shifter in reverse order of removal.
- Confirm solenoid and shifter operation and reinstall the console side panel.

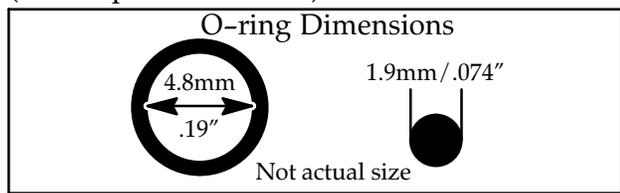
WASHER PUMP LEAKING AT FITTINGS — 2013-15 Outlander Sport/RVR. If you find leakage at the washer pump forward of the right

front tire, or the washer is inop, check if the washer pump fluid inlet/outlet assembly has become dislodged from the pump (refer to service manual Group 51 - Exterior —> Windshield Wiper and Washer for information). Confirm if the o-rings on the pump outlets are in place. If o-rings are missing, it is NOT necessary to replace the entire washer pump.

Though not available from your facing PDC, suitable replacements can be sourced locally using o-rings made of EPDM (Ethylene Propylene Diene Monomer) rubber, with an I.D. of 4.8mm and a material cross section of 1.9mm (NAPA p/n - 727-2602).

Install the new o-rings to the outlet fluid connections and reinstall the outlet to the pump. If the o-rings are simply dislodged, but not lost, and they are not cut or damaged, they can be reused. If it is necessary to replace the gasket between the fluid tank and pump, it is available separately (PNC 84233, p/n 8260A161).
