SERVICE CAMPAIGN BULLETIN

CAMPAIGN REF: 02E
TITLE : Roll Over Valve Vent Pipe Check
DOCUMENT # : 12 K 001
AFFECTED VEHICLES : McLaren P1™

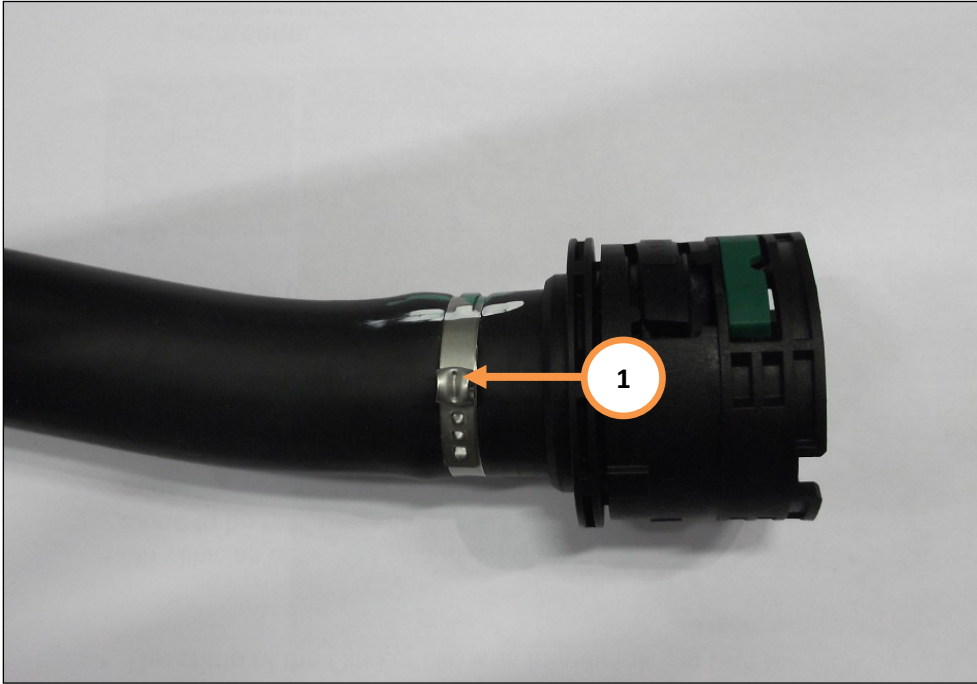
SITUATION : Quality Engineering at McLaren Automotive have identified that the fuel filler neck Oetiker clip crimp may come into contact with the roll over valve vent pipe.

1. Remove existing clip (1) from the fuel filler neck.
