SERVICE CAMPAIGN BULLETIN

CAMPAIGN REF # 02K
TITLE : McLaren P1™ Vehicle Software Update to Platform 7.1
DOCUMENT # : 12 M 001
AFFECTED VEHICLES : McLaren P1™

SITUATION : Quality Engineering at McLaren Automotive have released a new software platform for the McLaren P1™.

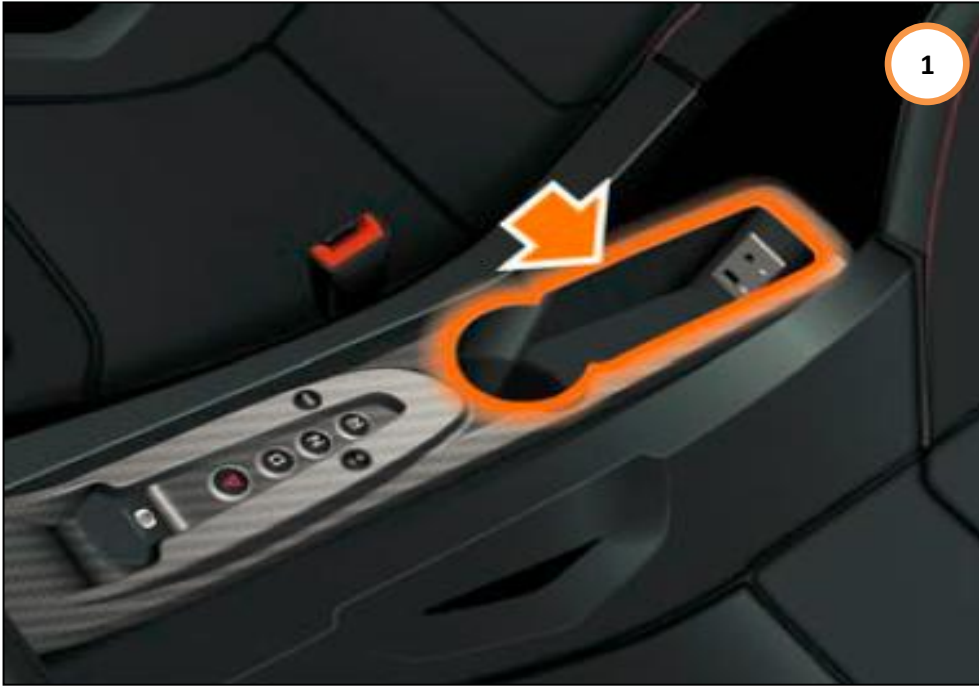
Care Point: During the update the key must be positioned at the rear cup holder/stowage area (1).
