SERVICE CAMPAIGN BULLETIN

CAMPAIGN REF: 02F
TITLE : Parking Sensors Heli-tape Disc Installation
DOCUMENT # : 11 A 049
AFFECTED VEHICLES : McLaren 650S Coupe and Spider

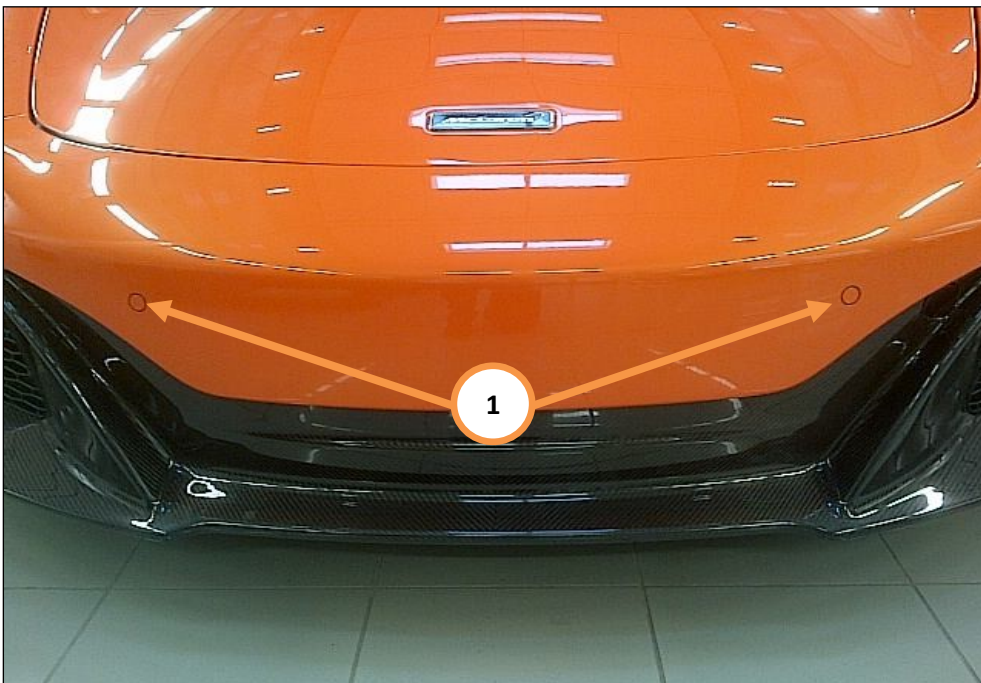
SITUATION : Quality Engineering at McLaren Automotive have identified that the front parking sensor may incorrectly detect an object when nothing is present in front of the vehicle.

1. Clean the surface of the front two centre parking sensors with an alcohol cleaning solution or similar product to remove any dirt and grease (1).

Care Point: Gently apply pressure to the outer ring avoiding direct pressure on the sensor which could cause the sensor to be pushed through the mounting.
