## SERVICE CAMPAIGN BULLETIN

**CAMPAIGN REF:** 02G  
**TITLE :** McLaren 650S - Driveshaft Nut Replacement  
**DOCUMENT # :** 11 B 008  
**AFFECTED VEHICLES :** McLaren 650S Coupe and Spider

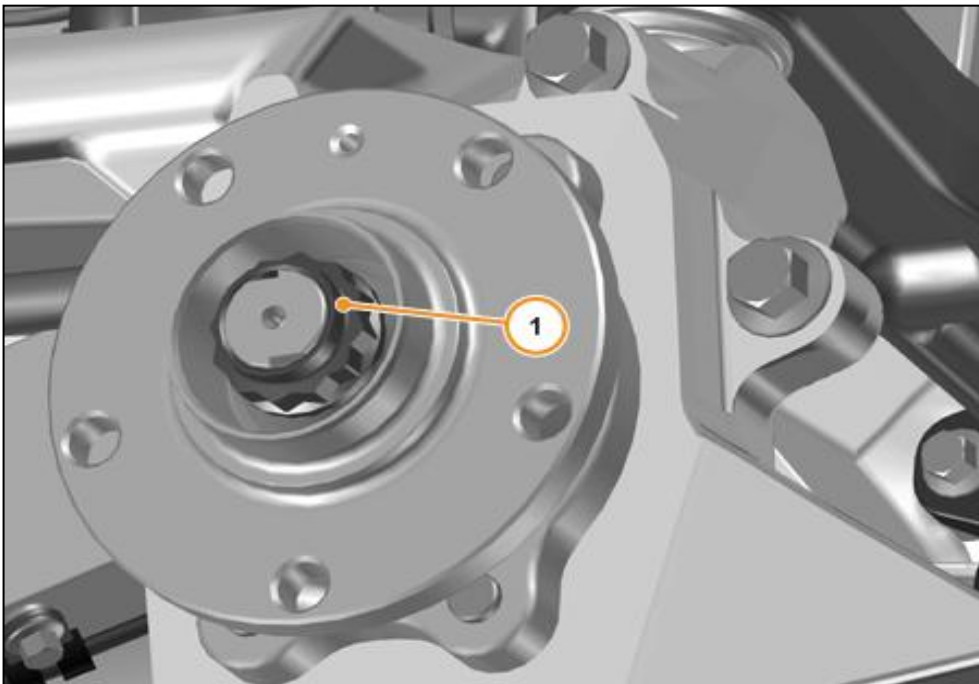
**SITUATION :** Quality Engineering at McLaren Automotive have identified that a number of McLaren 650's may have left production with the rear driveshaft nuts incorrectly torque.

1. Please refer to “AA-RM-02A04-04-007 – secure/lift vehicle on lifting platform” to lift the vehicle on the ramp.
2. Please refer to “AA-RM-03B03-01-001 – Remove/install wheel” to remove both rear wheels.
3. Remove the driveshaft nut (1) from both sides.
