SERVICE CAMPAIGN BULLETIN

CAMPAIGN REF: 02J
TITLE : Air Line Fastener Torque Check
DOCUMENT # : 11 F 017
AFFECTED VEHICLES : 12C Coupe and Spider

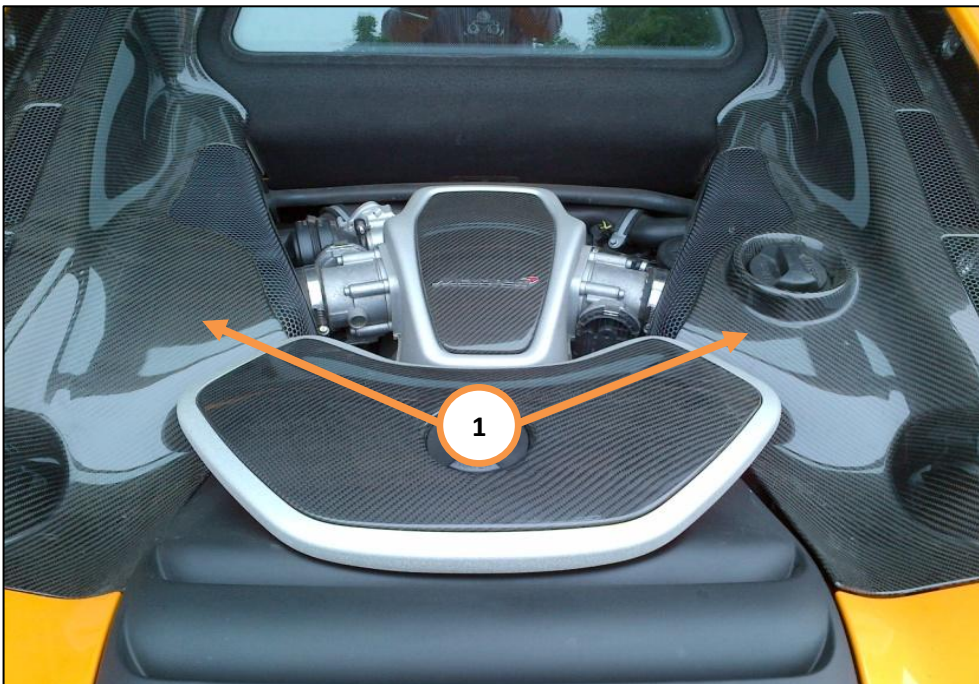
1. Please refer to AA-RM-02A03-04-005 – Remove/install engine compartment side cover to remove the side covers (1).

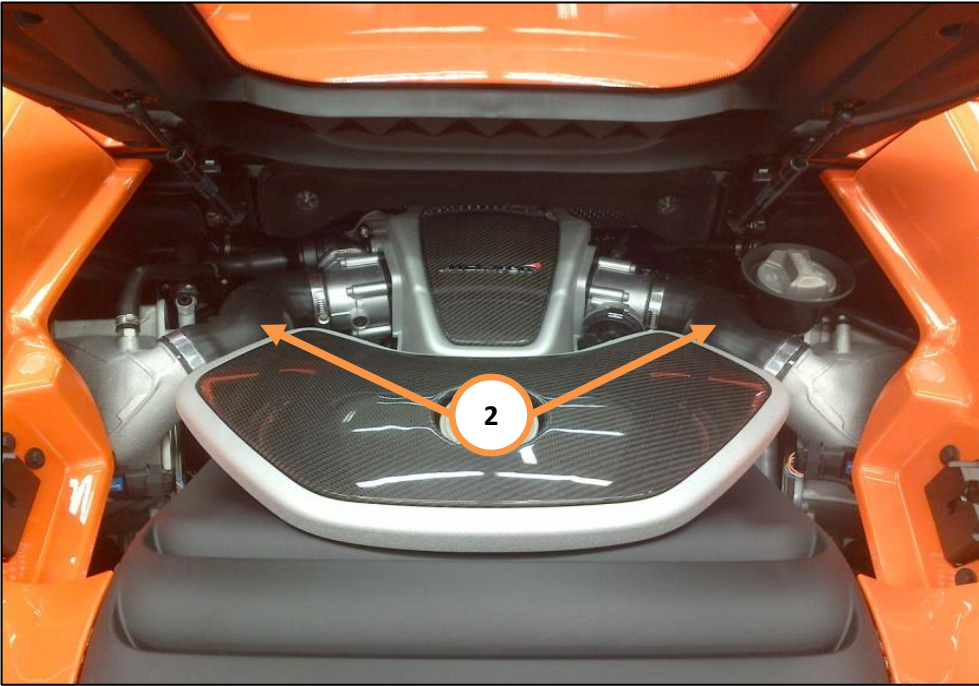
2. Remove both water charge air cooler to throttle body hoses (2).

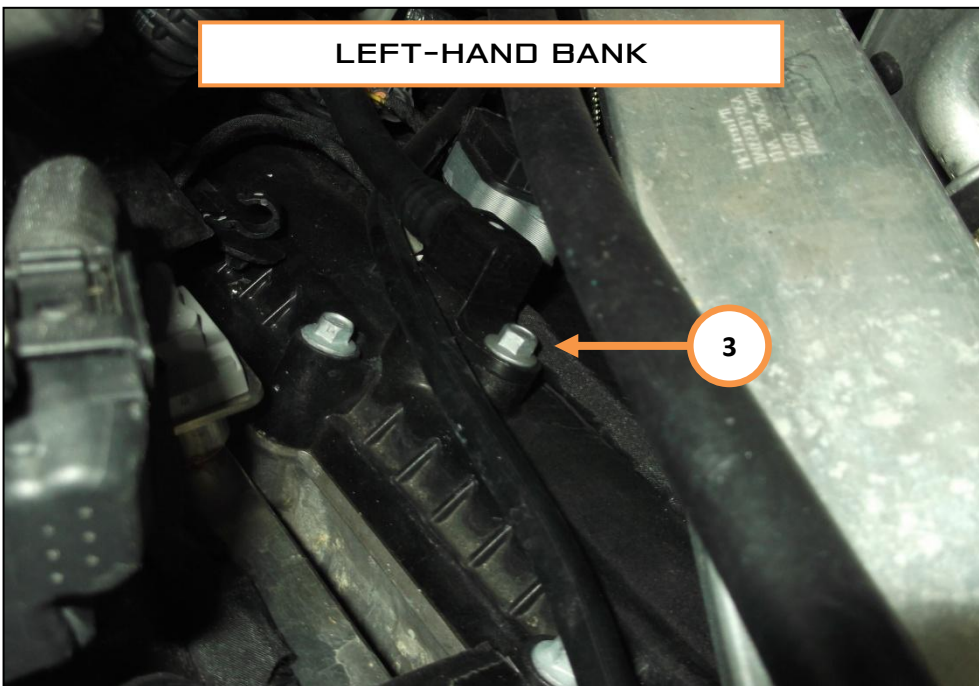
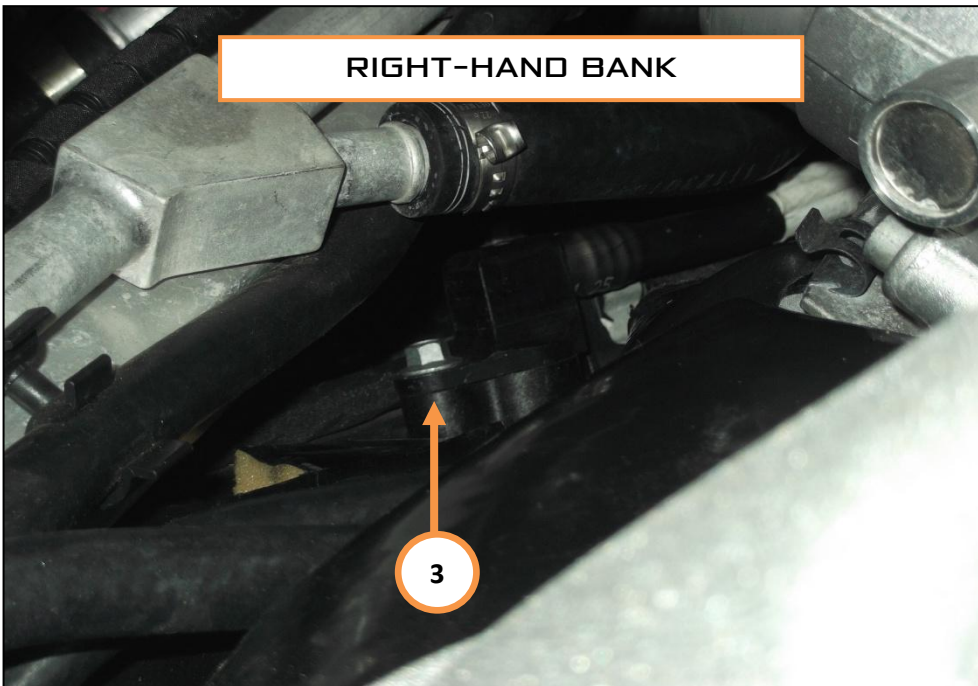
3. Locate the air line fastener (3) which is positioned at the top of the camshaft cover.

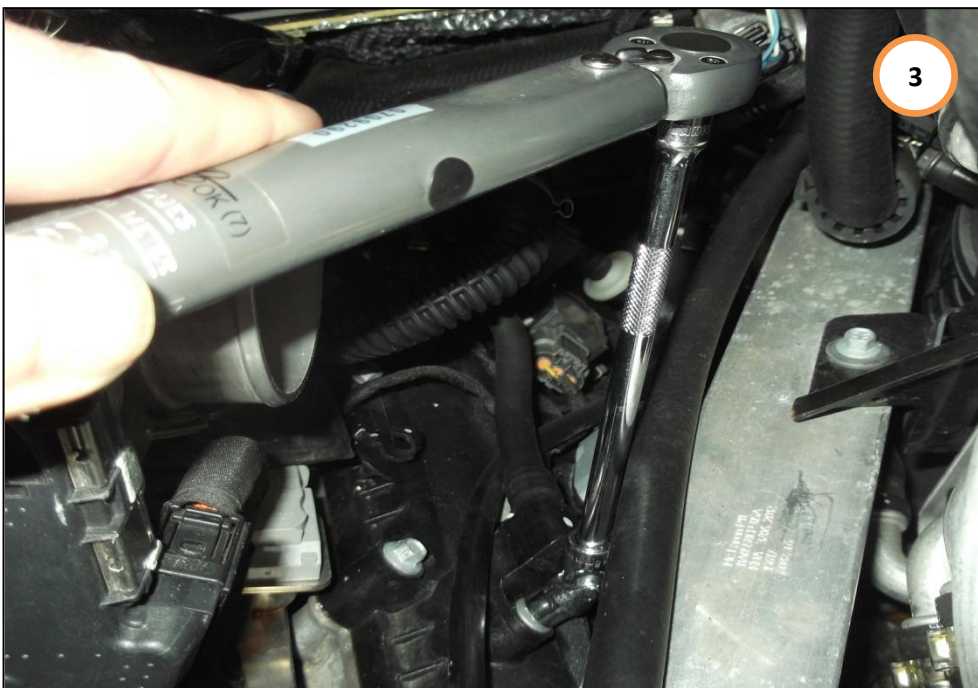
SITUATION : Quality Engineering at McLaren Automotive have identified that a number of McLaren 12Cs vehicles could have two M6 Hex Bolts that hold the crankcase breather line to the engine crankcase breather system which may have the incorrect torque value. This could cause a leakage of vapour from the oil breather system.

4. Set the torque wrench to 10 Nm and check that the fastener is tightened to the correct torque (10 Nm) (3).

If the torque is incorrect continue to torque up to 10 Nm.
If the torque is correct no further action is required.
