SERVICE CAMPAIGN BULLETIN

CAMPAIGN REF: 02I
TITLE : McLaren 650S – Oil Filler Cap Replacement
DOCUMENT # : 11 F 018
AFFECTED VEHICLES : McLaren 650S Coupe and Spider

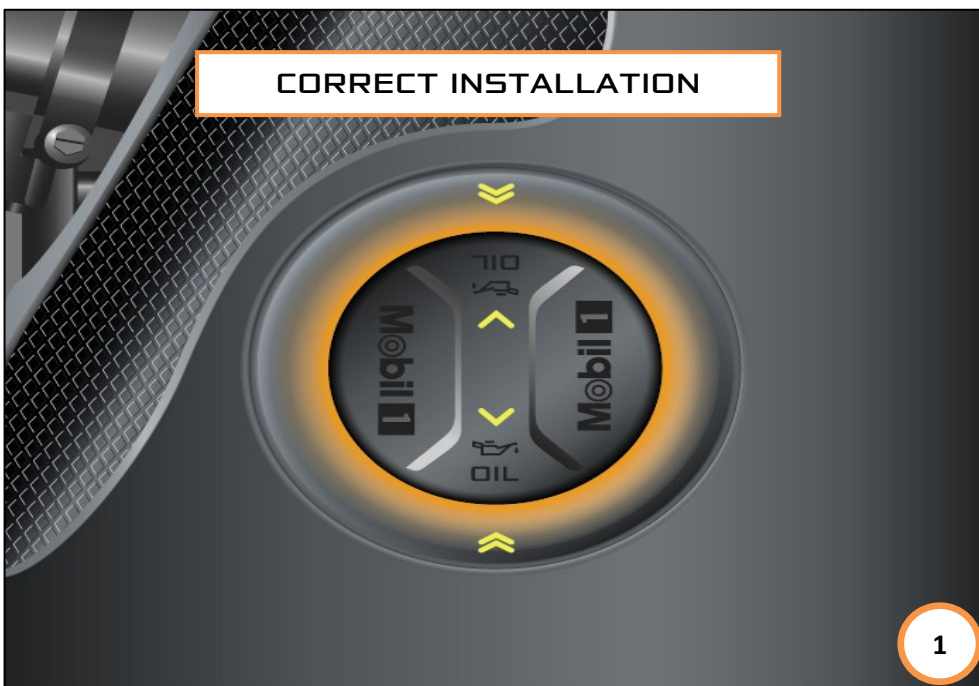
Care Point: Ensure oil filler cap is refitted correctly, with the markings on the cap and bowl aligned. If not, it may become detached and allow oil to escape the system. If closed correctly the handle should be facing directly to the front of the car with the recesses parallel to the engine compartment side covers. Examples of correct (1) and incorrect installation (2) below.
