## SERVICE CAMPAIGN BULLETIN

**CAMPAIGN REF:** 02X  
**TITLE :** Water Charge Air Cooler Pipes – Clip Check  
**DOCUMENT # :** 11 L 005  
**AFFECTED VEHICLES :** McLaren 650S Coupe and Spider

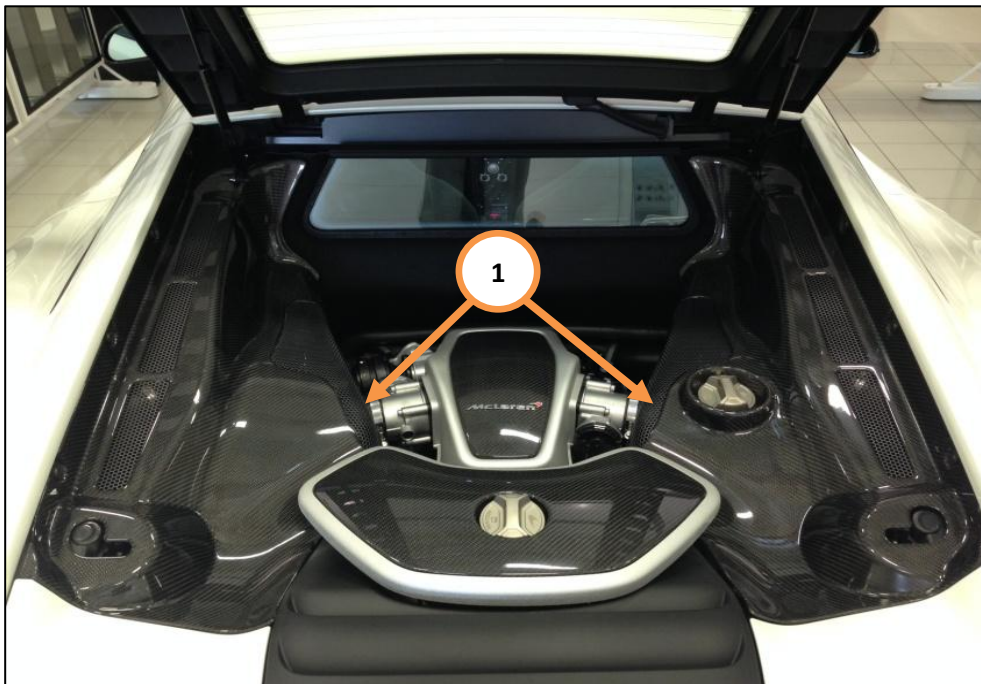
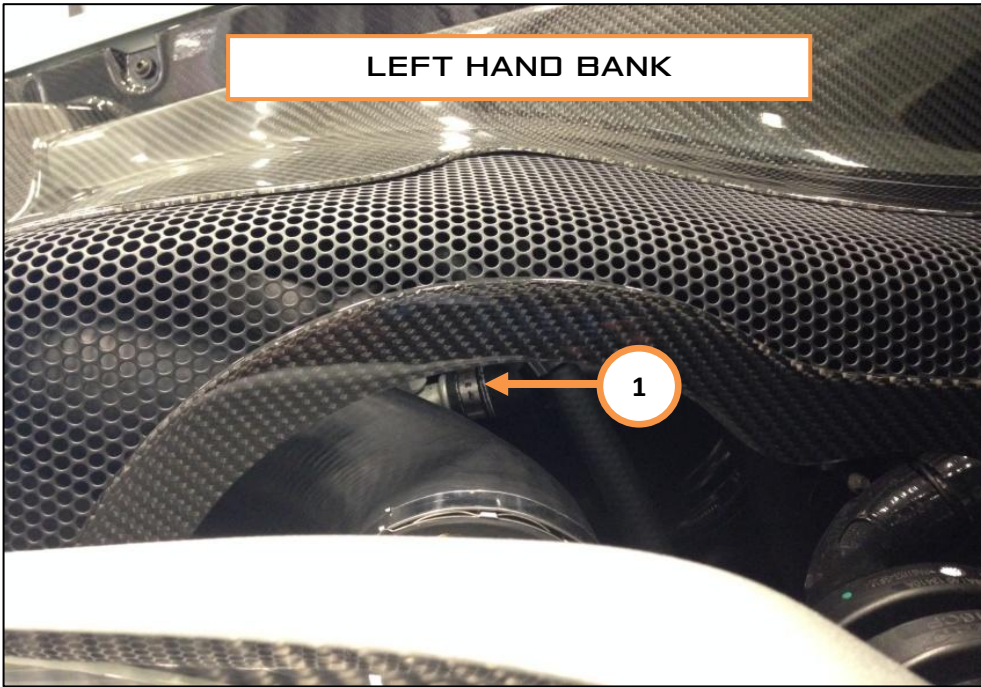
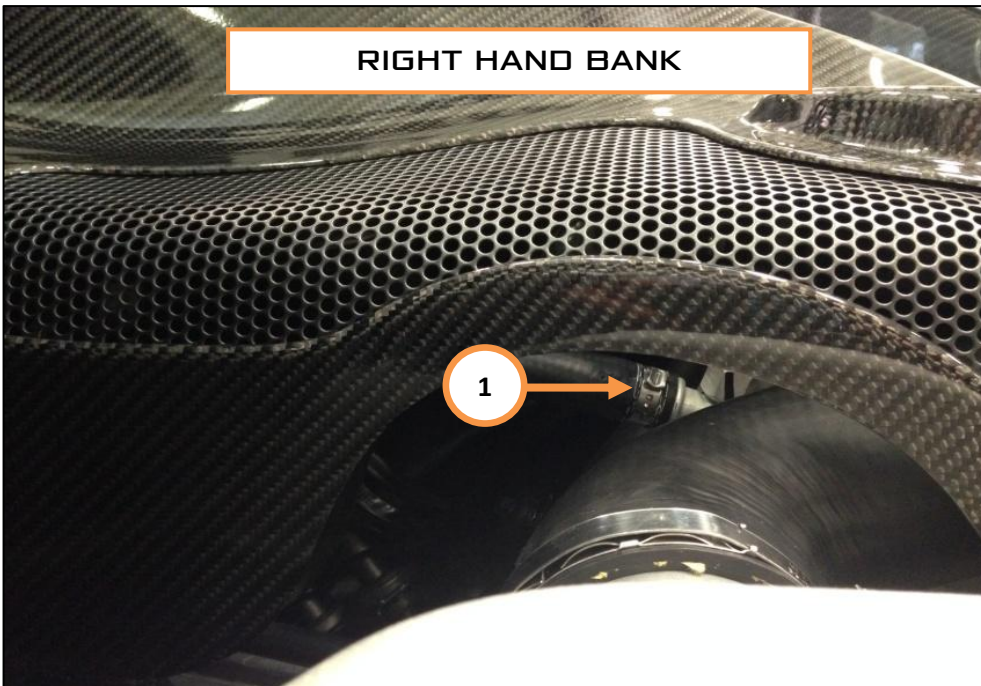
### INSPECTION ON COUPE

1. Inspect the Oetiker clip (1) located on the top side of the Water Charge Air Cooler assemblies.

**Care Point:** On the Coupe variant the Oetiker clip should be inspected through the beautification panel.

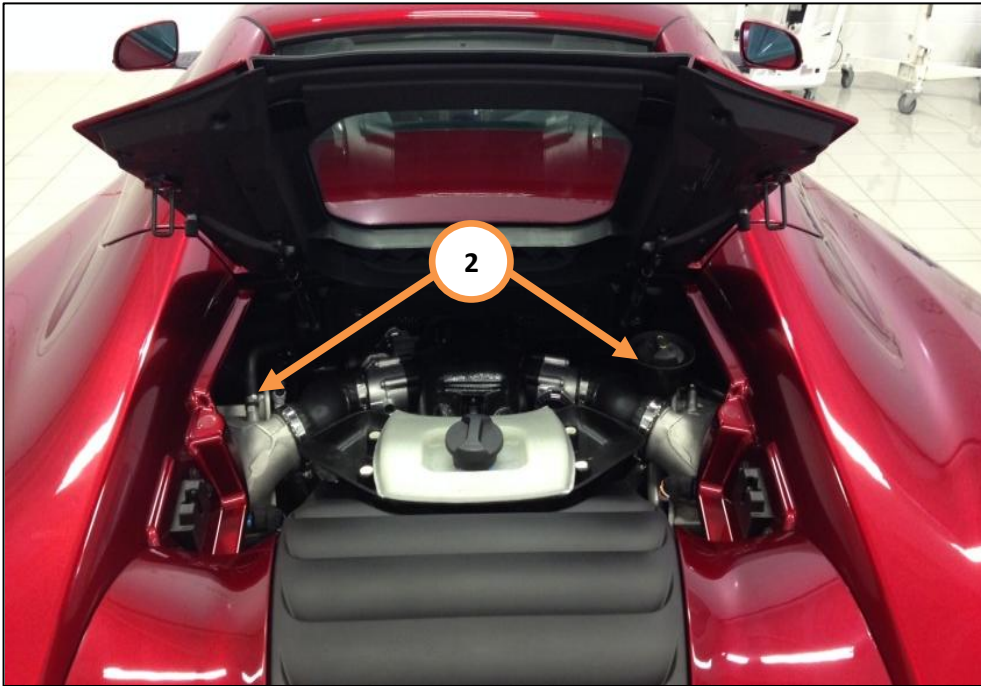
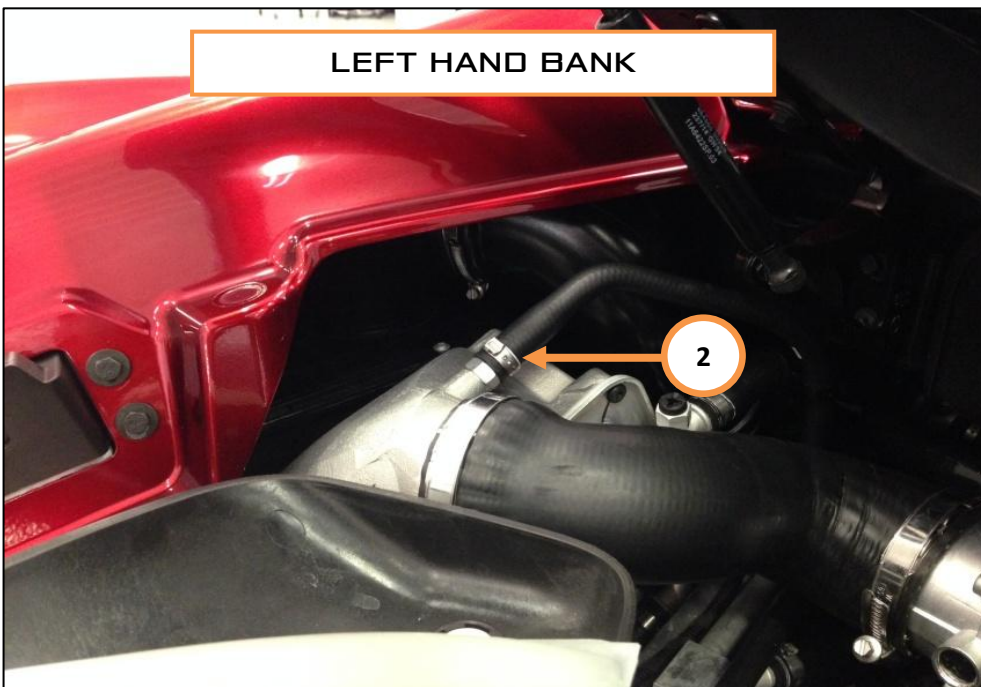
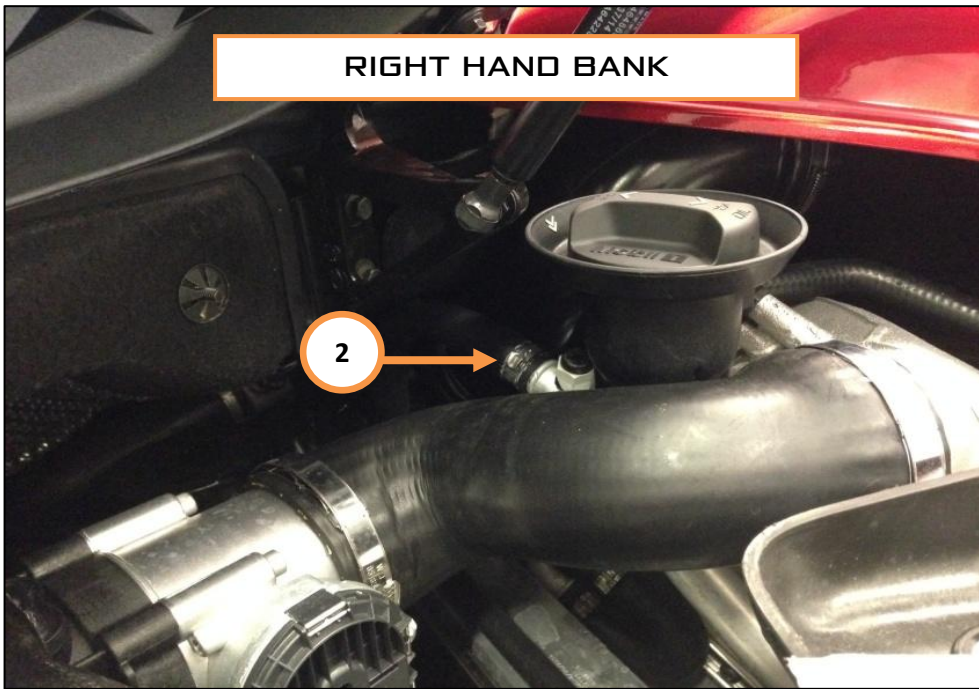
## INSPECTION ON SPIDER

2. Inspect the Oetiker clip (2) located on the top side of the Water Charge Air Cooler assemblies.

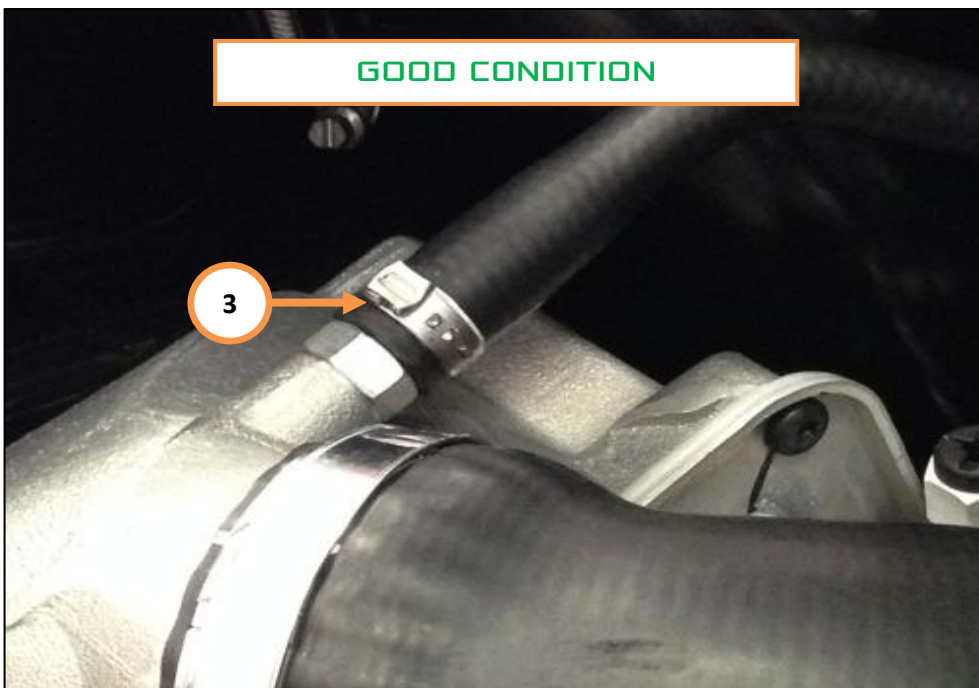
3. If the Oetiker clip is fully crimped (3) and the hose is fully located to the water charge air cooler, no further action is required.

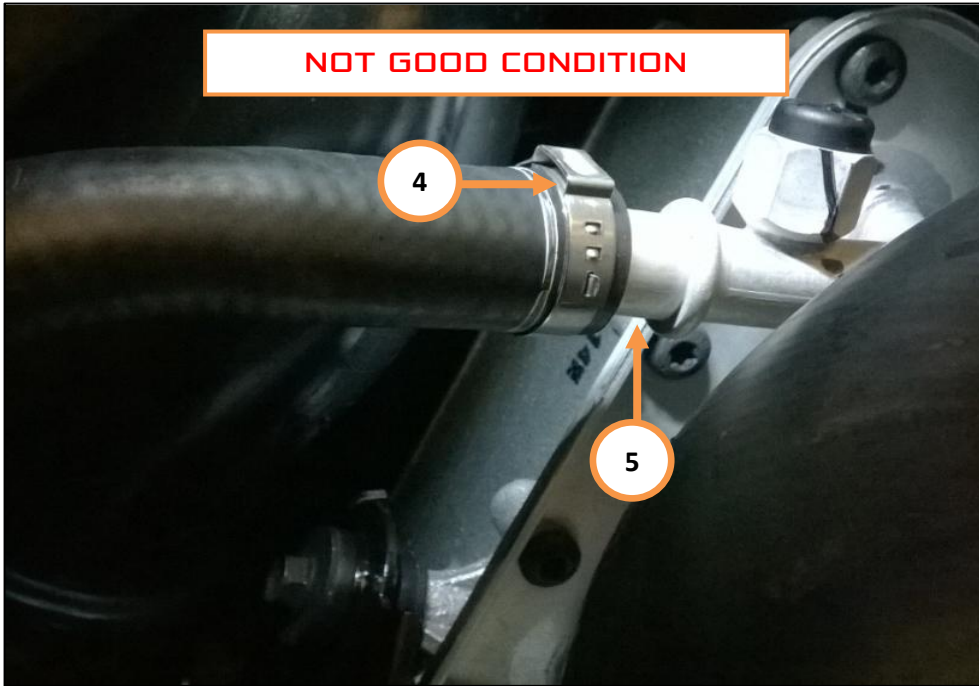
- If the Oetiker clip is not crimped (4) and/or the hose is not fully located to the water charge air cooler (5), the hose has to be pushed all the way on to the spigot and the Oetiker clip has to be crimped.

**Care Point:** To rework a McLaren 650S Coupe the beatification panels have to be removed. Please refer to SIS - AA-RM-02A03-04-005 - Remove/install engine compartment side cover
