SERVICE CAMPAIGN BULLETIN

CAMPAIGN REF: 020
TITLE : Module Software Platform Update to 8
DOCUMENT # : 11 M 070
AFFECTED VEHICLES : 650S Coupe and Spider

SITUATION : Quality Engineering at McLaren Automotive have released a new software platform for the McLaren 650S.

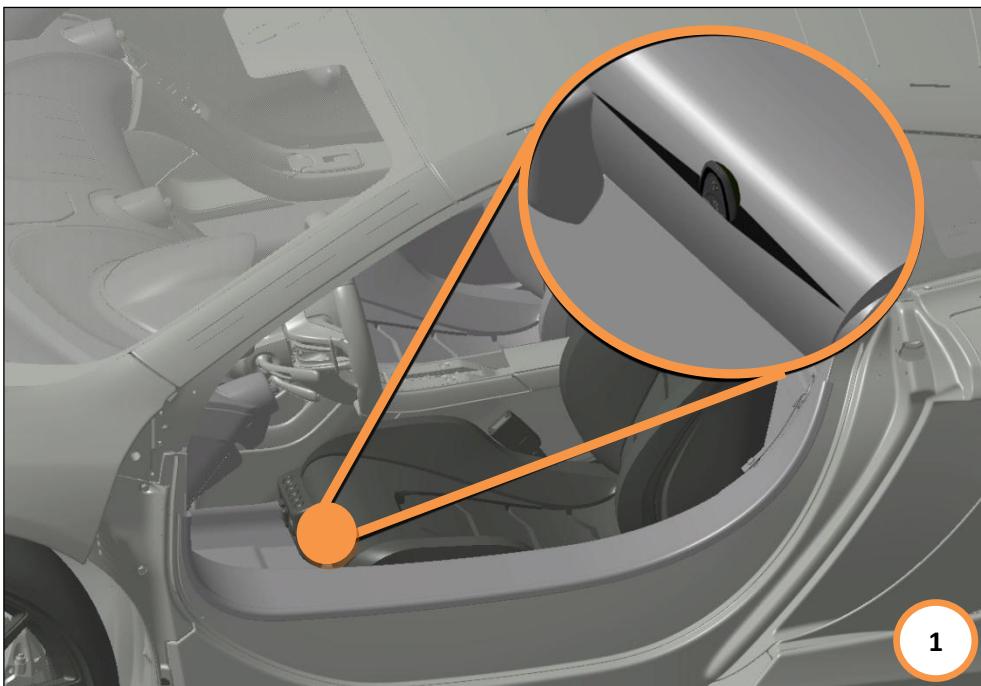
Care Point: The key must be positioned in the driver's seat front pocket, picture below (1).
