SERVICE CAMPAIGN BULLETIN

CAMPAIGN REF: 02S
TITLE : Module Software Platform Update to 8.1 Federal Markets Only
DOCUMENT # : 11 M 074
AFFECTED VEHICLES : McLaren 650S Coupe and Spider

SITUATION : Quality Engineering at McLaren Automotive have released a new software platform for the McLaren 650S.

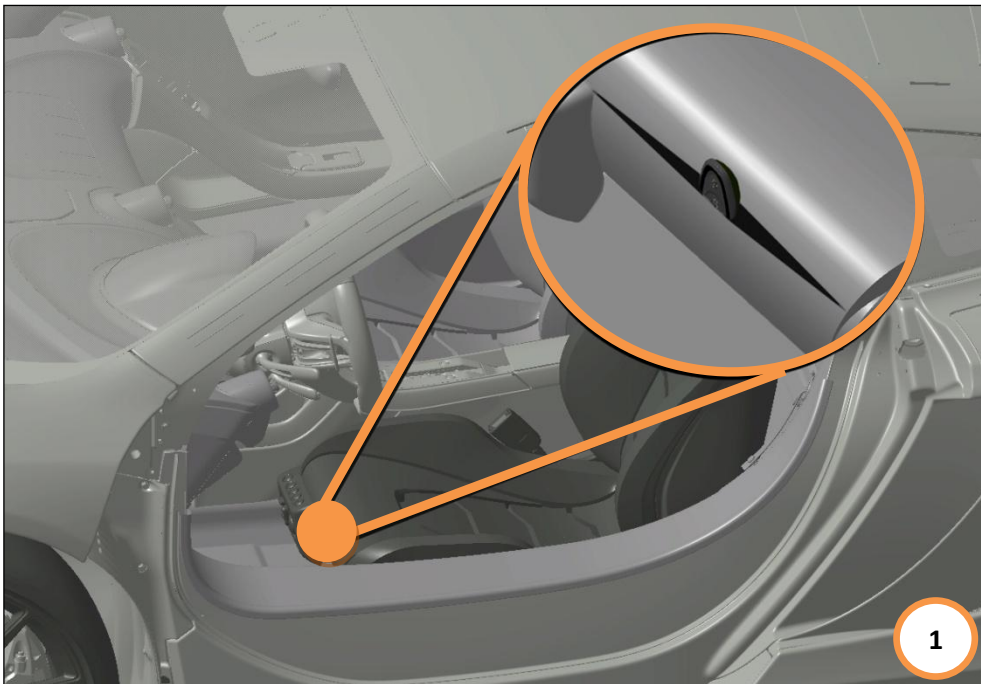
Care Point: The key must be positioned in the driver's seat front pocket, picture below (1).
