## SERVICE CAMPAIGN BULLETIN

**CAMPAIGN REF:** 033  
**TITLE :** Occupant Restraint Pretensioner Wiring  
**DOCUMENT # :** 11 M 082  
**AFFECTED VEHICLES :** McLaren 12C and 650S, Coupe and Spider

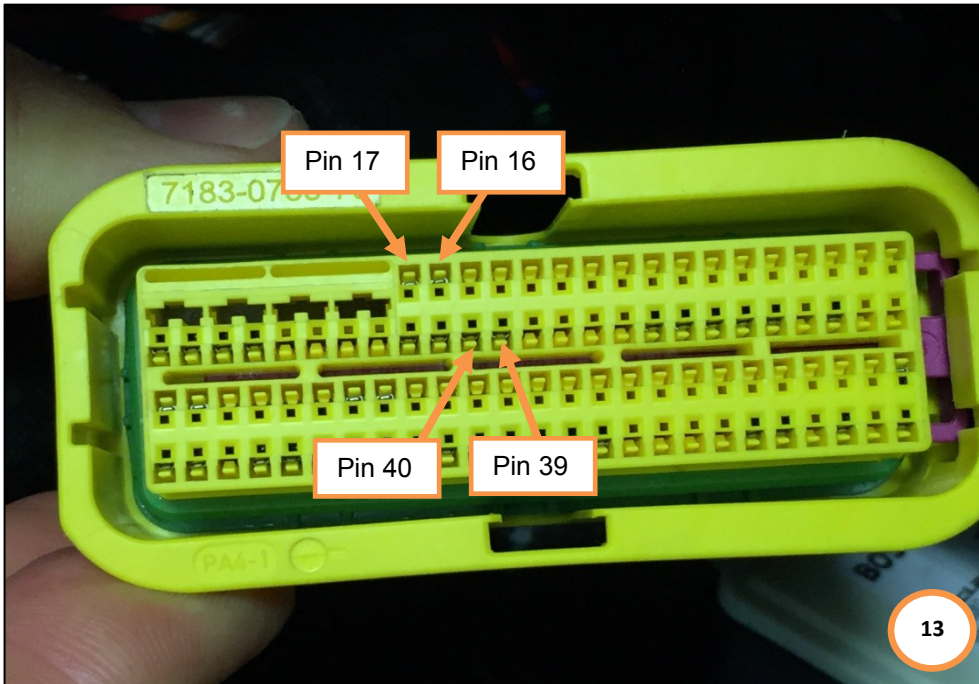
**SITUATION :** McLaren Automotive Engineering have identified that there is a range of affected right hand drive VINs that have been fitted with electrical wiring harnesses with an incorrect configuration which affects the operation of the seatbelt pretensioner system within the occupant restraint controller.

17. Locate the following electrical pins in the connector (13).

- Pin 16 V1593A wire colour orange
- Pin 17 R1758A wire colour blue
- Pin 39 R1755A wire colour blue
- Pin 40 V1577A wire colour orange

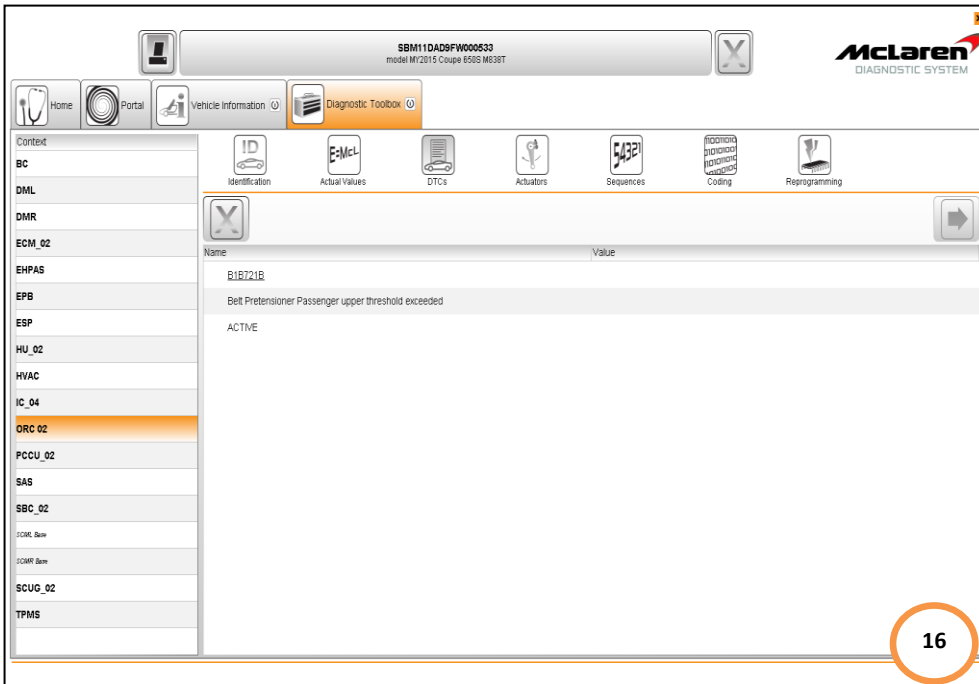
31. Select ORC or ORC\_02 depending on the Occupant Classification System that is installed to the vehicle and confirm the DTC B1B721B Belt Pretensioner Passenger upper threshold exceed has logged (16). Then proceed to step 32. If a different DTC has logged submit a Technical Request with the relevant information.

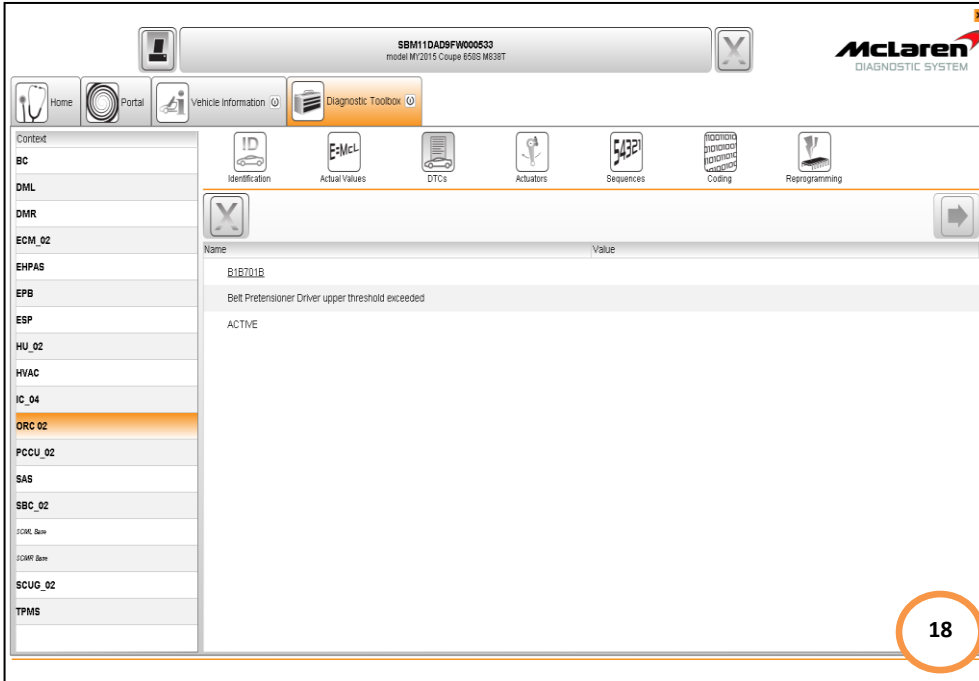
35. Repeat steps 28 to 29 and start a new MDS session.
36. Select ORC or ORC\_02 and perform a DTC clear in the ORC and confirm the DTC B1B701B Belt Pretensioner Driver upper threshold exceeded has logged and is Active (18) then proceed to step 36. If a different DTC has logged submit a Technical Request with the relevant information.
