Group:	27-Electrical System
Bulletin No.:	SB-14-025
Issue Date:	02-05-2014

# TECHNICAL SERVICE BULLETIN

## 2011MY-14MY JUNCTION BOX CORROSION DUE TO WATER INTRUSION

2011MY – 2014MY Hino Conventional NE8J, NJ8J, and NV8J vehicles

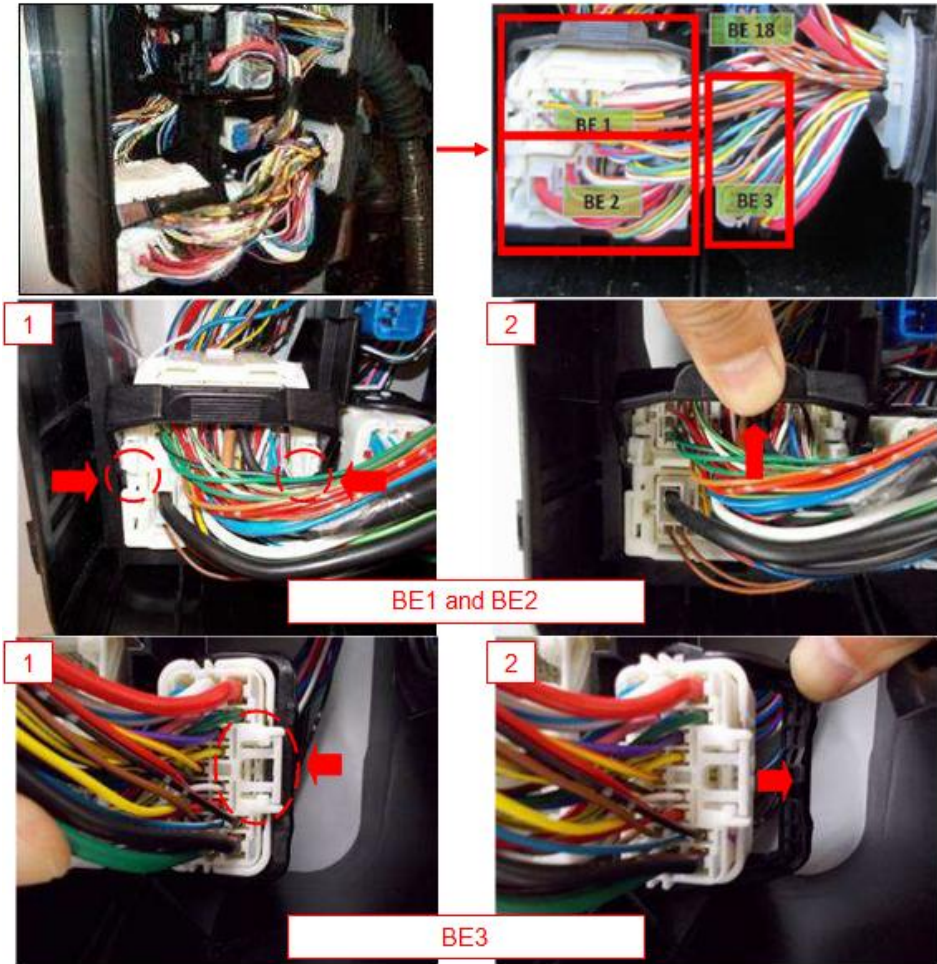
**4.** Release the lever locks on connectors BE1, BE2, and BE3. Remove the connectors for inspection of the wire terminals for corrosion.

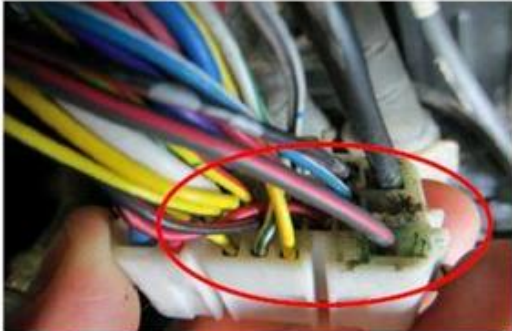
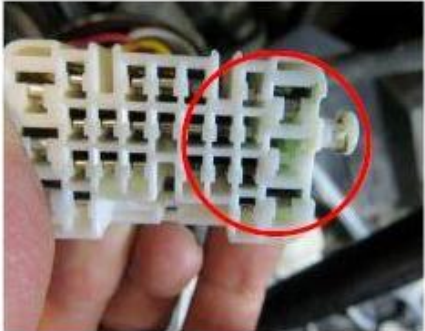
5. See the photographs for examples of corroded wire terminals. It will be at the dealers' discretion to determine if the corrosion damage is severe enough to warrant replacement of the effected wire harness, or to repair the terminals on the existing wire harness. If the wire harness is deemed to be repairable, proceed to the Wire Terminal Repair Procedure, below.

If the corrosion damage is severe, replace the effected wire harness as needed. After replacement of the harness, proceed to the Junction Box Cover Repair Procedure, below.

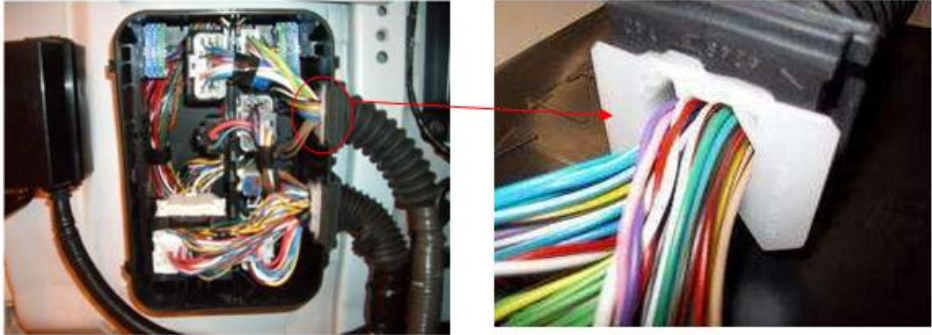
**1.** Inspect the upper wire harness support inside the rubber grommet. If the upper harness support is white in color, it will need to be replaced with the enhanced gray wire harness support.

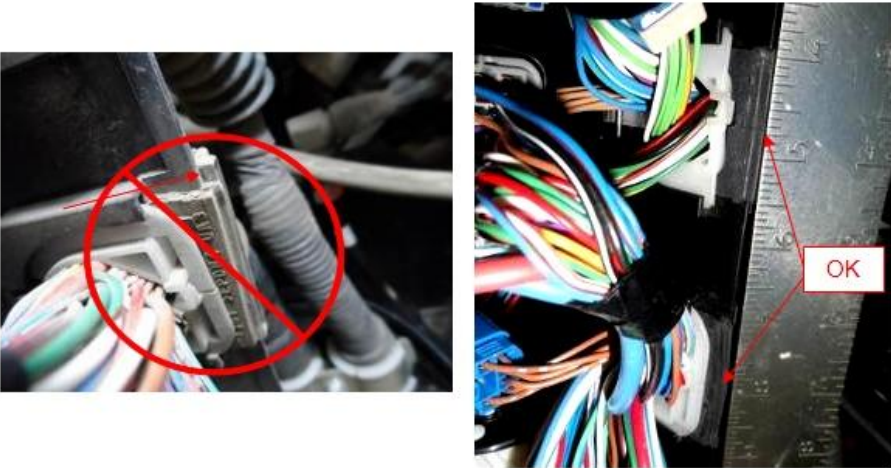
**5.** Verify that both upper and lower harness grommets are flush with the sealing surface of the junction box. If the harness grommet is sticking up, remove and reposition the harness grommet to ensure the grommet will be flush with the sealing surface.

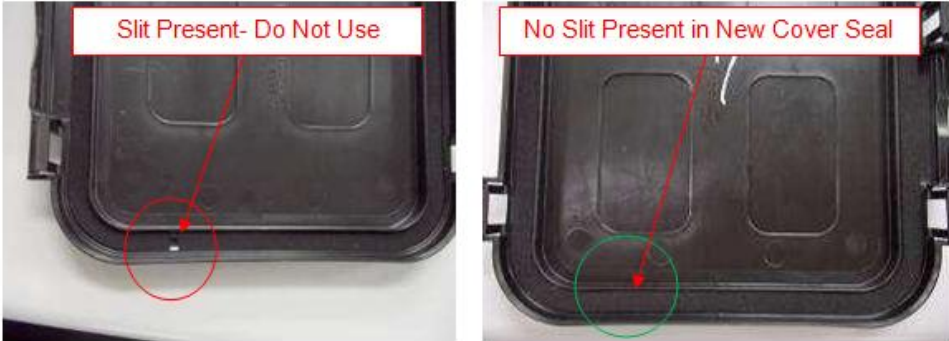
**6.** Inspect the junction box cover seal for a slit near the bottom corner. If a slit is present in the seal, replace the junction box cover with the enhanced junction box cover which has no slit in the seal.
