Tech Tip No:	14-002
Group:	27-Electrical System
Issue Date:	01-09-2014

TECH TIP

ELECTRICAL ISSUES OR FALSE STARTER ENGAGEMENT DUE TO COOLANT INTRUSION INTO JUNCTION BOX

11MY – 14MY Hino Conventional NE8J, NJ8J and NV8J model vehicles.

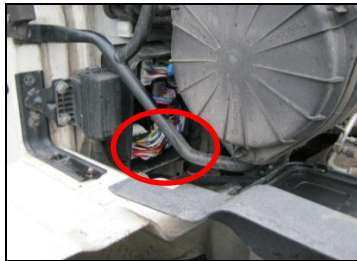
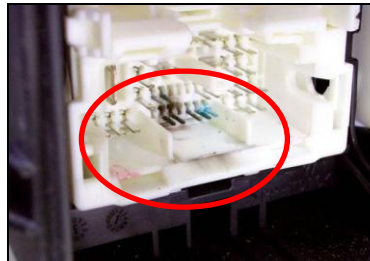
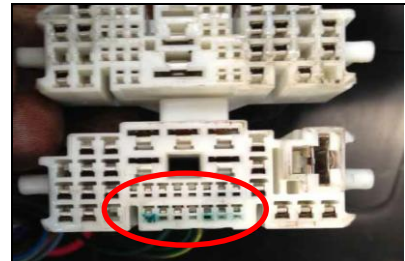
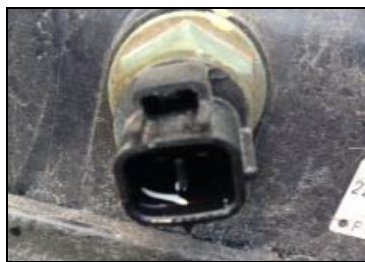
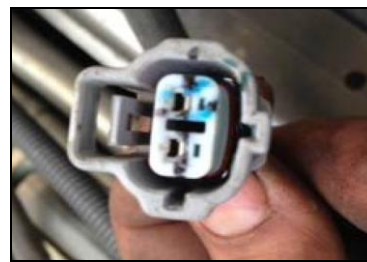
Electrical issues or false starter engagement due to coolant intrusion into the junction box.

If the customer is reporting uncommanded starter engagement when the turn signals or brake lamps are activated, inspect connector BE-2 for signs of corrosion and coolant contamination. This connector is located within the junction box mounted on the engine bay bulkhead. If coolant intrusion is found, inspect the coolant level sensor located at the top of the radiator for signs of leaking. If the coolant level sensor leaks, coolant can migrate through the chassis/frame harness into bulkhead connector BE-2.
