# TECHNICAL SERVICE BULLETIN

## 2013MY-15MY COE HYBRID CAB LEANING TO THE DRIVER'S SIDE

| Bulletin No.: | SB-14-011 |
| Issue Date: | 07-10-2014 |

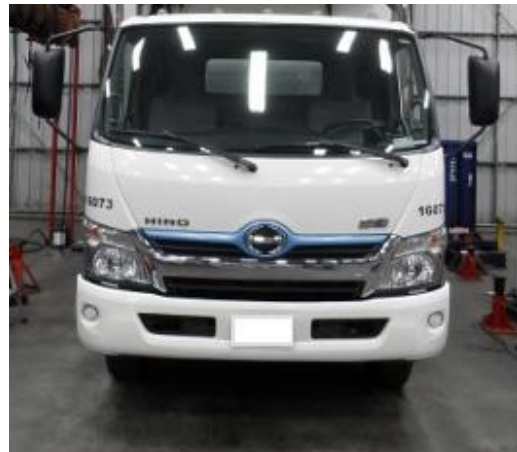
1. Park the vehicle in a paved location that is known to be level ground. View the vehicle head on. Does the cab of the vehicle appear to be leaning to the driver's side?

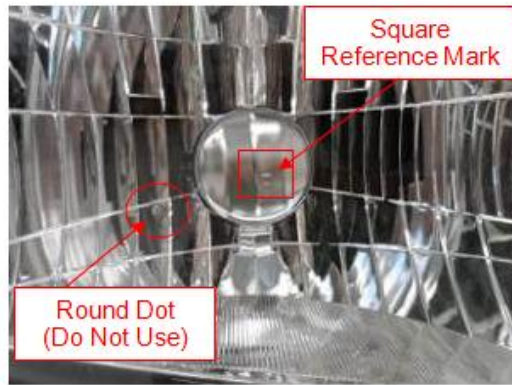
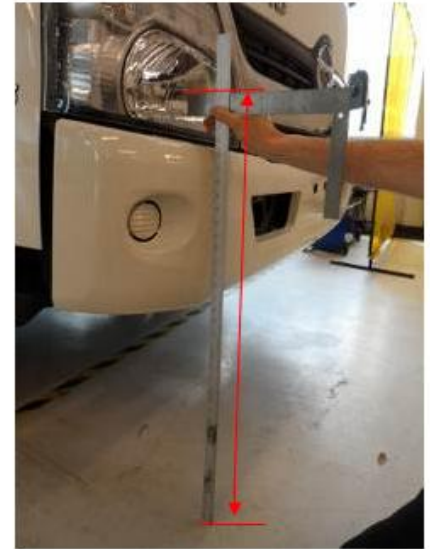
2. Measure the distance from the ground to the square reference mark in the headlamp lens on both sides of the vehicle. Use of a metric meter stick in millimeters is recommended for accuracy. Subtract the driver's side measurement from the passenger's side measurement. This will be the difference in lean from side to side.

**Example:** 893mm passenger's side – 883mm driver's side = 10mm lean to driver's side.

- If the value is between 6mm and 15mm, perform **Repair Procedure A**
- If the value is between 16mm and 20mm, perform **Repair Procedure B**
- If the value is 21mm or greater, perform both **Repair Procedures A and B**

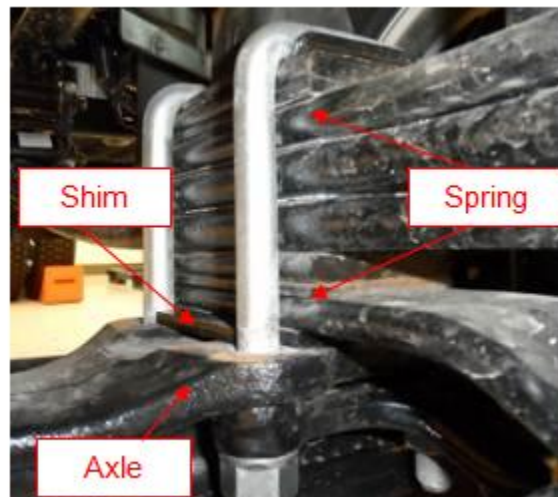
1. Inspect for an existing 6mm shim (4847537060) between the front axle and the bottom of the driver's side leaf spring. If there is already a shim present, do not perform Repair Procedure A. Only one shim is allowed between the spring and the axle.
