Tech Tip No:	TT-14-032
Group:	11-Engine
Issue Date:	10/31/2014

11MY-14MY Conventional-Combustor Igniter Replacement Guidelines

2011MY-2014MY Conventional trucks

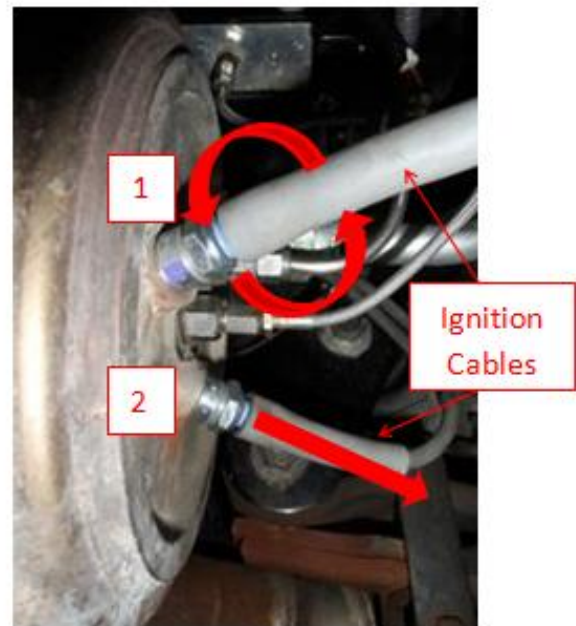
1. Remove the ignition cables from the igniter plugs. Grasp the ignition cables' rubber boot near the igniter and use a twisting motion to break the rubber boot loose from the igniter. Once the boot twists independently from the igniter, gently pull the boot off of the igniter.

NOTICE: Use caution not to break the ignition cables during removal. The ignition cables are fragile and can break if excessive force is used. Do not pull on the cable until the rubber boot will rotate independently from the igniter.

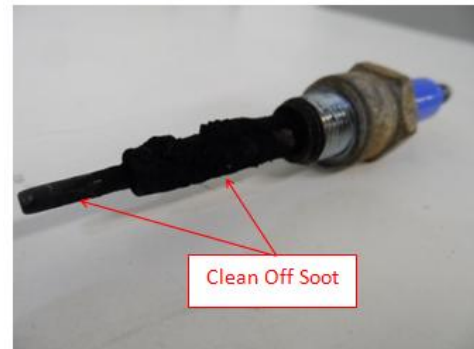
2. Remove both igniters from the combustion chamber. Remove any soot buildup on the igniters using brake cleaner and a rag.

NOTICE: Do not use a wire brush or other abrasive tools to clean the igniters.

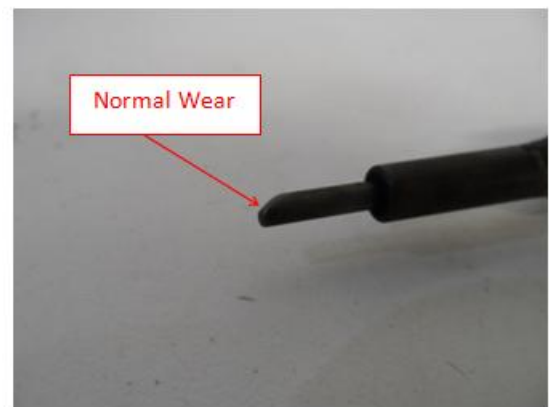
3. Inspect for cracks in the porcelain of the igniters. If there are any cracks or damage to the igniter, the igniter must be replaced. Note the wear on the tip of the igniter. Some wear is normal and does not justify replacement if the gap specification is met during the following steps, below.

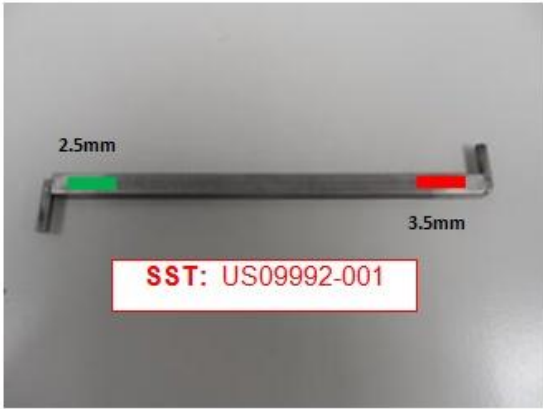
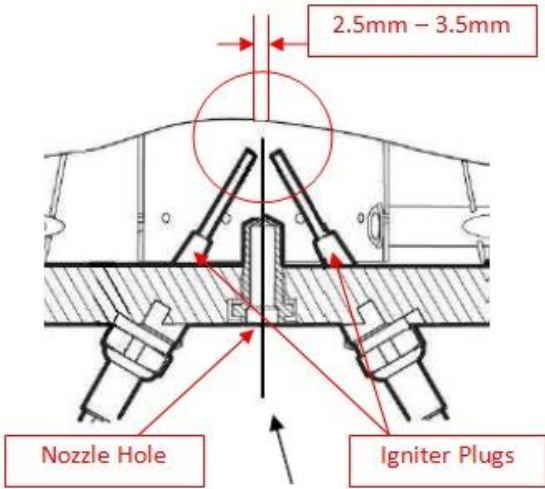
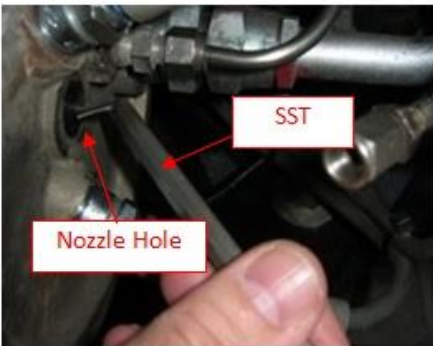
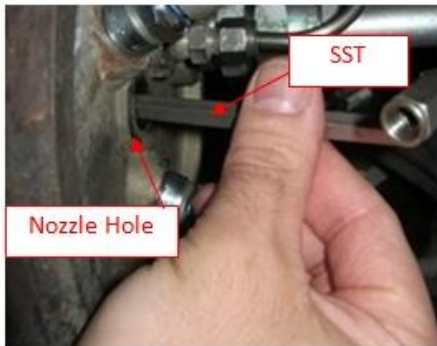
6. Reference the photographs and diagrams below. Using SST US09992-001, does the igniter gap fall within the specification?

Igniter Gap Specification: 2.5mm – 3.5mm.

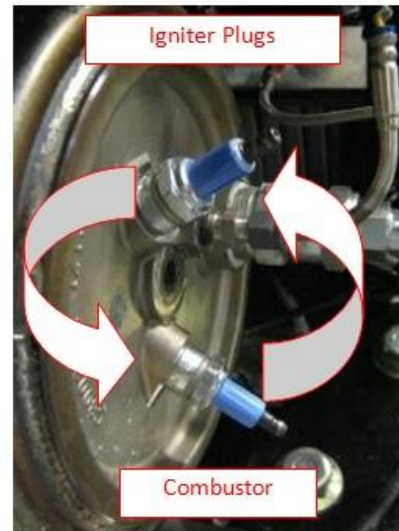
7. Remove the 2 igniter plugs and switch positions side to side. Reinstall both igniters and tighten to the specified torque.

Specified Torque: 22.0 lb-ft (29.8 Nm)
