## Roadster 2013 ST Upper Belt Guard Falling Off

BRP has received reports concerning 2013 ST model upper belt guards falling off. This only affects 2013 models.

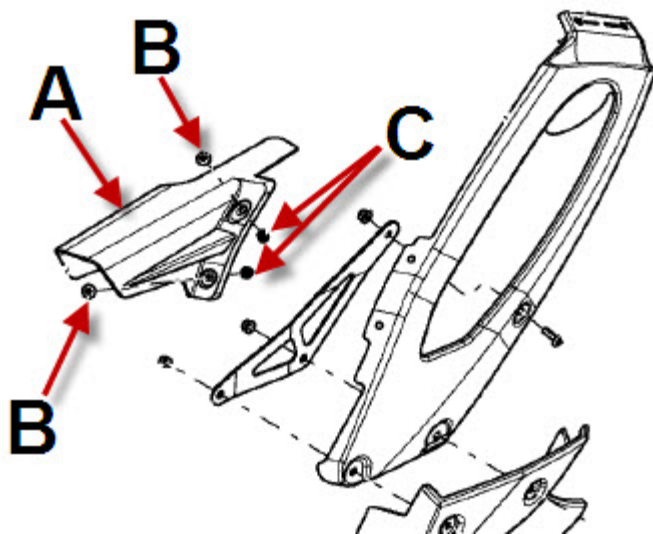
The problem has been identified as being the Torx screws being too short and not reaching the nylon of the nut. At the present time the MY13 parts catalog does not show the correct Torx screw, this will be corrected.

A. 705007213 upper belt guard

B. ~~250000349 Torx Screw M6x10~~ --> 250000454 Torx Screw M6x12 (X2)

C. 232361600 Nut M6 (X2)

If the belt guard has fallen off and needs to be replaced, order all parts above.

If you want to be proactive and replace the screws, order the correct screws since the nut's nylon has not been touched.
