L83X-A.01.14

To: Official After Sales Network
Subject: Installation Of Rubber Boot Onto Alternator
Date: 14th/02/14
Pages 4

Installation of rubber boot onto alternator.

All Lamborghini Model Aventdor MY 12, 13 and 14 Coupe And Roadster from VIN CLA00091 to VIN ELA02542.

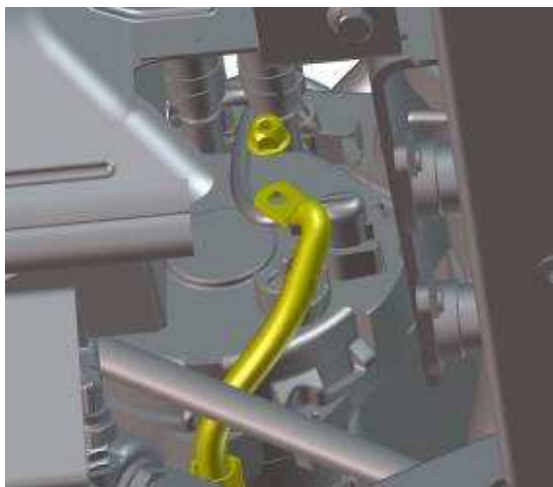
As a result of continuous product monitoring, Automobili Lamborghini Spa has found on some vehicles external corrosion on the alternator positive pole fastener.

6. Remove nut that secure alternator positive cable.
