L83X- A.04.14	<b>To:</b> <b>Subject:</b> <b>Date:</b> <b>Pages</b>	<b>Official After Sales Network</b> <b>Drivability enhancement</b> <b>11<sup>th</sup>/07/2014</b> <b>26</b>	 
------------------	---	--	---

Drivability enhancement

All Lamborghini Aventador MY **13** and **14** and up to VIN **ELA02756**.

As a result of continuous product monitoring, Automobili Lamborghini Spa has introduced a new software that manage engine, gearbox and instrument cluster to enhance driveability.

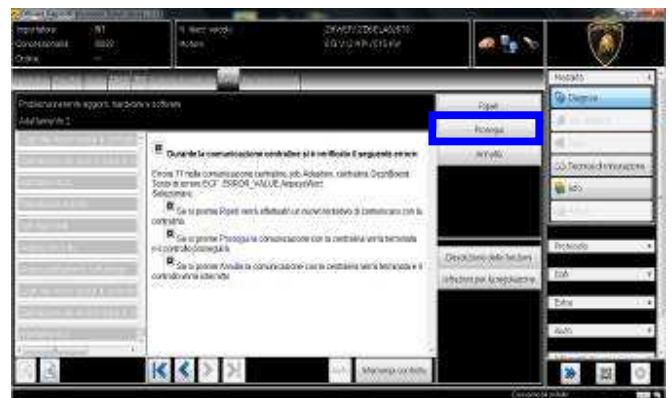
It is possible that the first time the update of the parameters 29 and 30 fails, with the following error in the figure:

In that case

- turn the ignition OFF;
- wait 1 minute before turning the ignition ON again;

Select “Repeat”.

In the case there was again the screen with the error of missing communication shown in figure,

Select “Continue” (for each parameter not yet updated)
