L83X-A.12.14	<b>To:</b> Official After Sales Network <b>Subject:</b> Wheel housing rework. <b>Date:</b> 01 <sup>st</sup> /08/2014 <b>Pages:</b> 4

**Subject**  
Wheel housing rework.

**Model**  
All Lamborghini Model Aventador Coupé and Roadster MY 12, 13 and 14 from VIN ELA00091 to VIN ELA02597.

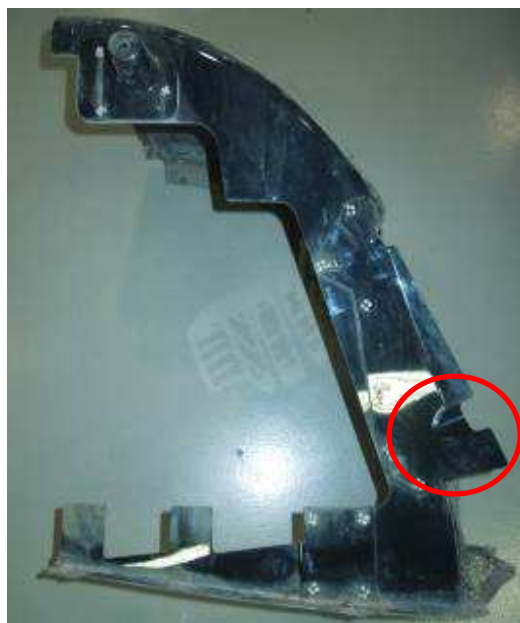
Left rear wheel housing (p/n 470810981B).

**Information to the field**  
As a result of continuous product monitoring, Automobili Lamborghini Spa has found that on some vehicles rear wheel houses may become distorted due to high temperature.

surface which needs to be reworked can be detected by mean of a visual inspection: check in the pictures below the area circled in red.

**Field solution**  
Rework both rear wheel housings.
