L834-
T.01.14

To: Rete di Assistenza ufficiale Lamborghini
Subject: A Pillar Monocoque Sealing
Date: 07th/02/14
Pages: 3

Monocoque A pillar sealing.

All Lamborghini Aventador LP 700 Coupe MY 12 and 13 from VIN **CLA00091** to VIN **DLA01695**

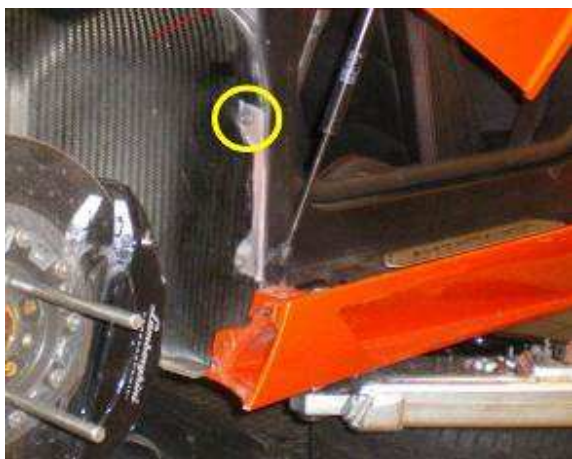
1. Remove the wheel arch undershield: left and right sides (chapter 08 21 – A).
2. Drain the water from the intermediate hole located in the wheel housing on both sides as shown in picture: holes are symmetrical on the left and right.

(Remark: the picture below shows right sides both sides are symmetrical)

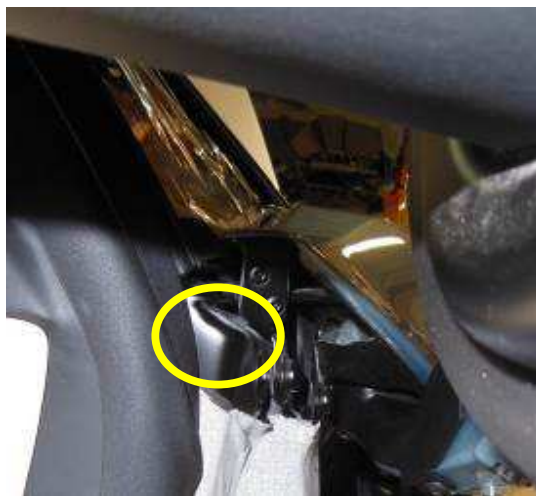
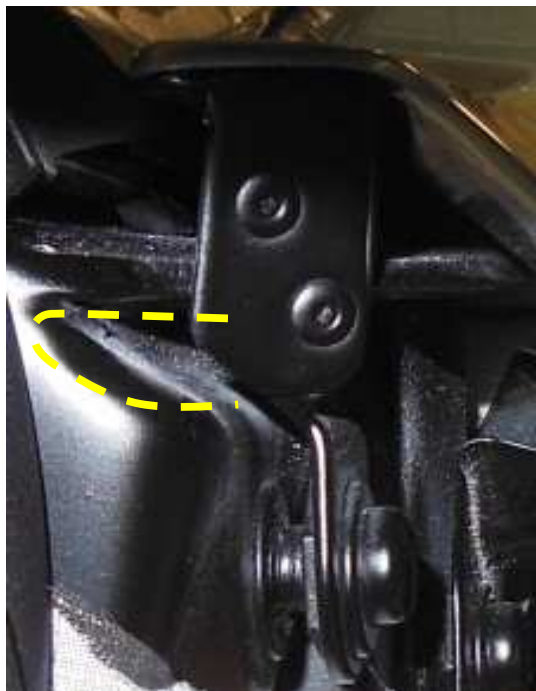
3. Open Both doors.
4. Find the surface to be sealed
