TO: Service Locations

FROM: Service Systems Development

SUBJECT: **Guidelines for EPA10 and GHG14 Aftertreatment Cores**

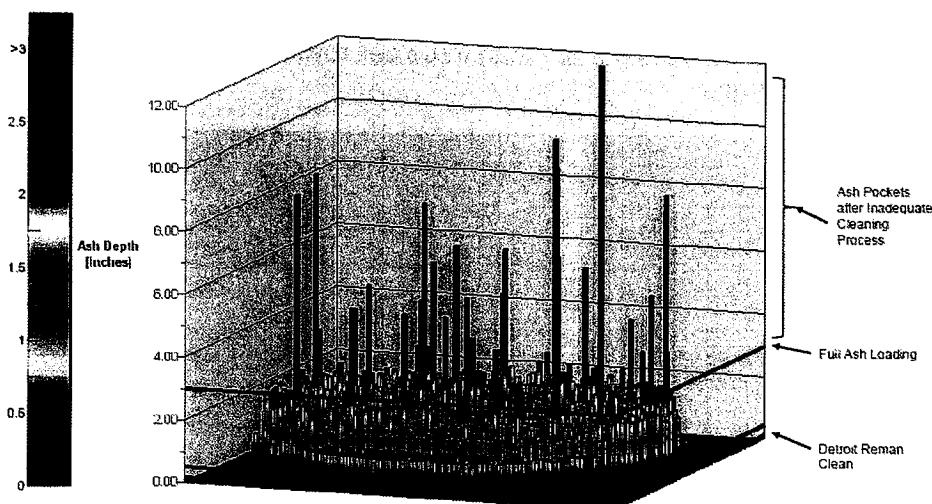
**3D View of Ash Content After Inadequate Cleaning**

**Air Cleaning Diesel Particulate Filters:** Detroit does not endorse ash measuring and air cleaning on EPA10 and GHG14 Diesel Particulate Filter (DPF). Data has shown that air cleaning the filter does not consistently achieve a uniform removal of ash across the filter. Ash left behind from air cleaning results in hot spots within the substrate, leading to cracks, which allow unfiltered exhaust to pass through the DPF. Detroit's ReMan offers new lower priced cleaned DPFs starting May 7, 2014 for service. The graphic below illustrates the ash content of an air-cleaned filter.

Excessive ash accumulation in the DPF from improper cleaning will also lead to over temp of the filter. Once the filter exceeds 790°C, platinum in the filter vaporizes and passes to the SCR. The SCR Catalyst is then poisoned, resulting in a “Low NOx Conversion Efficiency” fault and replacement of the SCR Catalyst.

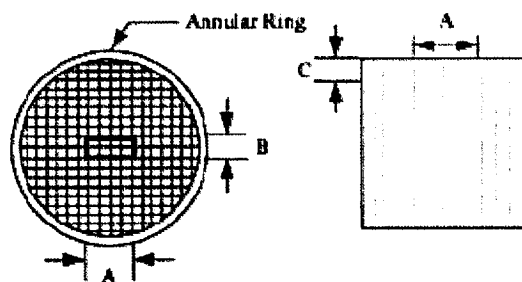
**Specification Limit:****Radial (A)**

Less than or equal to .500" (12.7 mm)

**Circum (B)**

Less than or equal to .251" (6.38mm)

**Axial (C)**

Less than or equal to .125" (3.18 mm)

- Maximum gouge per face not to exceed 5
- Minimum separation between gouges is 1.960" (29.78mm)
- Cumulative gouge are not to exceed 0.5% of substrate face

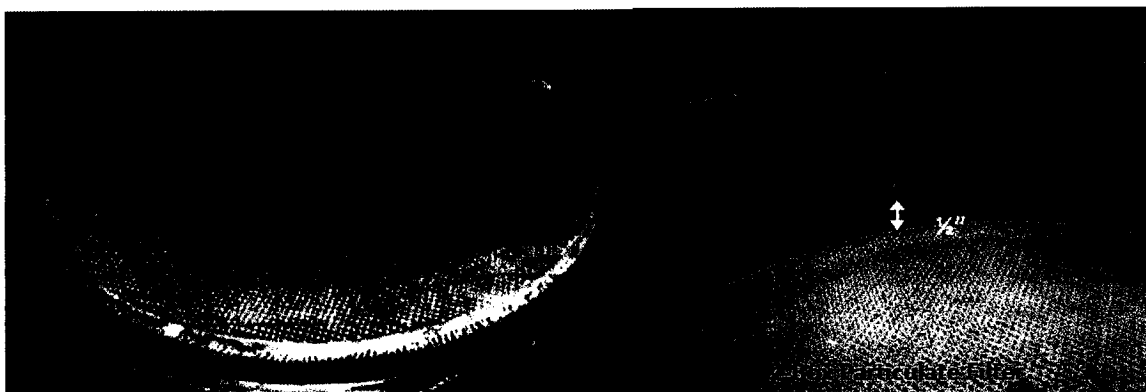
**Substrate Slippage:** Substrate which moves inside the stainless steel can is known as slippage, caused by unusually high back pressure. Substrates flush or protruding past the can flange that come into contact with or within 1/2" (12.7 mm) of sensor or sensor bung are considered unacceptable.

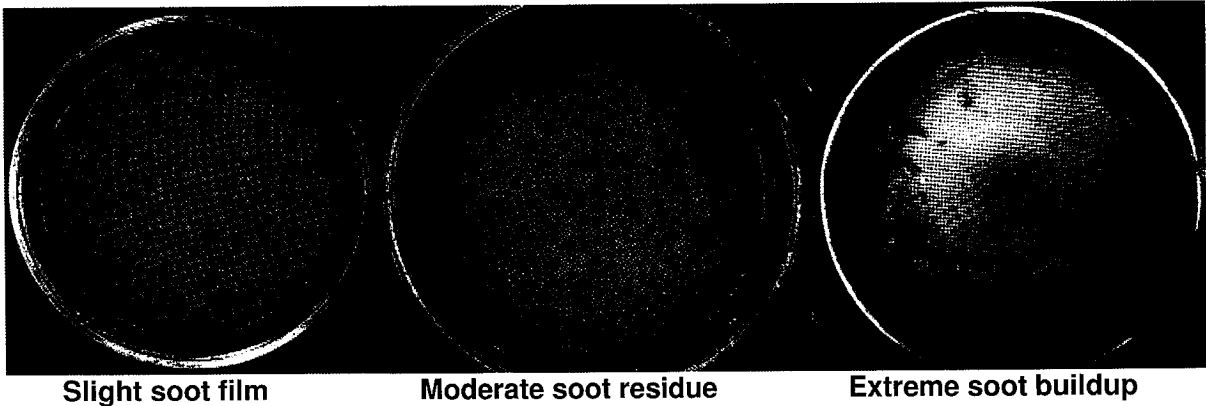
**Horizontal Cracks:** If the DPF substrate face has any soot residue around the circumference of the substrate, that could be an indication of internal cracks. Internal horizontal cracks allow soot and ash to pass through the substrate. Soot evidence, identified with a wipe of a light colored cloth, can be a slight amount of black film around the edges of the exhaust side to moderate and extreme cases where soot buildup occurs. All circumstances are considered unacceptable core.
