## MY2014 Infiniti QX60 CVT Rev Sensor Retailer Inspection

Reference: PC261

Date: January 15, 2014

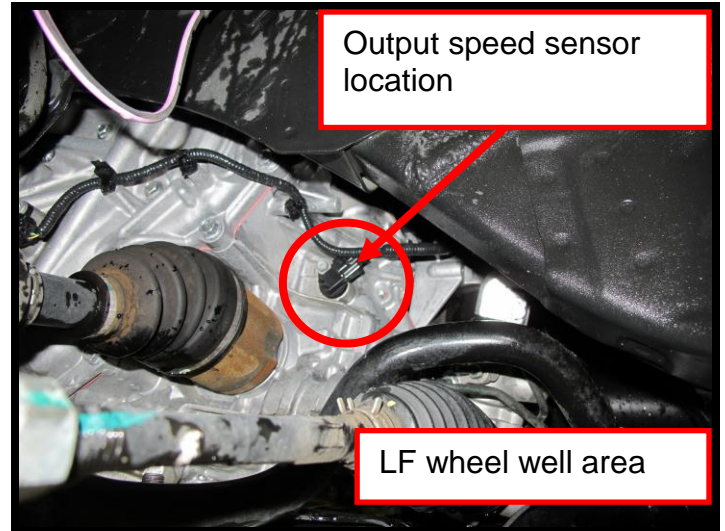
Figure 1

2. Raise the vehicle on the hoist.
3. Look into driver side (LF) wheel well to locate the output speed sensor, see Figure 1.

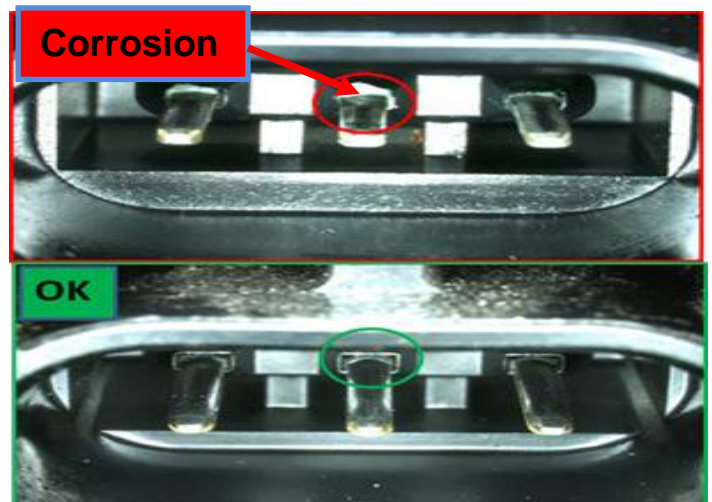
Figure 2

Infiniti is conducting a Retailer Service Action to inspect the CVT output speed sensor on certain specific 2014 Infiniti QX60 vehicles currently in retailer inventory only. On a small percentage of vehicles, the CVT output speed sensor terminals may have accumulated moisture or corroded and the retailer will need to replace the sensor.

4. Disconnect harness from output speed sensor and remove sensor from transmission.
5. Inspect output speed sensor terminals and harness connector for corrosion or evidence of moisture intrusion.

- Is corrosion found on output speed sensor terminals? (see Figure 2)
- Is moisture intrusion found in output speed sensor harness connector?

- Replace output speed sensor with a new sensor assembly.
- Torque output speed sensor bolt to 5.9 N•m (52 in-lb).
- Dry harness connector with low pressure shop air and apply electric cleaner (CRC® QD® Electric Cleaner PN 05103 or equivalent).
