SERVICE BULLETIN

Classification: EC14-001	Reference: NTB14-005	Date: February 4, 2014
-----------------------------	-------------------------	---------------------------

2013 NV200; MIL ON WITH DTC P0456

APPLIED VEHICLE: 2013 NV200 (M20)
APPLIED VIN / DATE: Built before 3N6CM0KN(*)DK 692556 / June 20, 2013

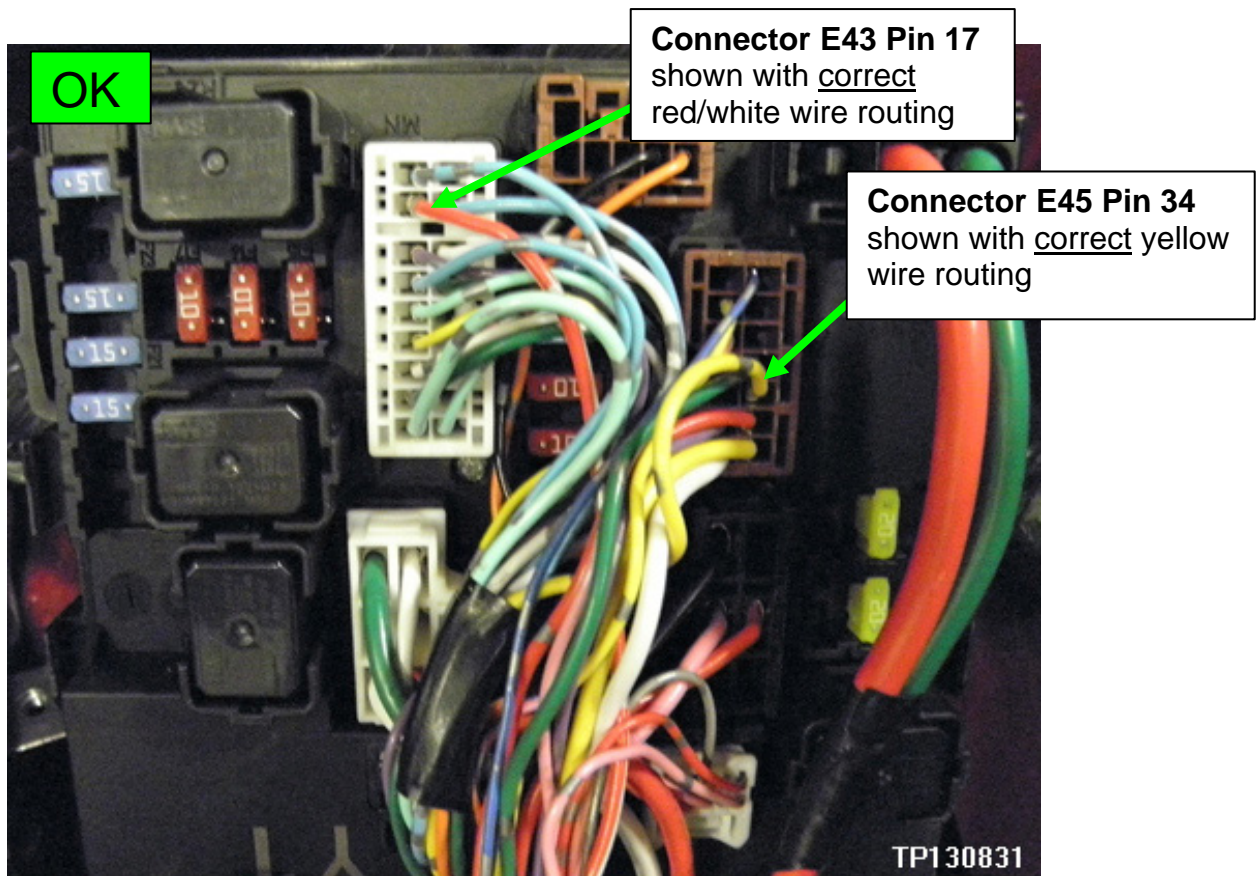
Figure 1

1. Turn the ignition OFF.
2. Remove the cover from the IPDM.
3. Inspect harness connectors shown in Figure 1.
 - Connector E43 pin 17, wire should be Red with White strip.
 - Connector E45 pin 34, wire should be Yellow.

NG: If harness connectors E43 pin 17 is yellow, and E45 pin 34 is red/white, proceed to **Harness Repair** on the next page.

OK: If harness colors are OK as shown above, the harness repair section of this bulletin does not apply. Refer to the Electronic Service Manual (ESM) for further diagnostics.
