SERVICE BULLETIN

Classification: AT13-021	Reference: NTB14-019	Date: March 21, 2014
-----------------------------	-------------------------	-------------------------

2014 ROGUE; MIL ON WITH DTC P2765, P0500, P1574, P1715 OR P0720

APPLIED VEHICLES: 2014 Rogue (T32)
APPLIED TRANSMISSION: CVT8

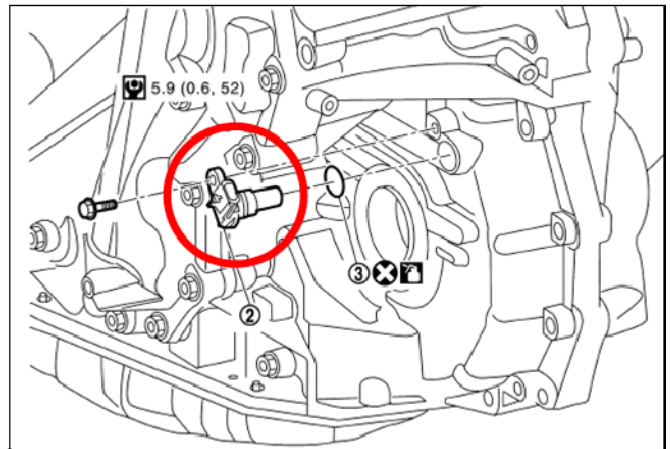
Figure 1

- Moisture and/or corrosion is present on or around the Secondary Speed Sensor pins.

- Remove the moisture from the Harness connector with CRC QD (or equivalent) electric cleaner.
- Replace Secondary Speed Sensor shown in Figure 1.
