# SERVICE BULLETIN

Classification: BT14-004	Reference: NTB14-036	Date: April 30, 2014
-----------------------------	-------------------------	-------------------------

## MURANO CROSSCABRIOLET; SOFT TOP POOR APPEARANCE / FIT NEAR SKYLIGHT GLASS

**APPLIED VEHICLE:** 2011 - 2014 Murano CrossCabriolet (Z51)

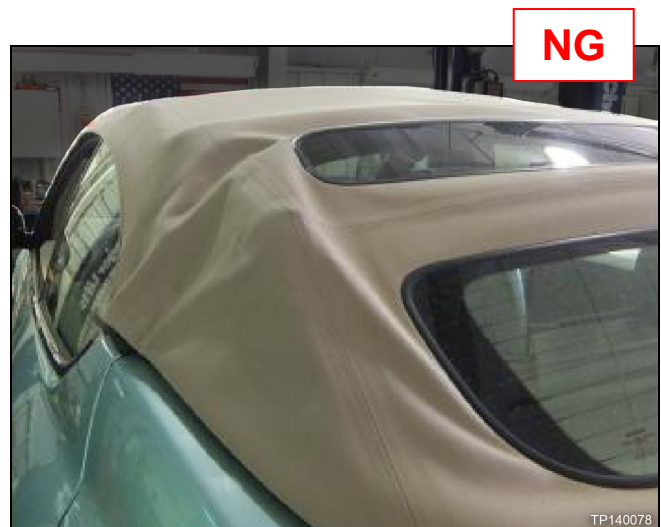
Figure 1

The soft top has a loose fitting appearance (see example in Figure 1).

- The pressure links are adjusted improperly.

**NOTE:** The pressure links adjust the fourth bow, which is located between the skylight glass and rear window.

Adjust/shorten the fourth bow pressure link(s).

- Use the adjustment procedure in this bulletin's **SERVICE PROCEDURE** starting on page 2.

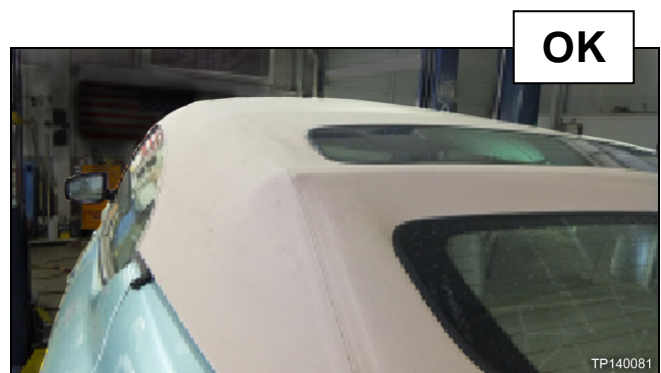
- Figure 1a shows a soft top with proper fit.
