SERVICE BULLETIN

Classification: BT14-005	Reference: NTB14-037	Date: April 30, 2014
-----------------------------	-------------------------	-------------------------

MURANO CROSSCABRIOLET; SKYLIGHT GLASS CONTACTS REAR SEAT HEADRESTS WHEN OPENING THE SOFT TOP

APPLIED VEHICLE: 2011 - 2014 Murano CrossCabriolet (Z51)

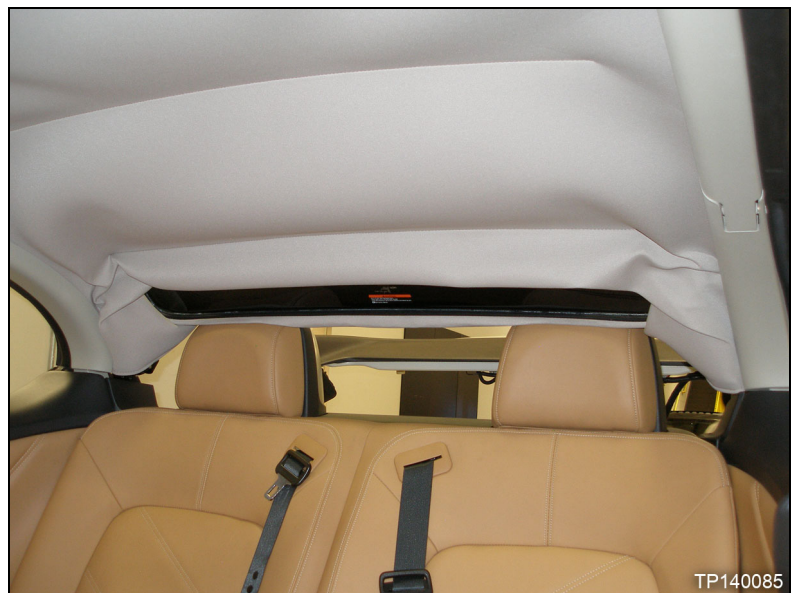
Figure 1

The skylight glass, when opening the soft top, comes in contact with the rear seat's headrests (for example, see Figure 1).

- The soft top may not open any further once the skylight glass catches on the headrests.

Adjust/lengthen the fourth bow pressure link(s).
