SERVICE BULLETIN

Classification: ST12-009b	Reference: NTB13-017b	Date: August 28, 2013
------------------------------	--------------------------	--------------------------

2013 ALTIMA SEDAN; NOISE FROM THE HYDRAULIC ELECTRIC POWER STEERING (H-EPS)

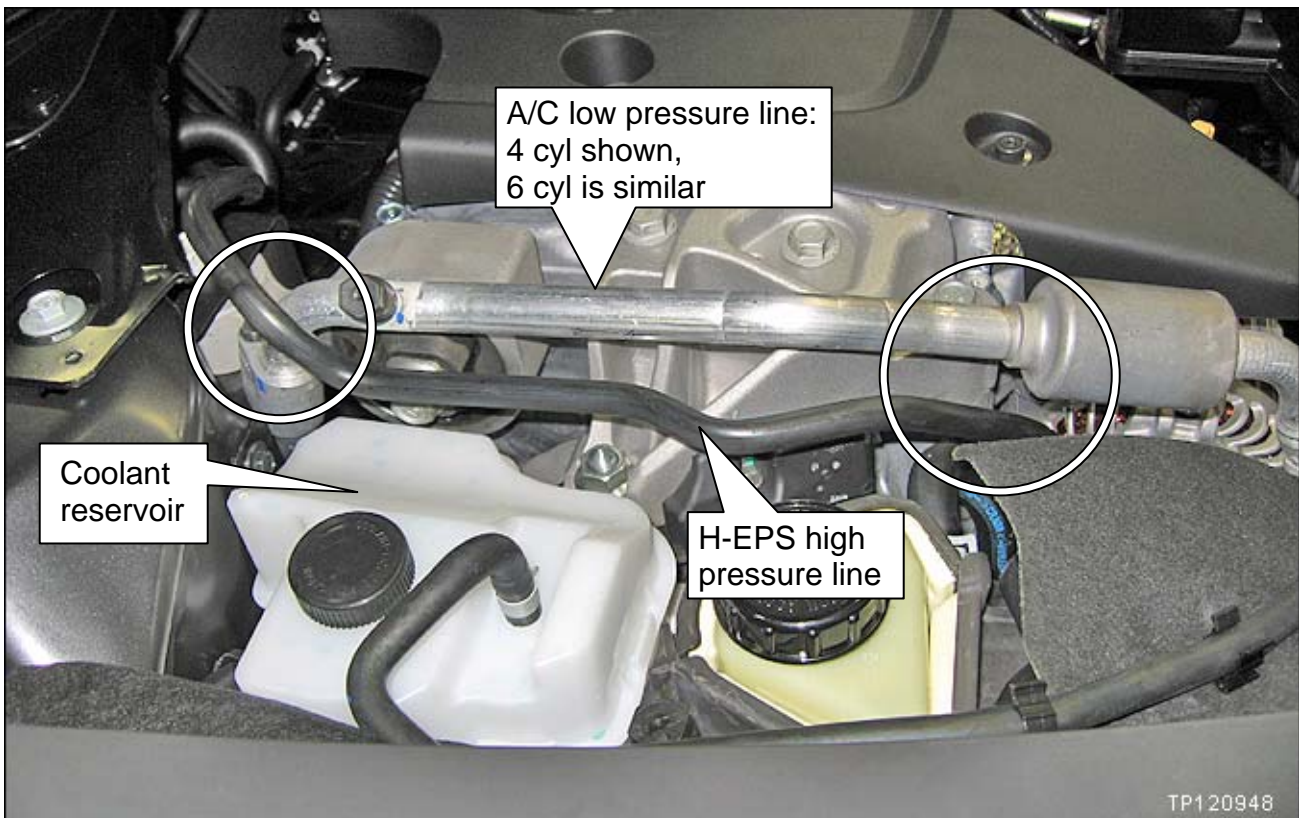
Figure 5

5. Make sure the H-EPS high pressure line and the A/C low pressure line are **not** touching (see Figure 5).
- Check the two locations circled in Figure 5.
 - If the lines are touching, reposition the lines so they are **not** touching.

6. Make sure the H-EPS high pressure line is **not** touching the coolant reservoir (see Figure 5).

- Make sure the coolant reservoir is mounted correctly; its locator boss must be seated in the mounting hole.
- If needed, reposition the H-EPS line so it is **not** touching the reservoir.

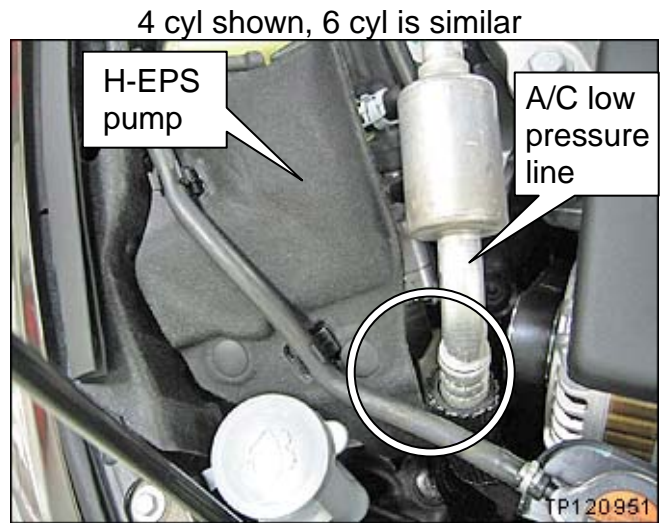
Figure 6

7. Make sure the A/C low pressure line is **not** touching the H-EPS pump.

- Check the location circled in Figure 6.
- If needed, reposition the A/C low pressure line so it is **not** touching the H-EPS pump.

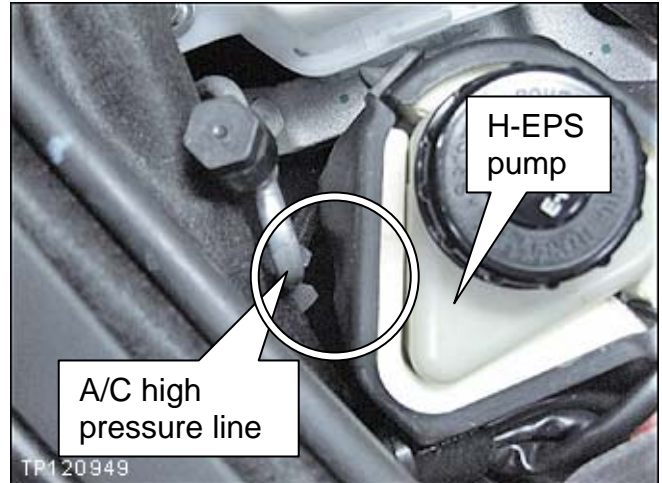
Figure 7

8. Make sure the A/C high pressure line is **not** touching the H-EPS pump.

- Check the location circled in Figure 7.
- Wiggle the H-EPS pump and observe the A/C high pressure line. If it moves it is touching.
- If needed, reposition the A/C high pressure line so it is **not** touching the H-EPS pump.

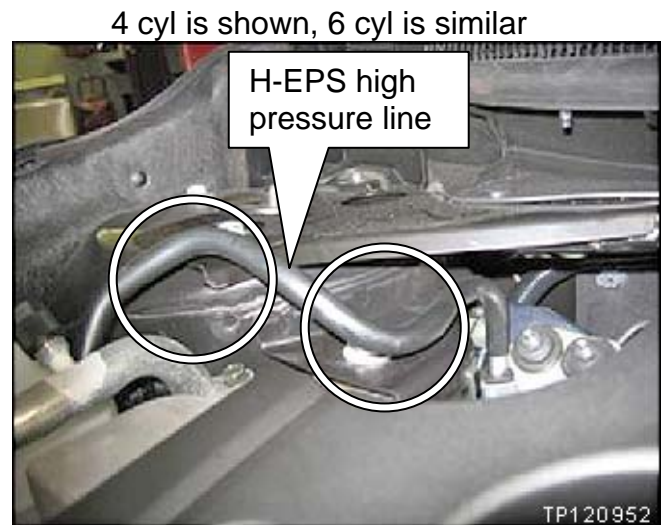
Figure 8

9. Make sure the H-EPS high pressure line is **not** touching the strut tower brace or the torque rod mounting bracket.

- Check the two locations circled in Figure 8.
- If needed, reposition the H-EPS high pressure line so it is **not touching**.

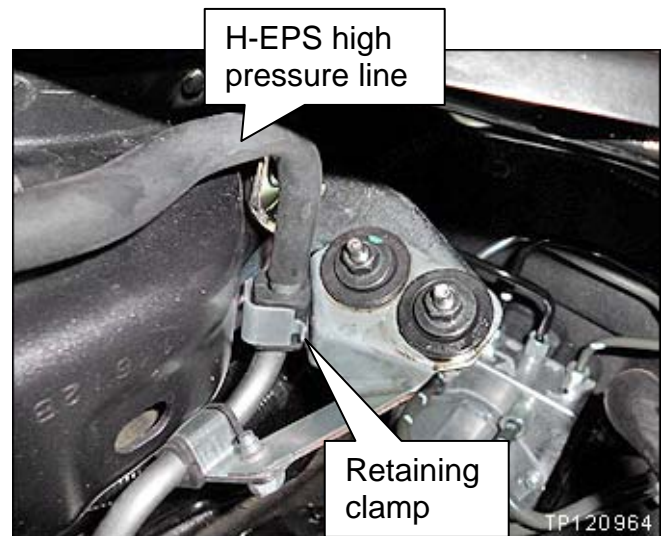
10. **For 4 cylinder models only:**
Check the H-EPS high pressure line retaining clamp shown in Figure 9.

- Make sure the clamp is secured correctly.
- Figure 9 shows a clamp that **is not** secured correctly.
- If the clamp is loose like the one shown in Figure 9, replace the H-EPS high pressure line.

- Refer to the Service Manual for replacement information.

NOTE: If the H-EPS high pressure line needs to be replaced, replace the H-EPS bracket at the same time (see page 15 or 16, as it applies).

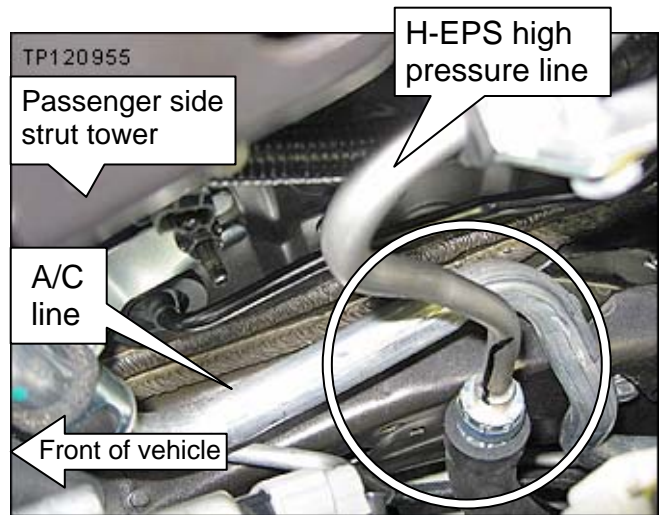
Make sure the H-EPS high pressure line is not touching the A/C line or vehicle body.

NOTE: The view in Figure 10 is downward from the inboard side of the passenger side strut tower.

- Check the area circled in Figure 10.
- If needed, reposition the lines so they are **not** touching.
- If needed, reposition the H-EPS line so it is **not** touching the vehicle body.

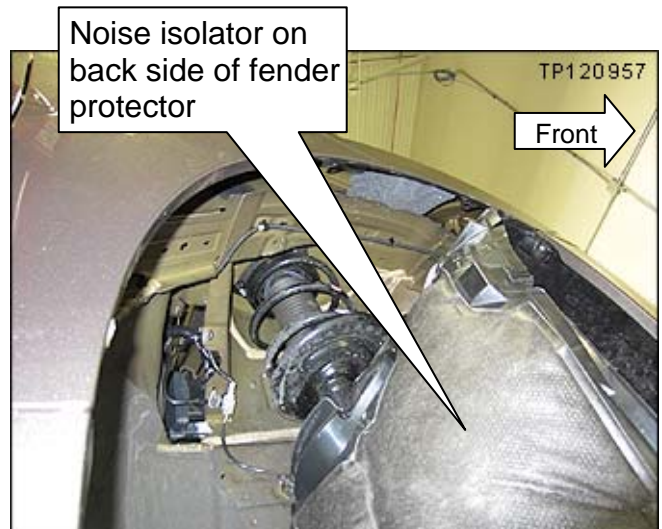
Figure 11

12. Make sure the noise insulator is installed inside the RH (passenger side) front fender protector:

- a. Remove the passenger side front wheel.
- b. Partially remove the fender protector.
 - Refer to the Service Manual as needed.
- c. Confirm the insulator is in place.
 - Make sure the insulator is installed correctly, or
 - If damaged or missing, replace the fender protector with insulator.

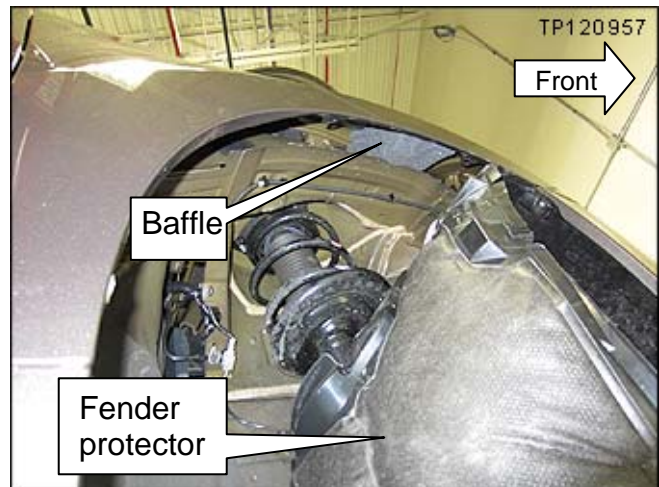
Figure 12

13. Make sure the baffle is positioned properly inside the RH (passenger side) front fender.

- The baffle should be flush against the fender.
- When the fender protector is installed there should be no gap between the fender protector and the baffle.
- If needed, reposition the baffle or install a new one.

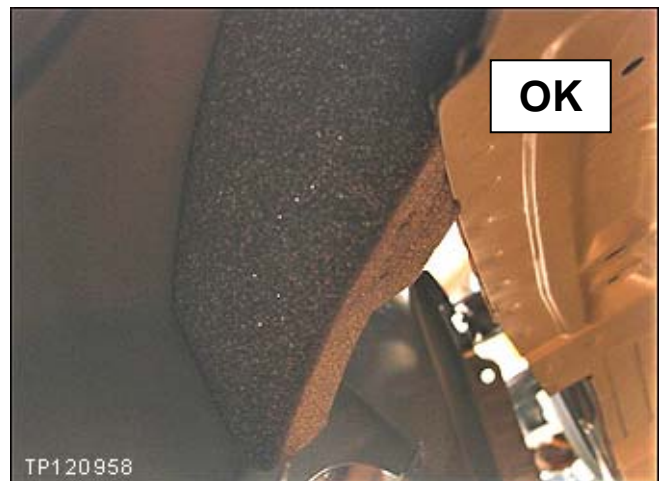
- Figure 13 – baffle is **installed correctly**.

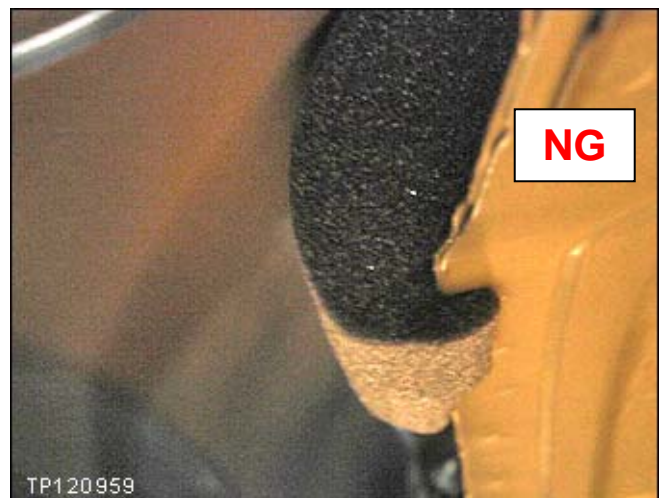
- Figure 14 – example of a baffle **installed incorrectly**.

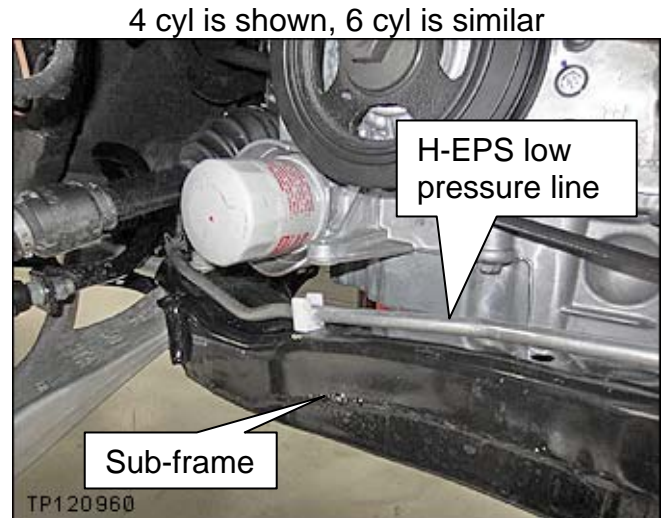
Figure 15

14. Make sure the H-EPS low pressure line is **not** touching the sub-frame near the front of the engine.

- If needed, reposition the H-EPS low pressure line so it does **not** touch the sub-frame.

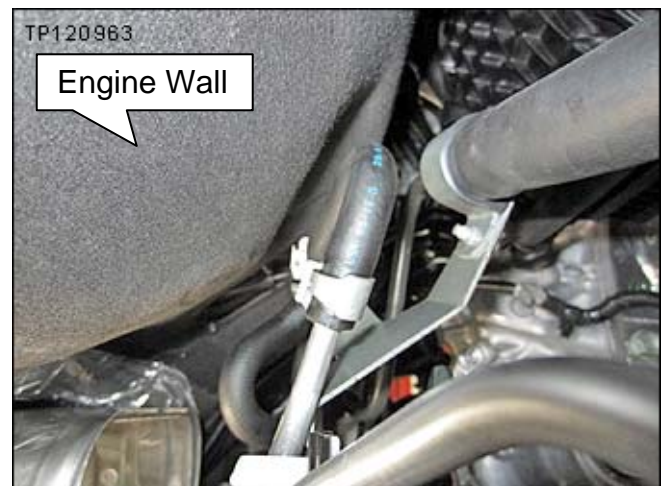
Figure 16

15. **For 4 cylinder models only:** Make sure the H-EPS lines under the vehicle are **not** touching surrounding parts.

- a. Lift the vehicle.
- b. Visually check the routing of the under-vehicle H-EPS lines.
 - If needed, reposition the H-EPS lines so they are **not** touching any surrounding parts.

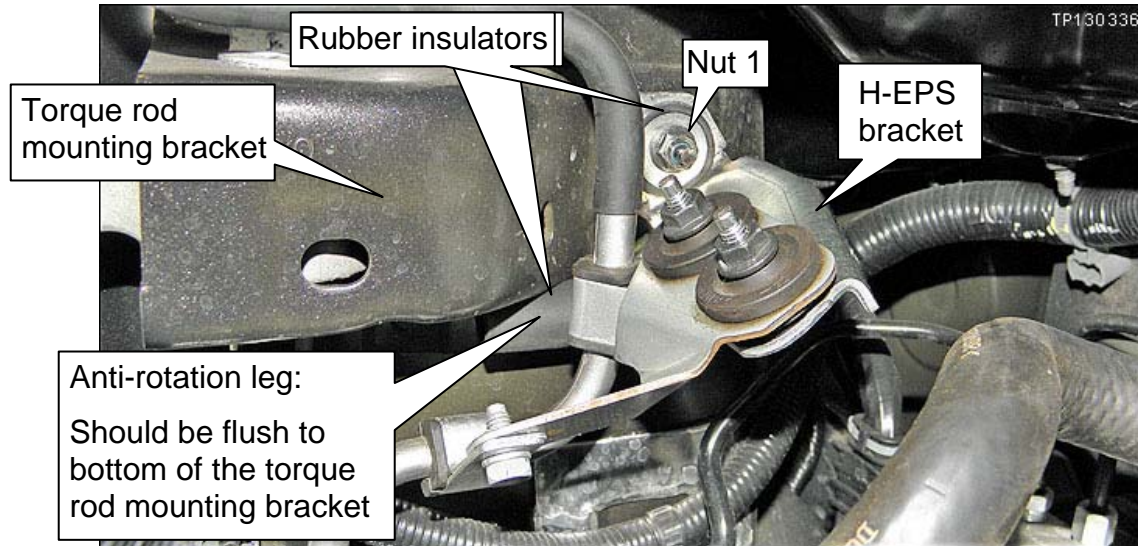
16. Make sure the anti-rotation leg of the H-EPS bracket is flush to the bottom of the torque rod mounting bracket (see Figure 17 and 18 as they apply).

17. Check the torque of Nut 1.

- If needed, reposition the H-EPS bracket so the anti-rotation leg is flush to bottom of the torque rod mounting bracket.

- Nut 1: 8 N•m (0.81 kg-m, **5.9 ft-lb, 71 in-lb**)

1a. Remove the 3 nuts shown in Figure 17.

2a. Remove the old bracket and install the new bracket.

3a. Reinstall the 3 nuts and torque to:

Nut 1: 8 N•m (0.81 kg-m, **5.9 ft-lb, 71 in-lb**)

Nut 2 & 3: 4.9 N•m (0.49 kg-m, **3.6 ft-lb, 43 in-lb**)

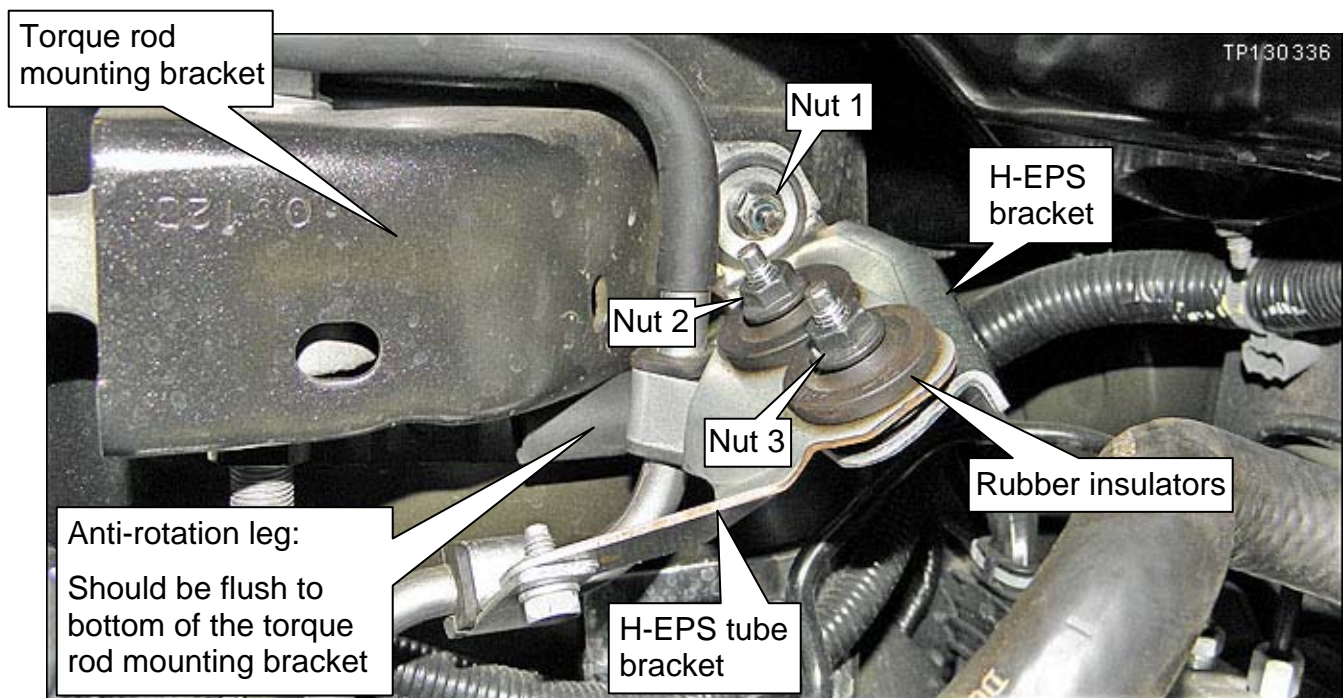
Figure 19

4a. Make sure the H-EPS bracket and the H-EPS tube bracket are not touching (see Figure 19).

5a. Make sure the anti-rotation leg of the H-EPS bracket is flush to the bottom of the torque rod mounting bracket (see Figure 19).

- There should be a gap between the brackets all the way around.
- Make sure the rubber insulators are seated properly.
- If needed, reposition the brackets so they are not touching.

- If needed, reposition the H-EPS bracket so the anti-rotation leg is flush to the bottom of the torque rod mounting bracket.
