SERVICE BULLETIN

| BT14-016 | NTB14-063 | July 8, 2014 |

370Z ROADSTER; STORAGE LID RUBS THE FIFTH BOW WHEN OPENING THE SOFT TOP

APPLIED VEHICLE: 2010-2014 370Z Roadster (Z34)

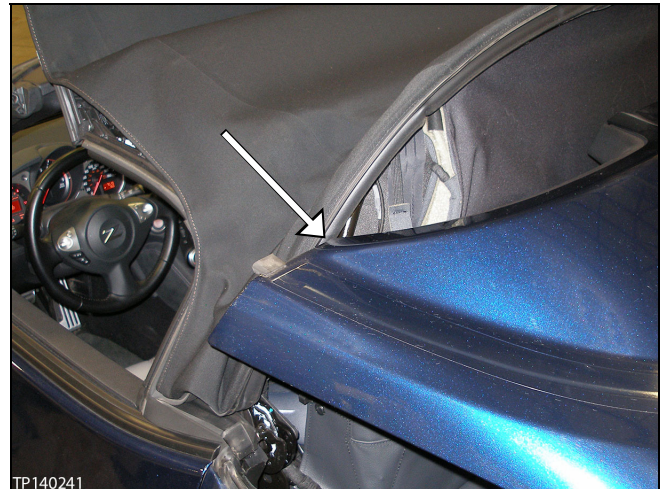
Figure 1

When opening the soft top, the storage lid rubs the fifth bow on the left and/or right side.

- This issue may not occur every time the soft top is opened. The vehicle may have to be parked for a day before the issue can be duplicated again.

1. Adjust both soft top pressure links.
2. Lube both pressure link pivot joints.
3. Adjust the storage lid.
 - Go to **SERVICE PROCEDURE** for repair instructions.
