SERVICE BULLETIN

Classification: BT14-017	Reference: NTB14-064	Date: July 8, 2014
-----------------------------	-------------------------	-----------------------

370Z ROADSTER; SOFT TOP WILL NOT FULLY CLOSE

APPLIED VEHICLE: 2010-2014 370Z Roadster (Z34)

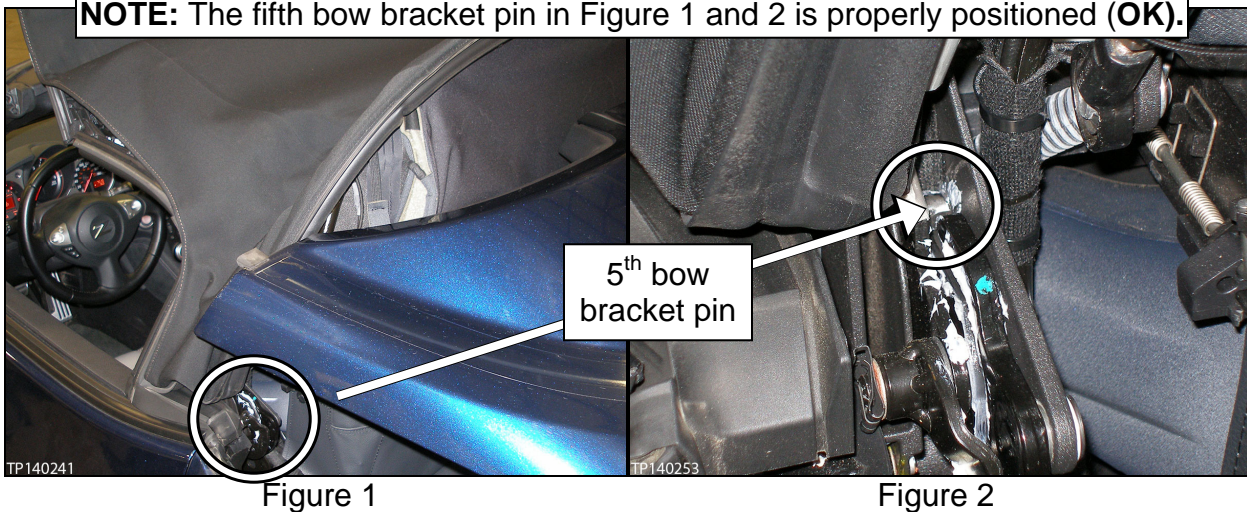
NOTE: The fifth bow bracket pin in Figure 1 and 2 is properly positioned (**OK**).

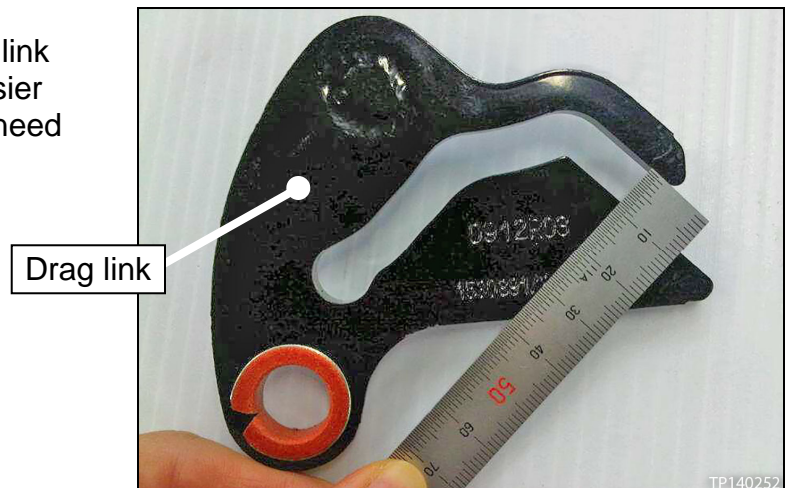
2. Measure the drag link channel (see Figure 3).

- Acceptable channel measurement range: 8.5 – 10 mm.

NOTE: Figure 3 shows the drag link removed from the vehicle for easier viewing. The drag link does not need to be removed for this bulletin.

Tip: For quick reference, initially use an 8 mm stud sized bolt as a measuring gauge. If the 8 mm stud sized bolt fits snug or not at all (does not fit loosely) in the drag link channel, the channel will need to be widened.
