EC13-016a

July 18, 2014

2011 – 2012 QX56; MIL "ON" WITH DTC P0420 AND/OR P0430

APPLIED VEHICLES: 2011 – 2012 QX56 (Z62)

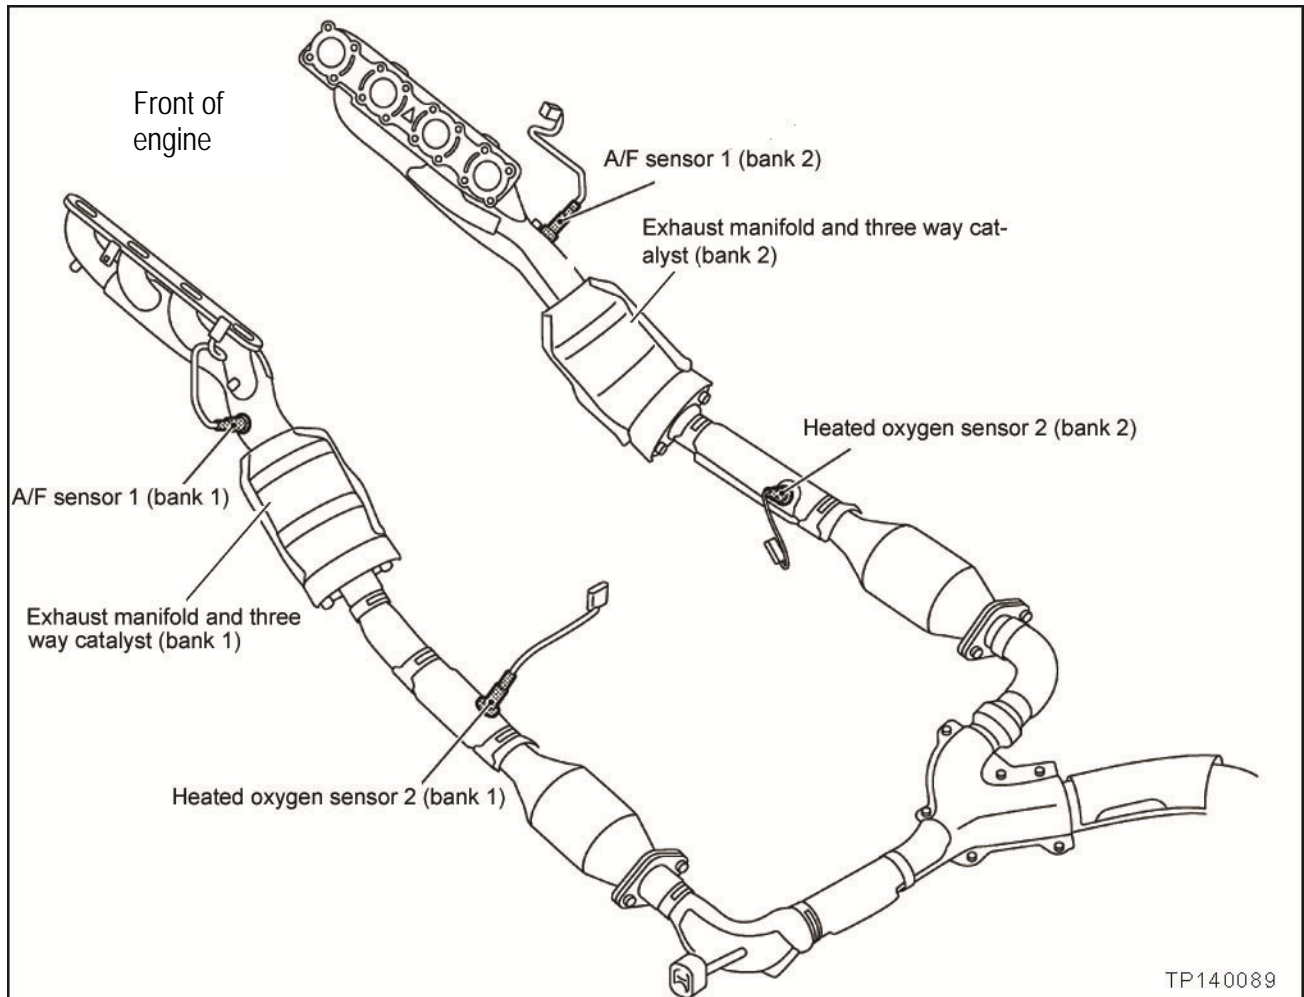
Figure 8

MIL "ON" with DTC P0420 and/or P0430 (Three Way Catalyst Function),

19. Replace the three way catalyst and A/F sensor as follows:

- If DTC P0420 is stored, replace Bank 1 exhaust manifold and three way catalyst, and A/F sensor
- If DTC P0430 is stored, replace Bank 2 exhaust manifold and three way catalyst, and AF sensor.
- Refer to the Electronic Service Manual (ESM), Section EM-Engine Mechanical, for replacement information.
