SERVICE BULLETIN

Classification: EL14-004a	Reference: NTB14-051a	Date: August 7, 2014
------------------------------	--------------------------	-------------------------

2013-2014 SENTRA; NO CRANK NO START AND DTCs STORED

APPLIED VEHICLE: 2013 - 2014 Sentra (B17)

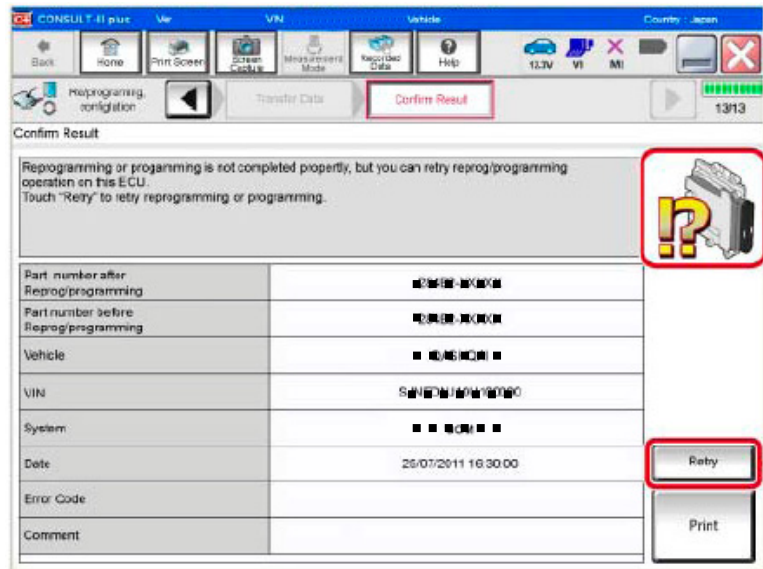
Figure 5

If reprogramming does not complete and the “!?” icon displays as shown in Figure 5:

- Check battery voltage (12.0 - 15.5 V).
- Ignition is ON, engine OFF.
- External Bluetooth® devices are OFF.
- All electrical loads are OFF.
- **Select retry and follow the on screen instructions.**
- “Retry” may not go through on first attempt and can be selected more than once.

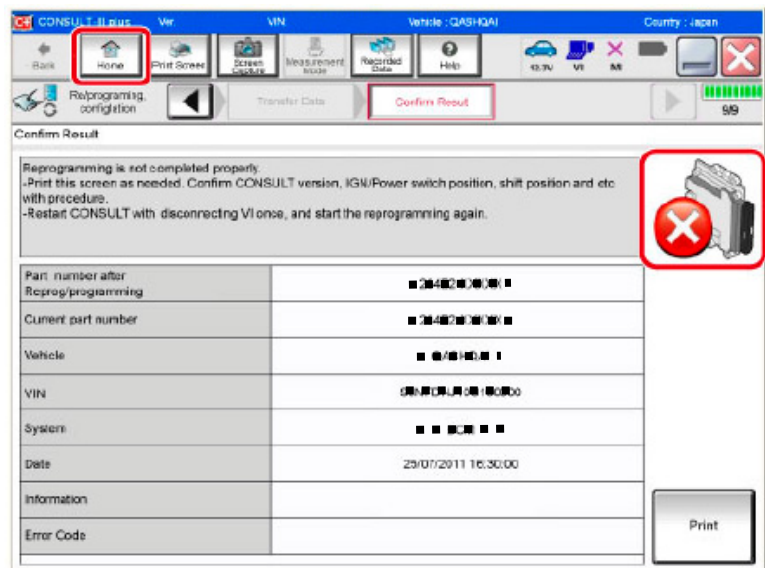
Figure 6

If reprogramming does not complete and the “X” icon displays as shown in Figure 6:

- Check battery voltage (12.0 - 15.5 V).
- CONSULT A/C adapter is plugged in.
- Ignition is ON, engine OFF.
- Transmission is in Park.
- All C-III plus / VI cables are securely connected.
- All C-III plus updates are installed.
- **Select Home, and restart the reprogram procedure from the beginning.**
