SERVICE BULLETIN

Classification: EL14-006	Reference: NTB14-011	Date: February 18, 2014
-----------------------------	-------------------------	----------------------------

2009 ALTIMA AND MAXIMA; STEERING COLUMN LOCK REPLACEMENT

APPLIED VEHICLES: 2009 Altima Sedan (L32)
2009 Altima Coupe (L32)
2009 Altima Hybrid (L32)
2009 Maxima (A35)

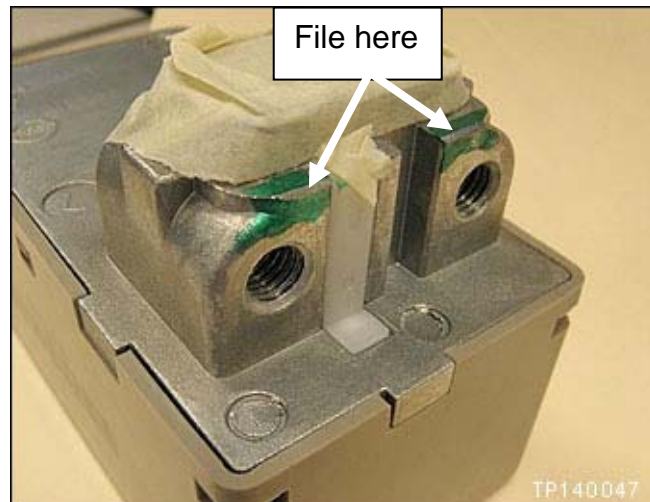
Figure 3

Close up after metal is removed:

- Use tape to cover openings and prevent metal shavings from entering the assembly.
- Remove only a **small amount** of metal as shown.
- After filing, if the assemble still will not fit, file a little more and retry.
