SERVICE BULLETIN

Classification: EL14-043	Reference: NTB14-095	Date: October 7, 2014
-----------------------------	-------------------------	--------------------------

2014 ROGUE; VEHICLE INFORMATION DISPLAY IMAGES ARE SHIFTED FROM NORMAL POSITION

APPLIED VEHICLES: 2014 Rogue (T32)

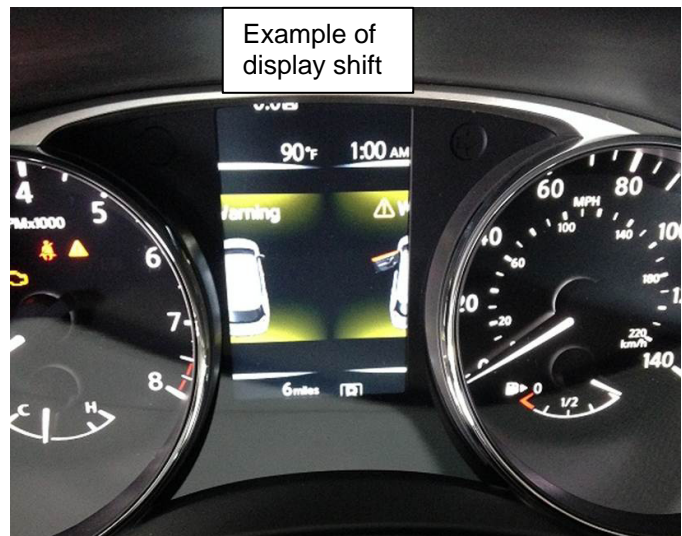
The images and information on the Vehicle Information Display are shifted from their normal positions, vertically or horizontally,

NOTE: This incident may be intermittent.

Reprogram the Vehicle Information Display (METER/M&A) per the Service Procedure in this bulletin.

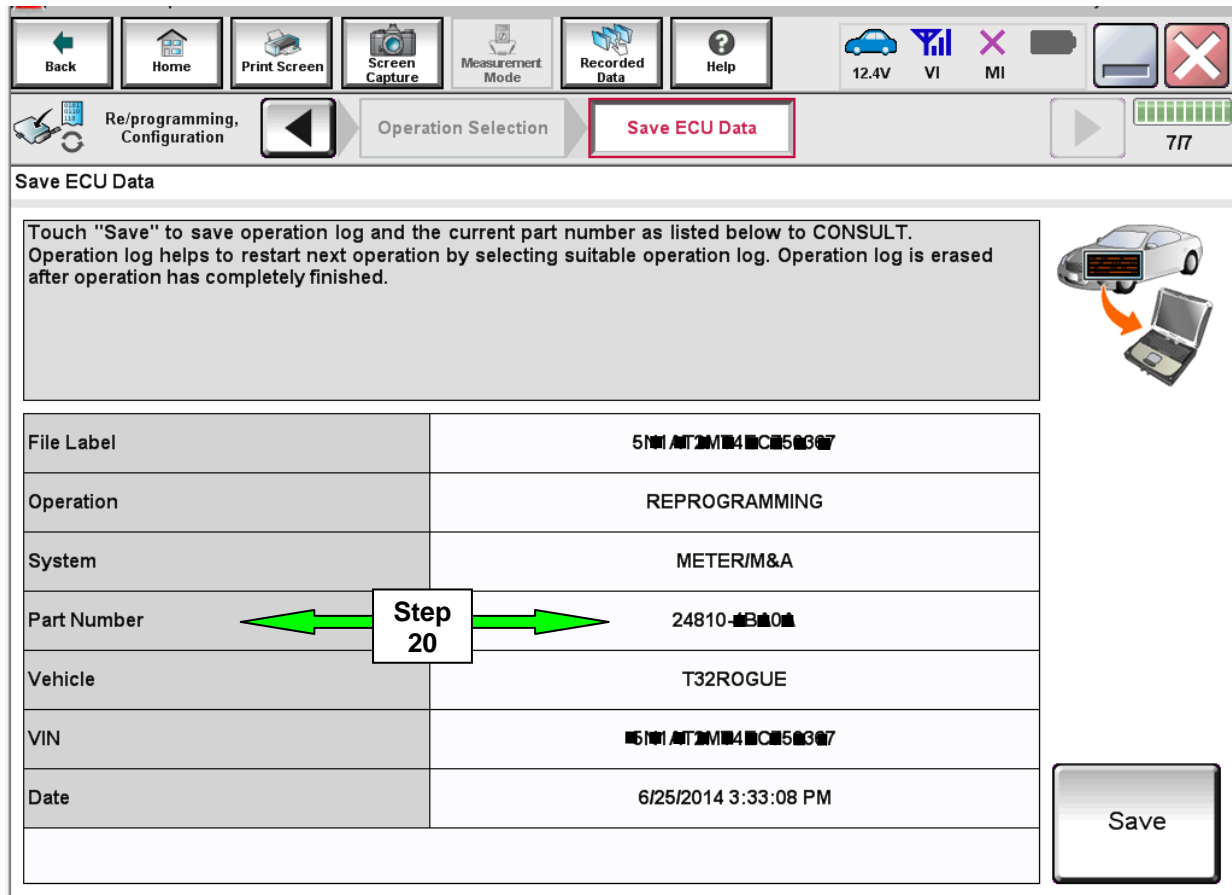
Figure 9

A. Find the METER/M&A **Part Number** and write it on the repair order.

NOTE: This is the current METER Part Number (P/N).

B. Compare the P/N you wrote down to the **Current Meter Part Numbers** in **Table A** below.

- If there is a match, the METER needs to be reprogrammed to resolve the incident described in this bulletin. Continue with the reprogramming procedure.
- If there is not a match, reprogramming does not apply. Refer to ASIST for further diagnostic information.

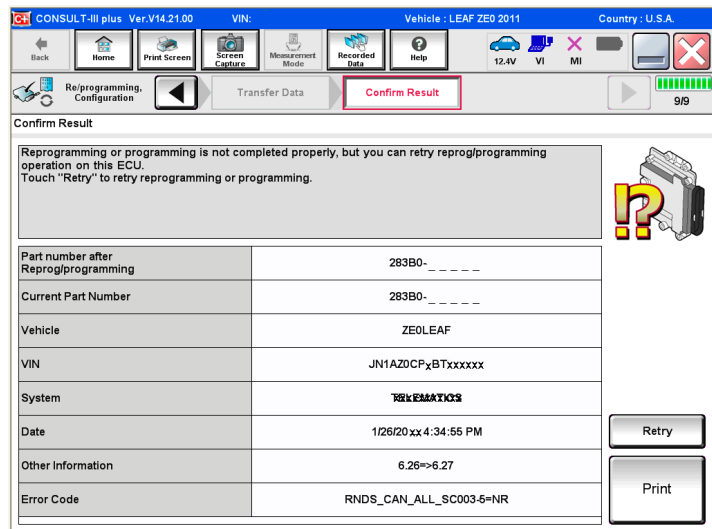
Figure 20

If reprogramming does not complete and the “!?” symbol displays as shown in Figure 20:

- Check battery voltage (12.0 – 15.5V).
- Ignition is ON, Ready Mode is OFF.
- External Bluetooth® devices are OFF.
- All electrical loads are OFF.
- **Select Retry and follow the on screen instructions.**

NOTE: Retry may not go through on first attempt and can be selected more than once.

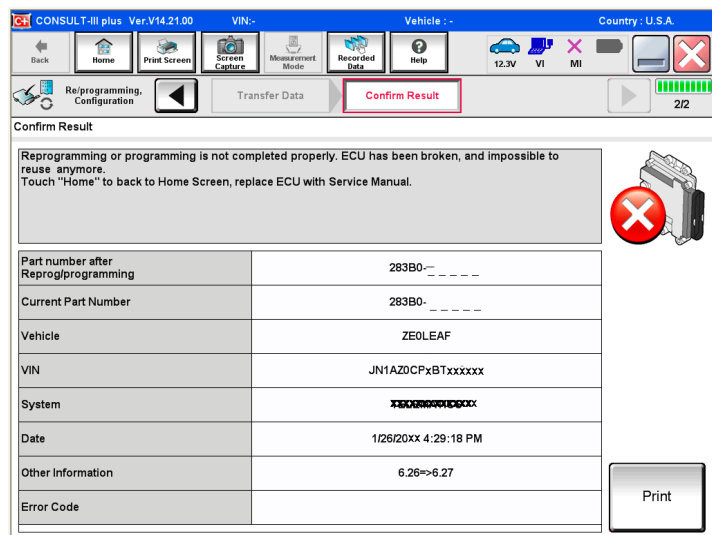
Figure 21

If reprogramming does not complete and the “X” symbol displays as shown in Figure 21:

- **Do not disconnect the plus VI or shut down C-III plus if reprogramming does not complete.**
- Check battery voltage (12.0 – 15.5V).
- CONSULT A/C adapter is plugged in.
- Ignition is ON, Engine is OFF.
- Transmission in Park.
- All C-III plus / plus VI cables are securely connected.
- All C-III plus updates are installed.
- **Select Home, and then restart the reprogram procedure from the beginning.**
