SERVICE BULLETIN

Classification: EL13-035b	Reference: NTB13-085b	Date: October 13, 2014
------------------------------	--------------------------	---------------------------

2014-2015 ALTIMA & 2014 ROGUE; AUDIO VISUAL SYSTEM SOFTWARE UPDATE

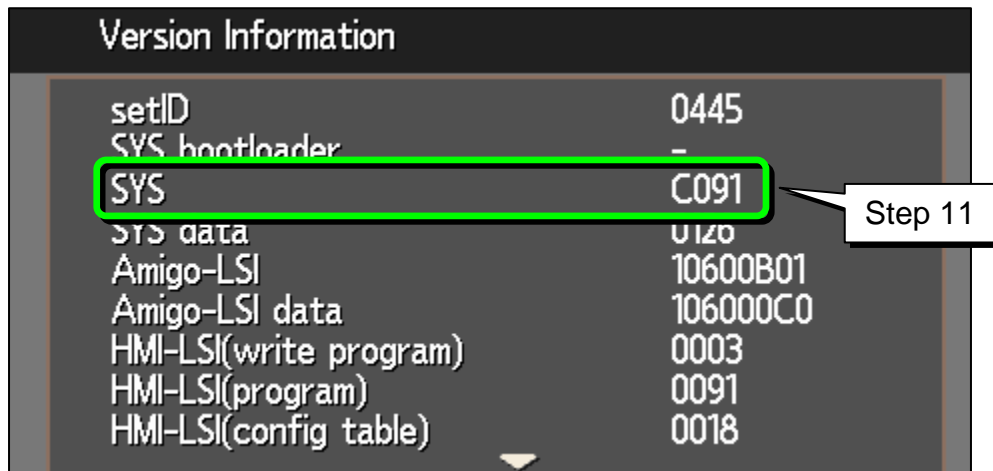
Figure 4

11. Check the **SYS** version number (Figure 4). It should **NOT** be "5091".

IMPORTANT: If the **SYS** version is "5091" this bulletin does not apply. Refer to ASIST for further diagnostic and repair information.

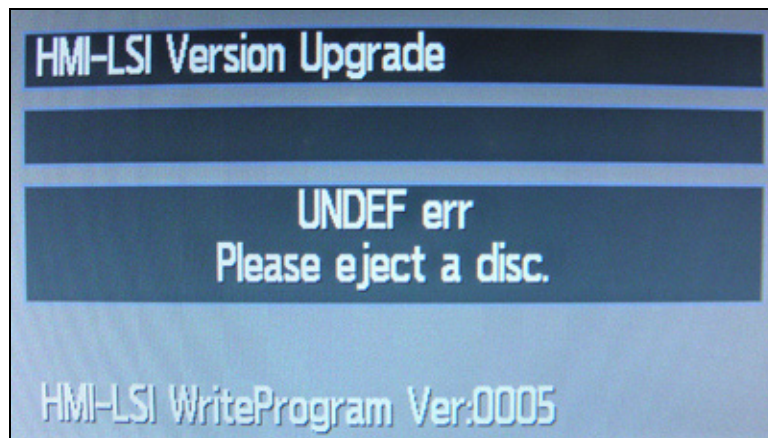
Figure 5

- Do not turn the ignition OFF or remove the USB Flash Memory while the software update is in progress.
- Do not remove the USB Flash Memory when “**UNDEF err Please eject a disc**” is displayed (see Figure 5).

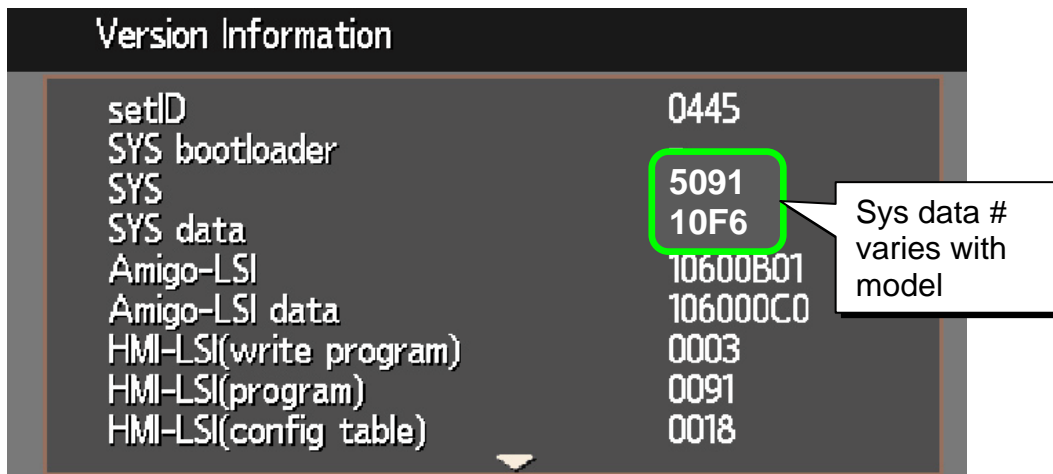
Figure 10

- f. Verify the **SYS** version and **SYS data** version (Figure 10) are correct as follows:

Model	Option	SYS	SYS data
2014-2015 Altima	Non-BOSE	5091	10F6
	With BOSE	5091	11F6
2014 Rogue	Without XM/APPS	5091	02F6
	With XM/APPS	5091	04F6

- If the version numbers are not correct, confirm the correct USB Flash Memory was used and perform steps 12 through 21 again.
