2014-15 Infiniti QX60 OCS ECU Module Retailer Inventory Inspection

Reference: PC328

Date: November 8, 2014

PROCESS NAME:	OCS ECU Module Check	PNC:	PC328	DATE:	11/7/14
VEHICLE AFFECTED:	2014-2015	INFINITI	QX60	REV:	01

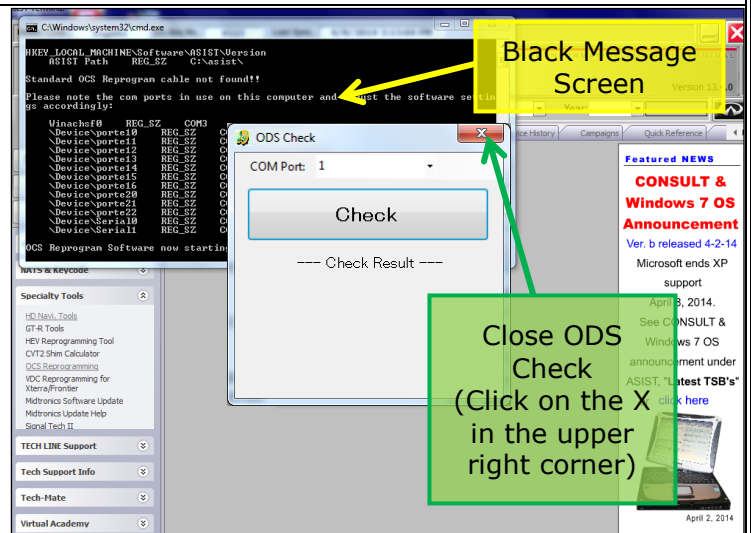
Figure 2

- If you get a black message screen as shown in Figure 2, this indicates that the reprogramming cable is not connected, or the cable driver did not install correctly.

- Close ODS Check.
- Close ASIST.
- Start over from step 1.

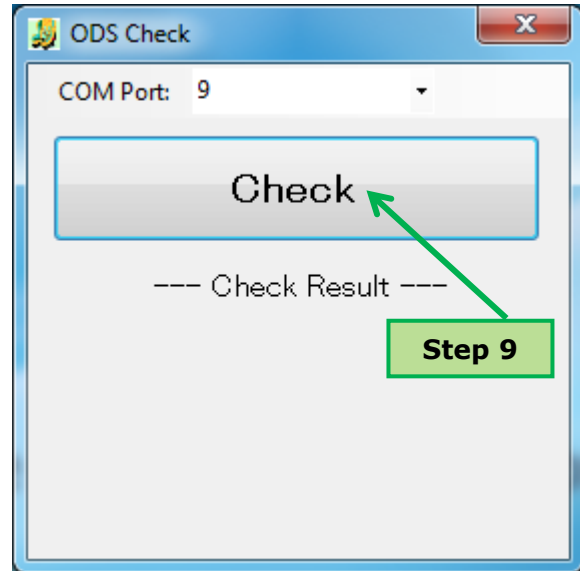
Figure 3

- If the error message “an error occurred on connection” displays:
 - a) Disconnect the J-51594 OCS reprogramming cable, both ends.
 - b) Reconnect the cable; make sure it is securely connected at both ends.

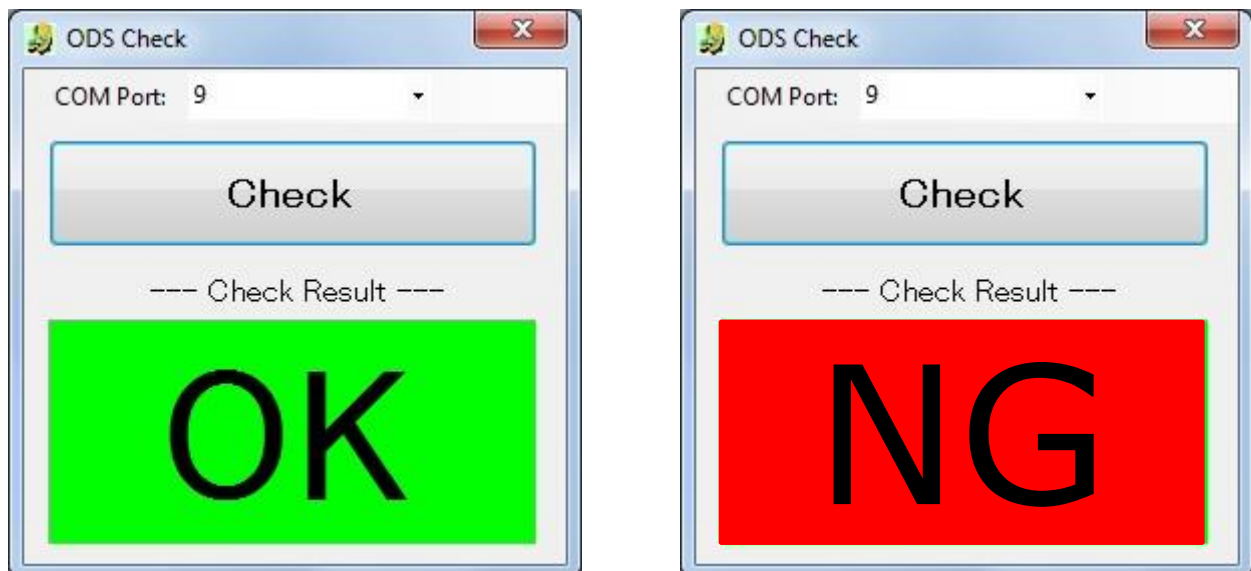
Figure 4

- Results will indicate **OK** or **NG** as shown in *Figure 4*.

- Continue to **HOLD VEHICLE**
- Email FQA Support (NNAFQASupport@Nissan-USA.com) with the following information and await instruction:
 - VIN
 - Dealer ID
 - Contact Information
