# SERVICE BULLETIN

BT14-023

## 2014 ROGUE; CARPET WET FRONT FLOOR AREA

**APPLIED VEHICLE:** 2014 Rogue (T32)

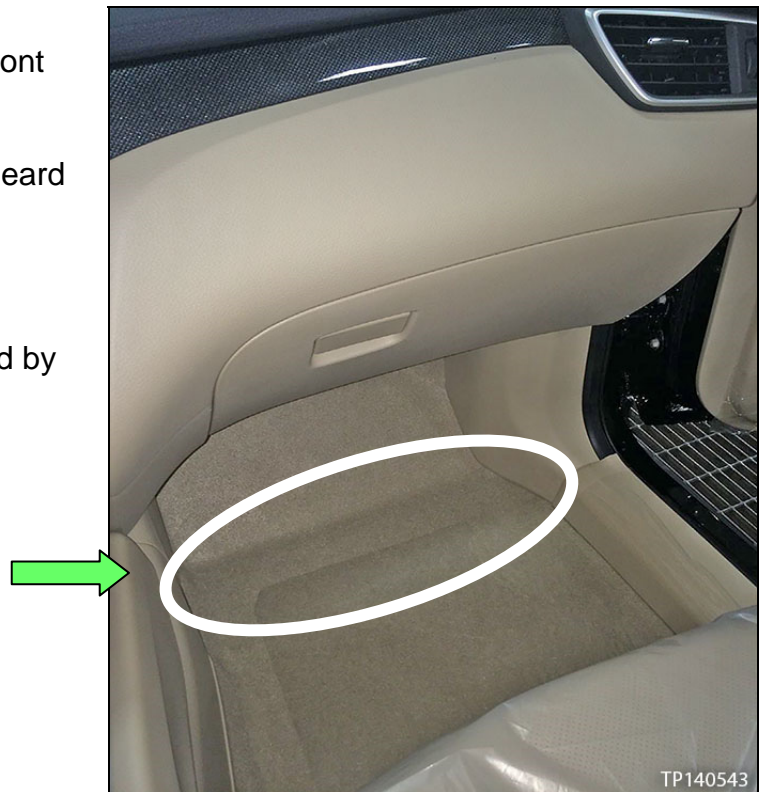
Figure 1

The carpet is wet on the driver and/or front passenger floor (see Figure 1).

1. Determine if the leak is from the kick panel and/or cowl end area.
2. If confirmed, apply body sealant to the incident areas as outlined in this bulletin.

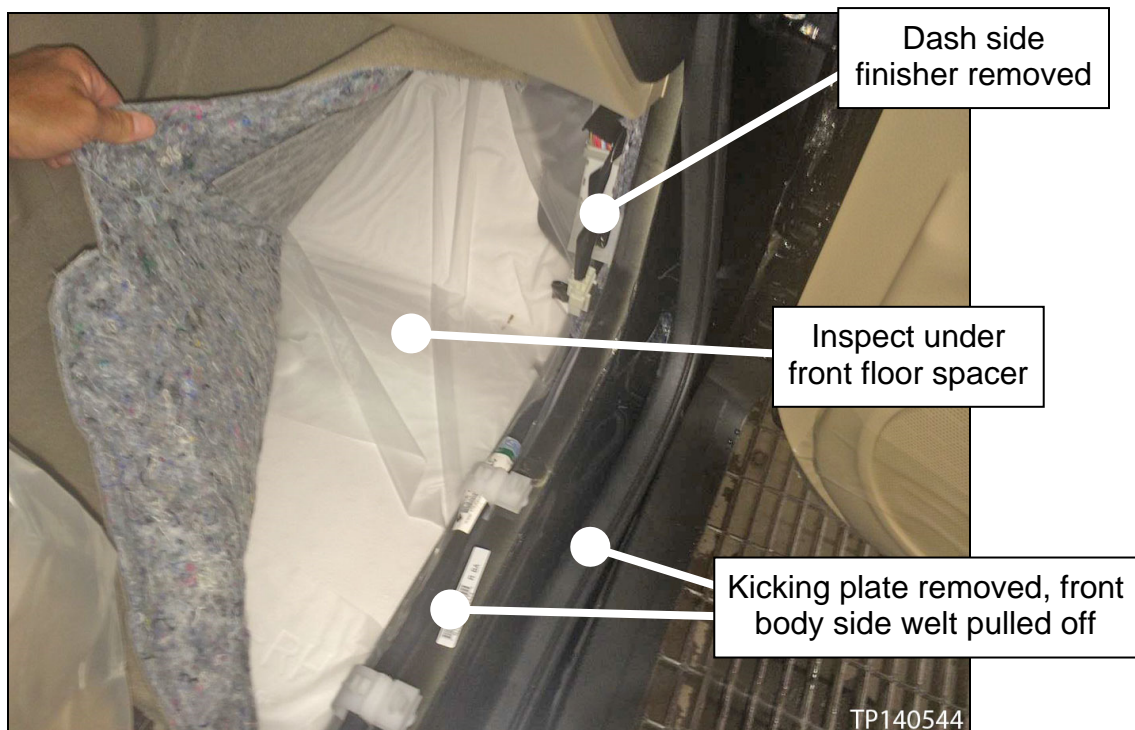
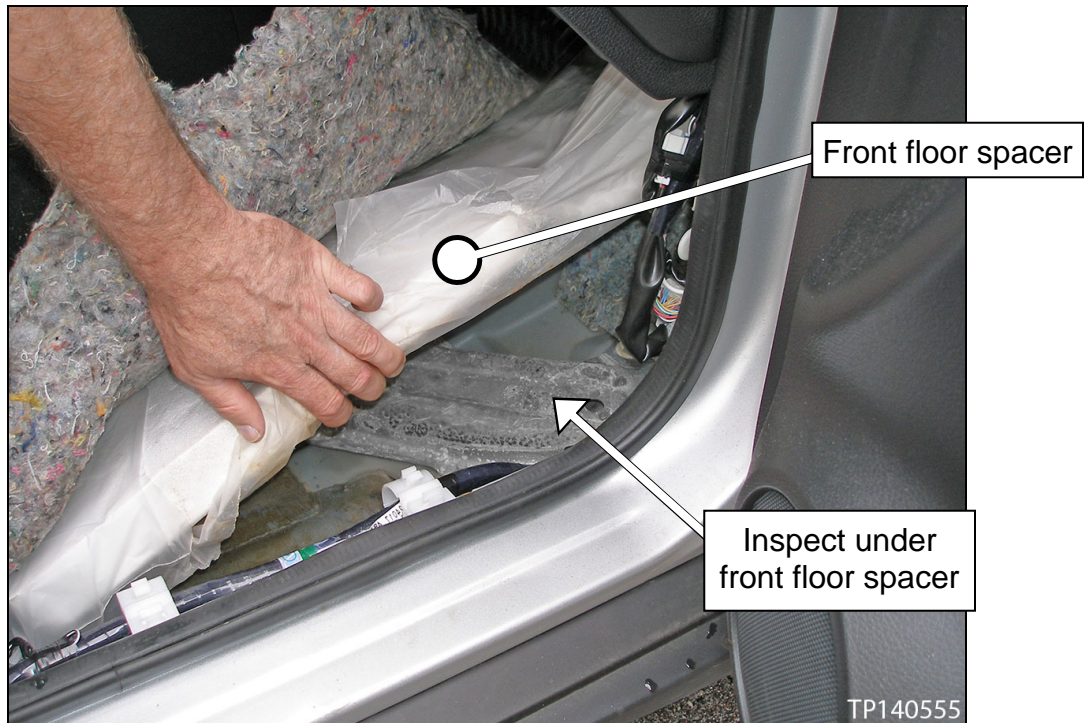
1. Pull back the front floor trim (carpet) on both driver and front passenger floors, even if only one side is wet (see Figure 2, and 2a on the next page).
2. To be able to pull back the carpet:
  - a. Remove the front kicking plates.
  - b. Pull off the front body side welts at the bottom.
  - c. Remove the dash side finishers.
    - Refer to the Electronic Service Manual (ESM), section **INT-Interior**, for removal of the parts stated in step 2a - c.
3. Check for water under the front floor spacers (see Figure 2 and 2a).

4. If water is found under one or both front floor spacer(s):
  - a. Thoroughly dry the area(s).
  - b. Skip to **Body Sealing** on the next page.
5. If no water is found below either front floor spacer:
  - a. Leave the vehicle interior disassembled.
  - b. Perform a water leak test at the cowl and wheel well areas.
    - Run water down inside the cowl and spray water in the wheel well areas with a garden hose or similar water supply.
      - Do not use an excessive amount of water. Do not use a pressure sprayer.
  - c. Check again for water under both front floor spacers.
6. If still no water detected after water leak testing:
  - a. This bulletin does not apply. Refer to ASIST and the ESM for further diagnosis.
7. If water is found:
  - a. Leave the vehicle interior disassembled.
  - b. Go to **Body Sealing** on the next page.

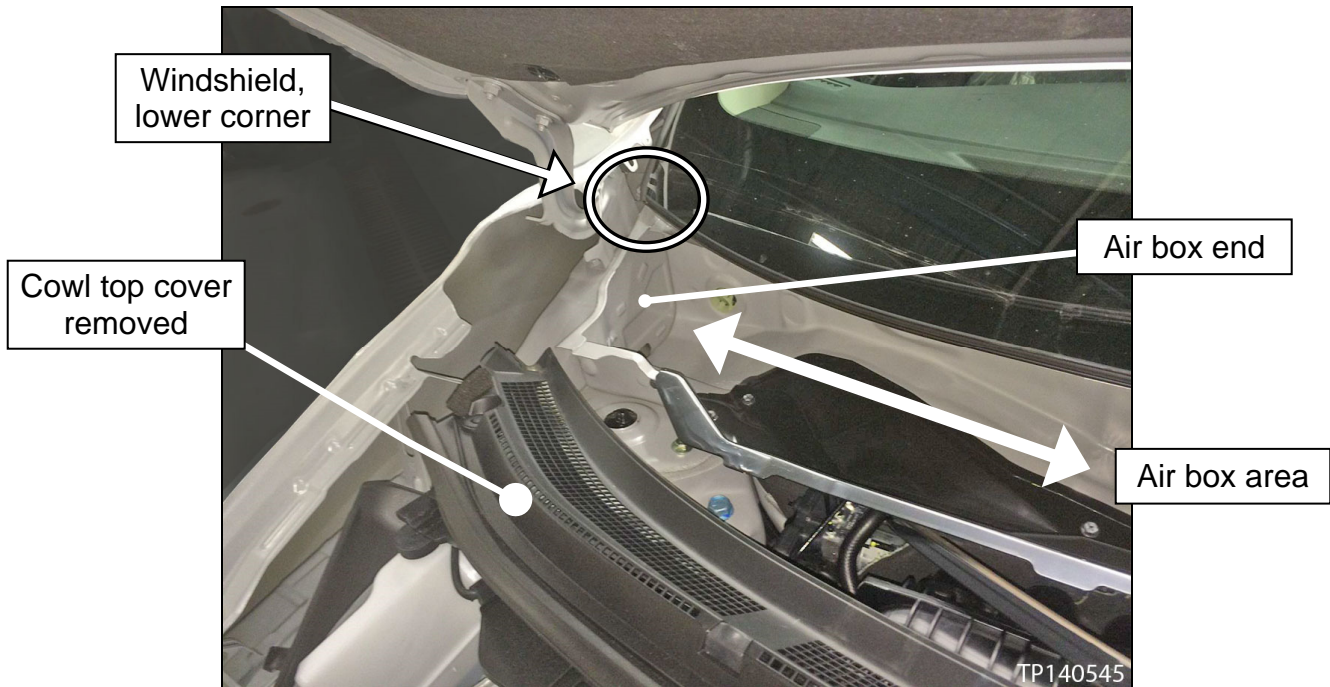
Figure 3: View of passenger side. Driver side similar.

1. Remove the cowl top cover (see Figure 3).
  - Refer to the ESM, section **EXT-Exterior**, for cowl top cover removal procedure.

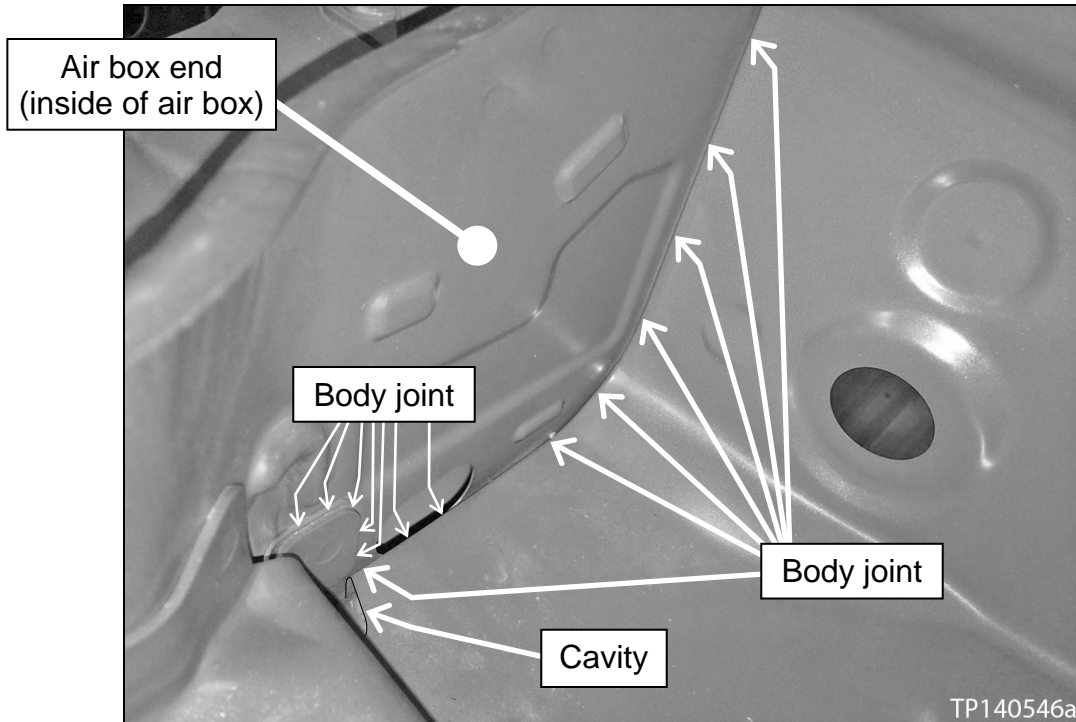
2a. Inspect for body sealer on the side that leaks where shown in Figure 4 and 5.

Figure 4: Body joint, passenger side. Driver side similar.

- Apply body sealer with a suitable applicator to all areas where body sealer is not seen.
- If an area is questionable, add body sealer.
- Use one of the body sealers listed in **PARTS INFORMATION** or equivalent.
- Follow the body sealer's directions for proper application.

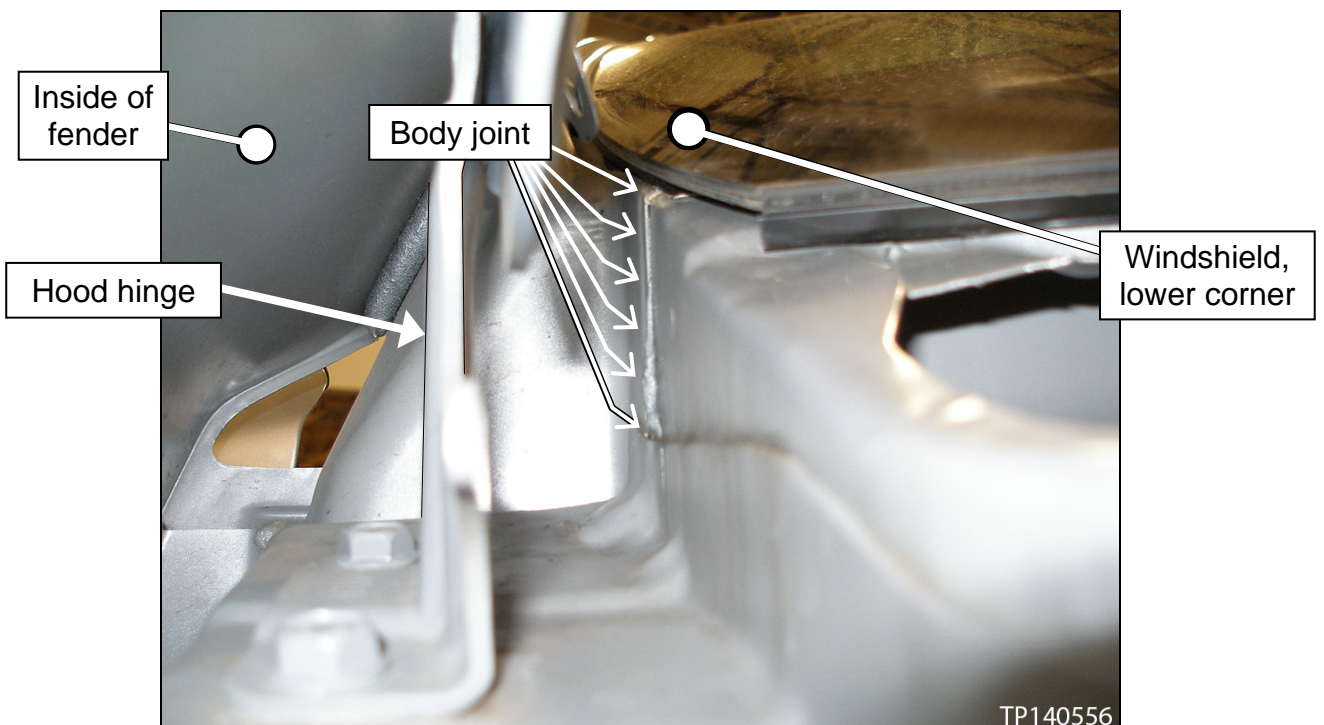
Figure 5: Body joint, passenger side. Driver side similar.

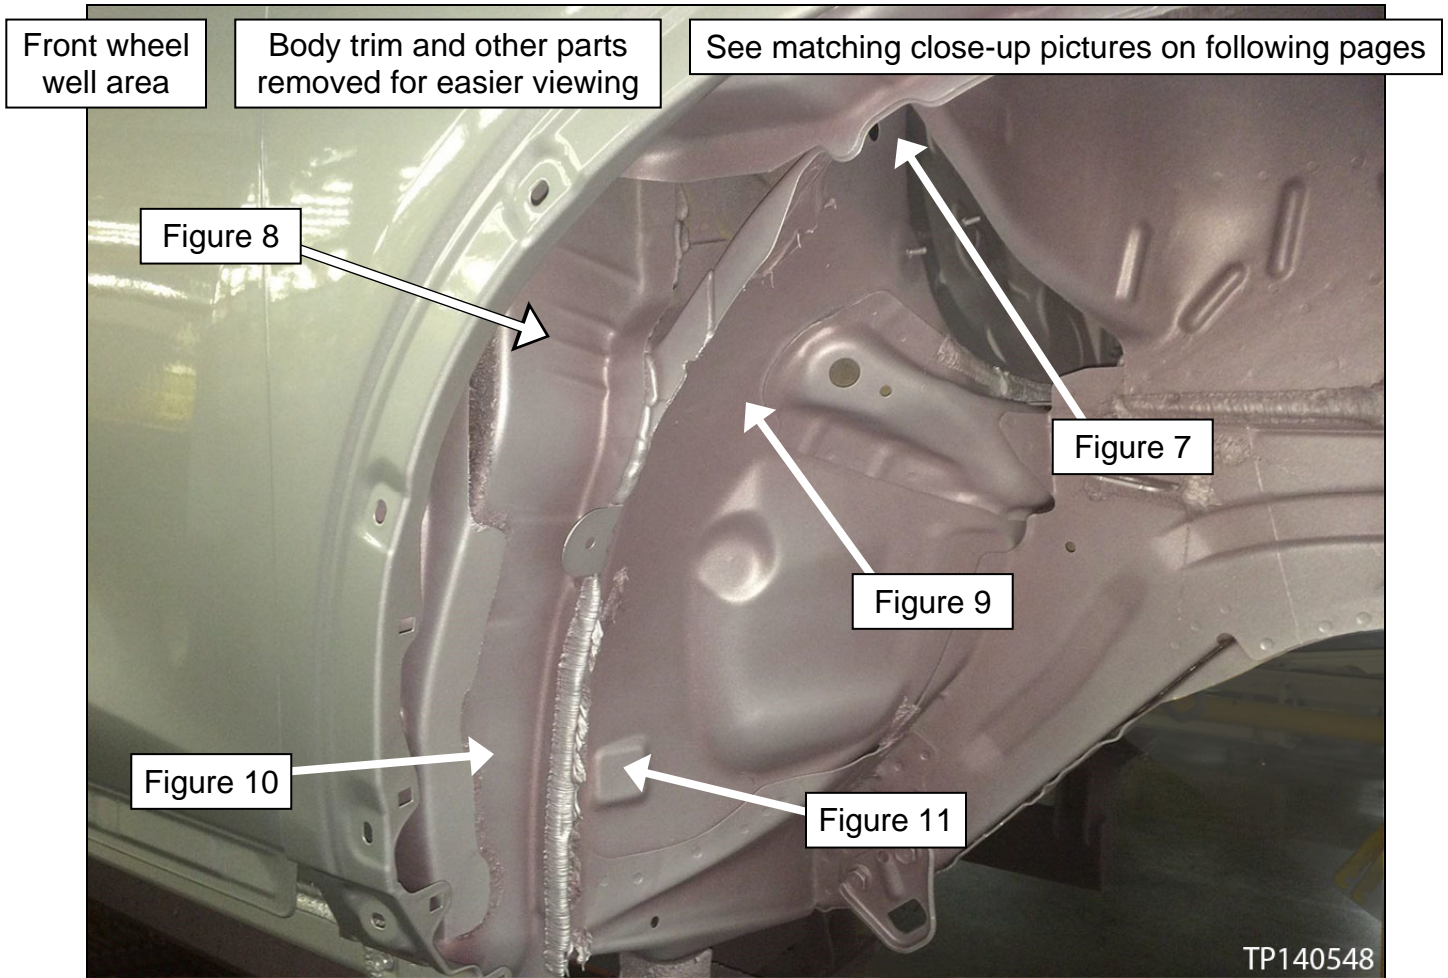
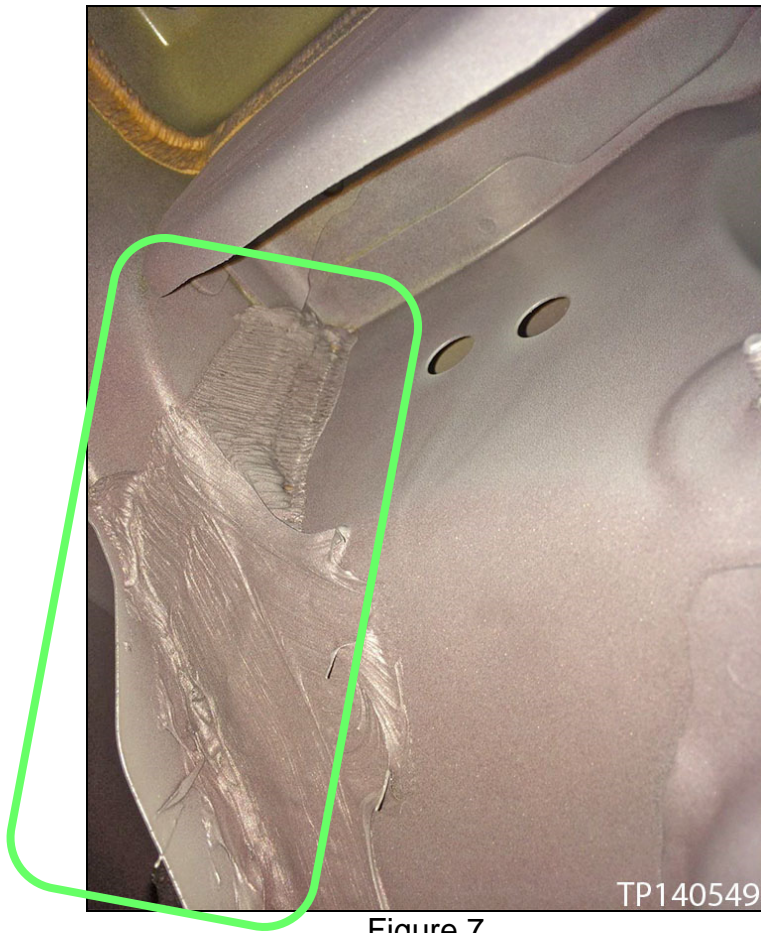
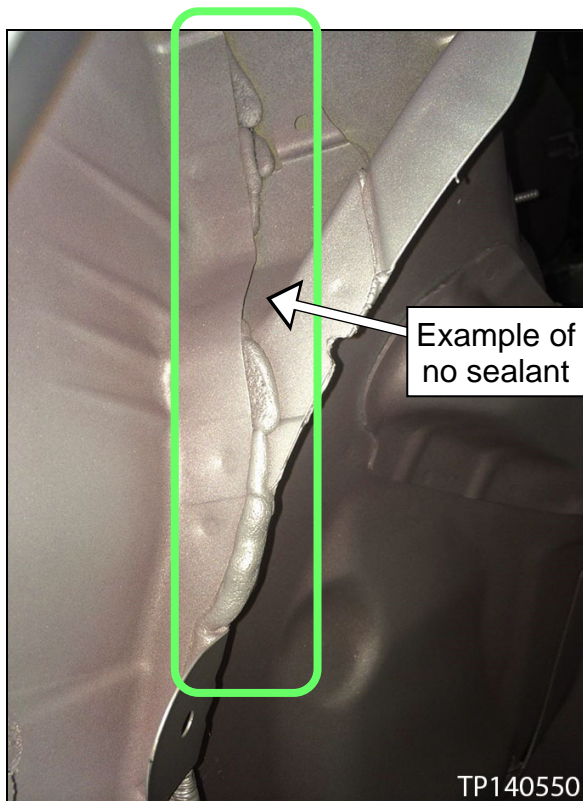
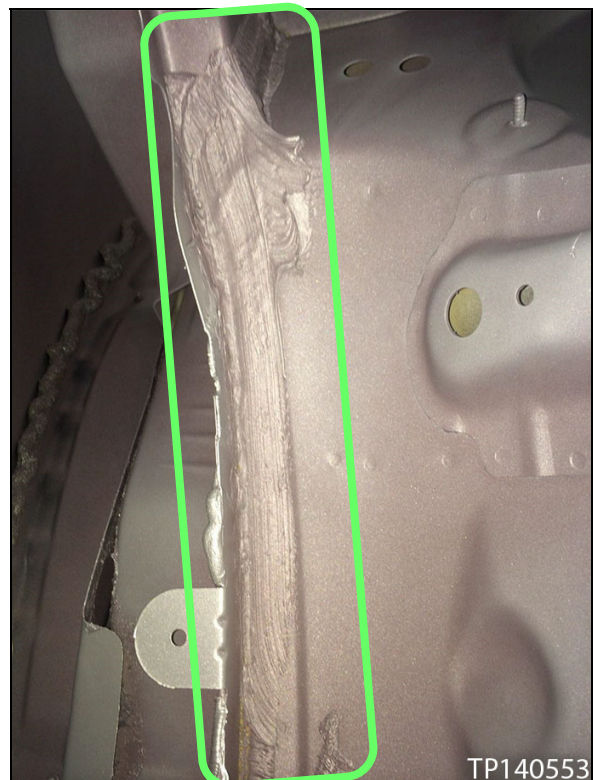
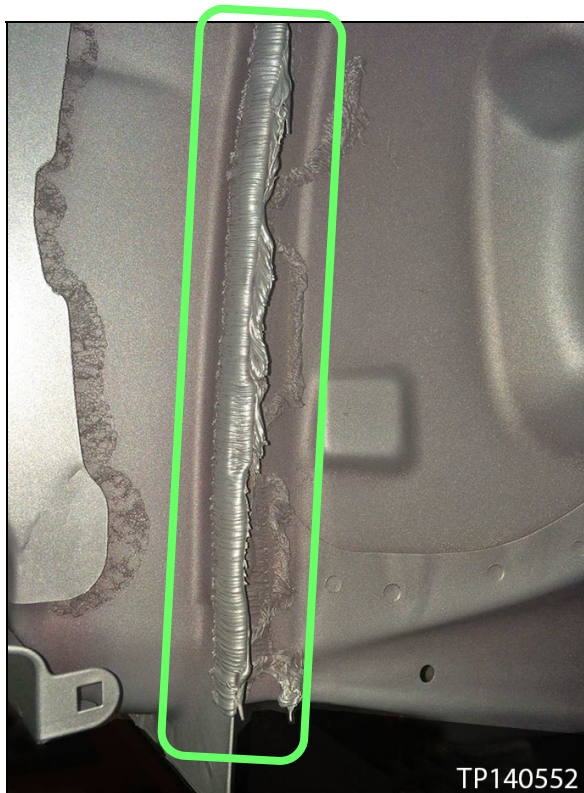
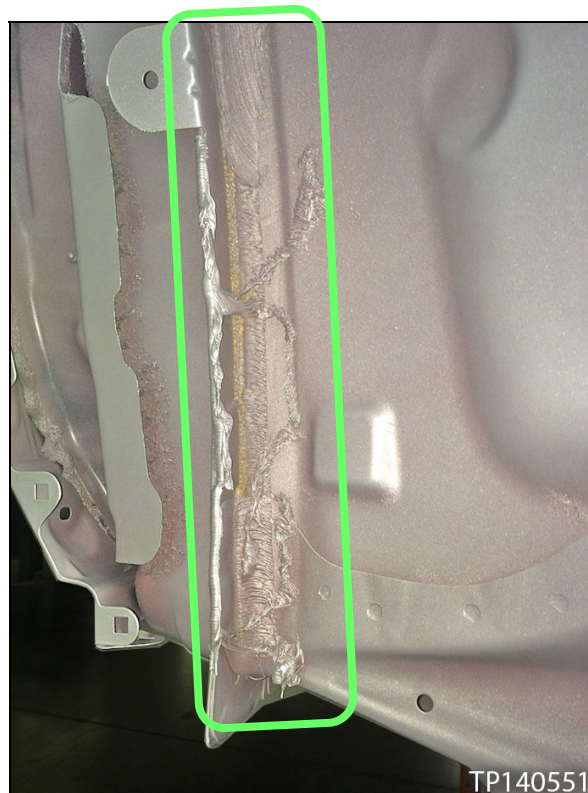
4. Inspect the areas shown in Figure 6 – 11 for body sealer or gaps in body sealer.
- Seal all areas where body sealer is not seen.
  - If an area is questionable, apply body sealer.

5. Once the sealer has sufficiently cured, perform another water leak test at the cowl and wheel well area(s).
  - First reassemble the fender protector(s) before testing the wheel well area(s).
    - Refer to the ESM, section **EXT-Exterior**, for front fender protector installation procedure.
  - Run water throughout in the cowl/air box area and spray water in the wheel well area(s) from a garden hose or similar water supply.
    - Drench these areas for a while but do not use an excessive volume of water. Do not use a pressure sprayer.
