# After-sales Retailer Support

## 2014 QX60 Hub & Torque Member Bolt

### Retailer Inventory Inspection

Reference: PC331

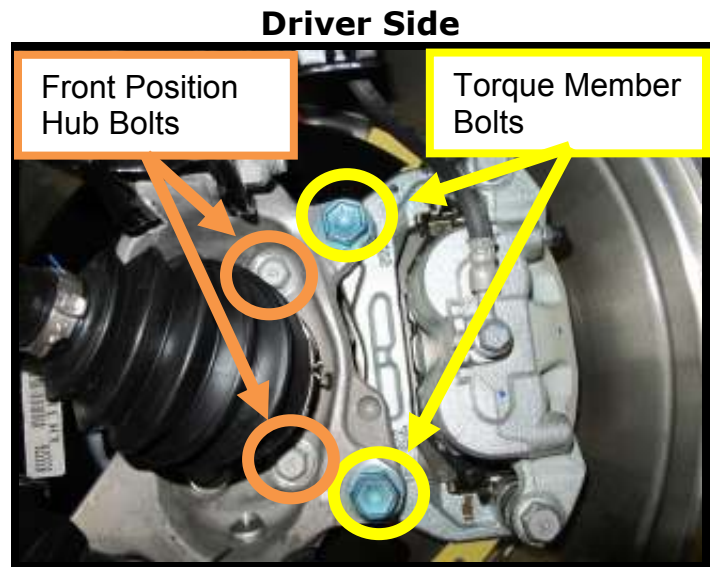
Figure 1

1. Turn the steering wheel to full left turn position.
2. Lift the vehicle using a hoist.
3. On the driver side knuckle, use a torque wrench to torque the following bolts (Figure 1):
  - Torque member bolts:  
123N·m (91 ft-lb)
  - Front position hub bolts:  
88.3N·m (65 ft-lb)

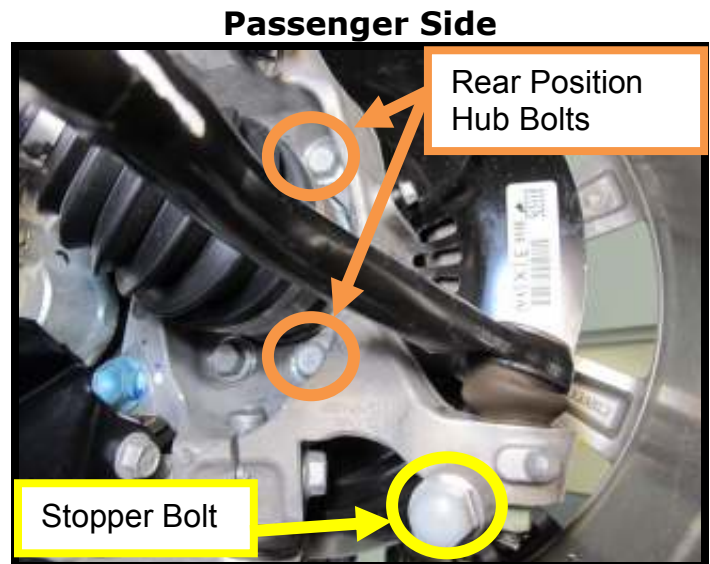
Figure 2

4. On the passenger side knuckle, use a torque wrench to torque the following bolts (Figure 2):
  - Rear position hub bolts:  
88.3N·m (65 ft-lb)
  - Stopper bolt:  
63N·m (46 ft-lb)

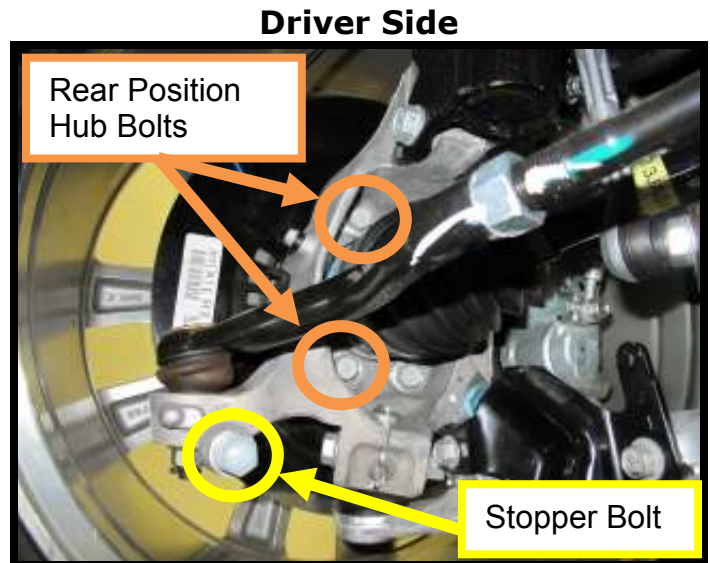
Figure 3

6. On the driver side knuckle, use a torque wrench to torque the following bolts (Figure 3):

- Rear position hub bolts:  
88.3N·m (65 ft-lb)
- Stopper bolt:  
63N·m (46 ft-lb)

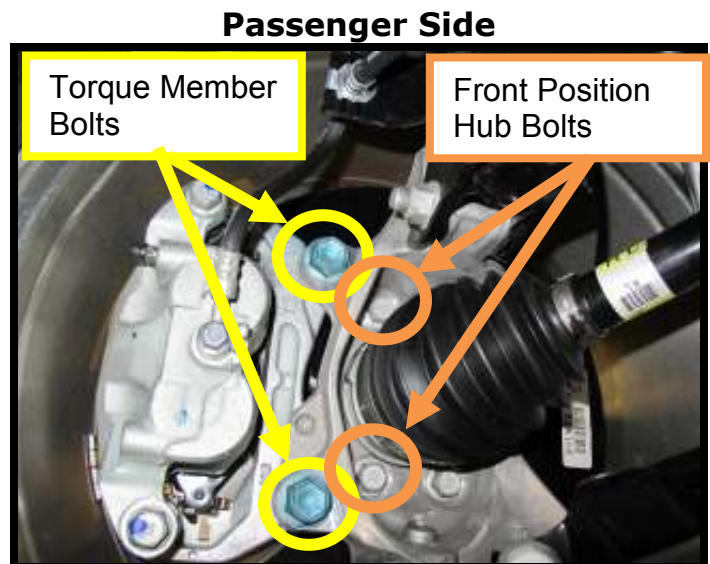
Figure 4

7. On the passenger side knuckle, use a torque wrench to torque the following bolts (Figure 4):

- Torque member bolts:  
123N·m (91 ft-lb)
- Front position hub bolts:  
88.3N·m (65 ft-lb)
