EC12-006a

ITB12-025a

December 16, 2014

## 2011-2012 QX56; ENGINE FAN IS NOISY AND VEHICLE HAS POOR ACCELERATION

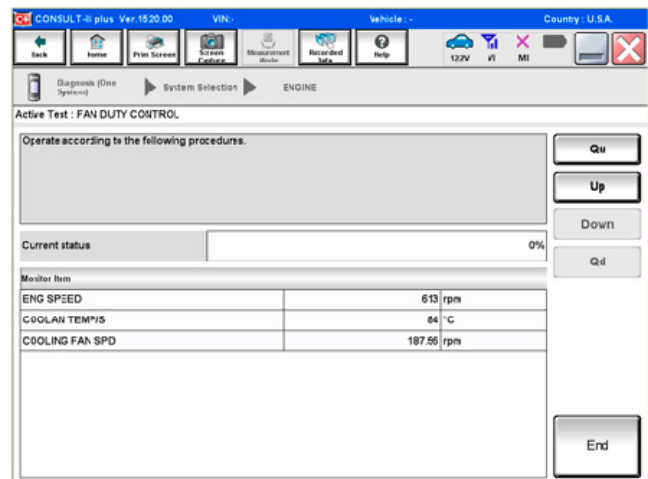
Figure 9

- Confirm that the cooling fan speed is below the engine idle speed.

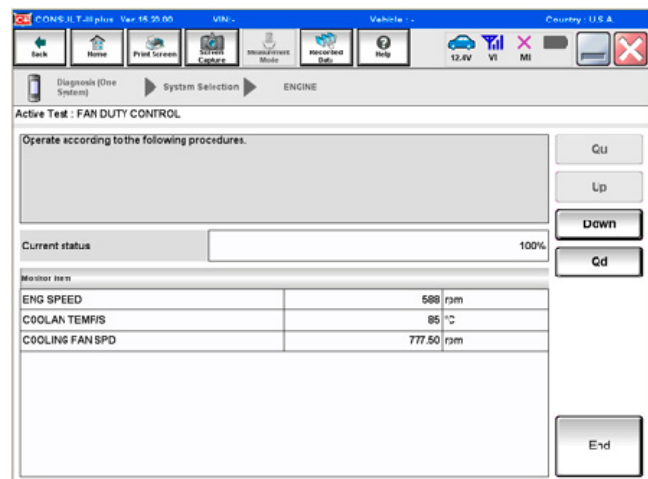
Figure 10

4. Now change the FAN DUTY to 100%.
  - A. Raise the engine speed slowly to 2000 rpm several times and allow it to return to idle, and then confirm that the fan speed increases above engine idle speed (this may take up to 1 minute).
  - B. If the fan speed increases, go to step 5.
  - C. If the fan speed **does not** increase, go to step 6.

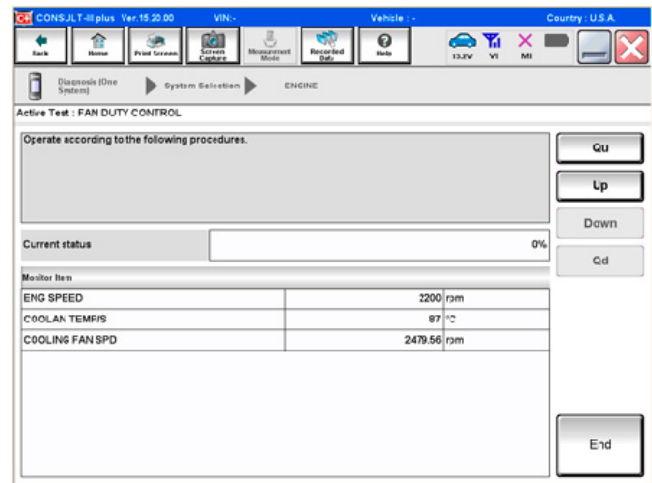
Figure 11

Slowly raise the engine rpm up to 2000 rpm and hold until the fan speed drops below 600 rpm (this may take up to 1 minute).

- A. **If the fan speed will not decrease**, return engine to idle and allow at least 3 minutes at idle for the fan speed to decrease below engine idle speed.
- B. If the fan speed **does not** decrease go to step 6.

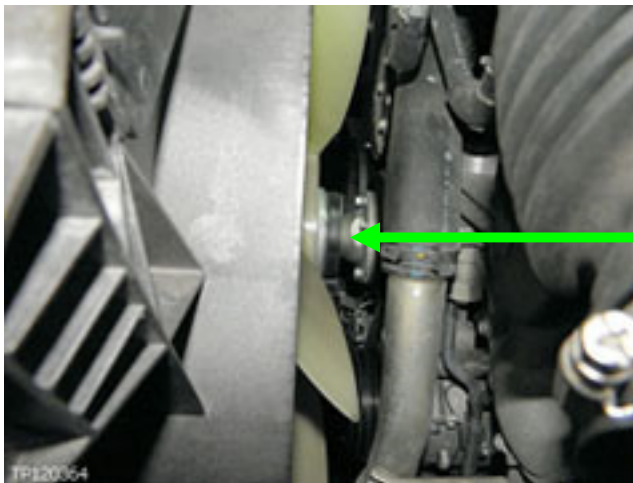
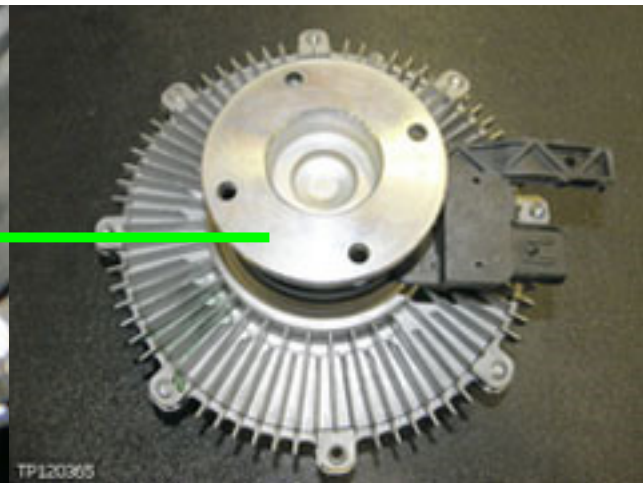
The Engine Cooling Fan is louder than normal.

There is a noticeable lack of power when accelerating in traffic, particularly in HOT weather.

6. If the fan speed will not increase (step 4) or decrease (step 5) using Active Test, replace the fan coupling shown in Figures 12 and 13.

- Refer to the ESM, section **CO-Engine Cooling System**, for removal and installation instructions.
