NISSAN BULLETIN

2015 Murano Air Duct Hose Dealer Service Action

Reference: PC337

Date: December 18, 2014

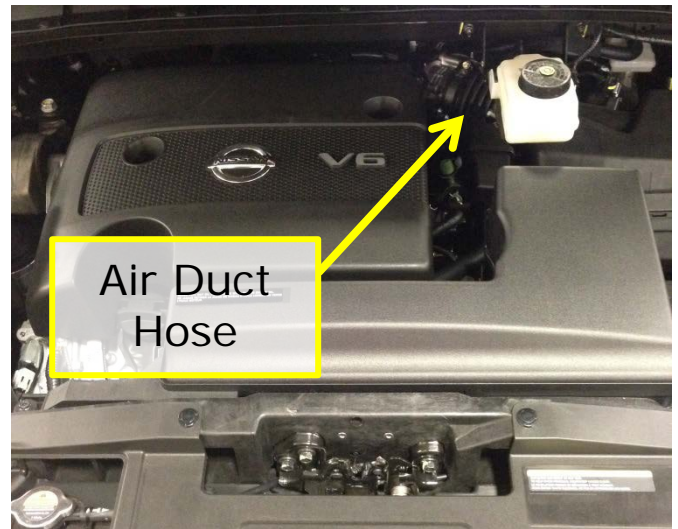
Figure 1

1. Open hood and locate Air Duct Hose between air cleaner case (upper) and electric throttle control actuator (*Figure 1*).

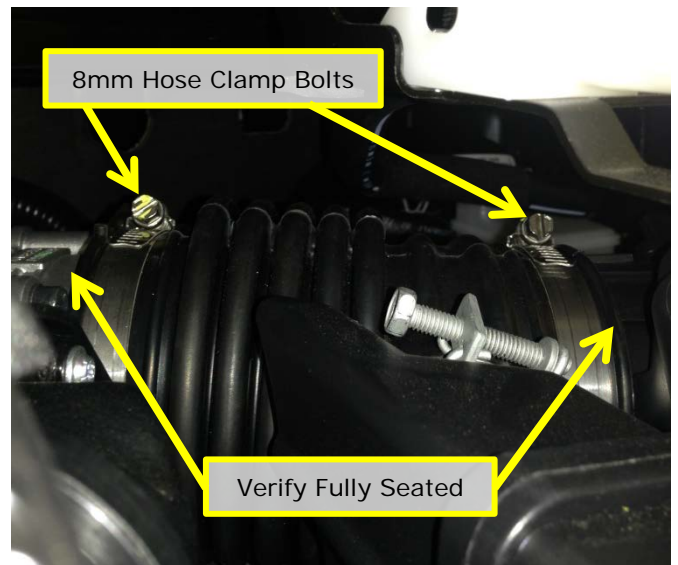
Figure 2

2. Verify air duct hose is fully seated on both ends and confirm both hose clamps are installed/tight (*Figure 2*).

If air duct hose was **not** fully seated or either hose clamp was **loose**

- Properly seat hose and/or tighten hose clamps.
- Close hood and **continue to next step**

3. Using Consult III, check for DTCs and clear if necessary.
